PRELIMINARY ENGINEERING REPORT
BLACKTAIL DAM
SWC #560
WILLIAMS COUNTY

NORTH DAKOTA
STATE WATER COMMISSION
SEPTEMBER 1990

PRELIMINARY ENGINEERING REPORT

Blacktail Dam Spillway Replacement
SWC Project #560

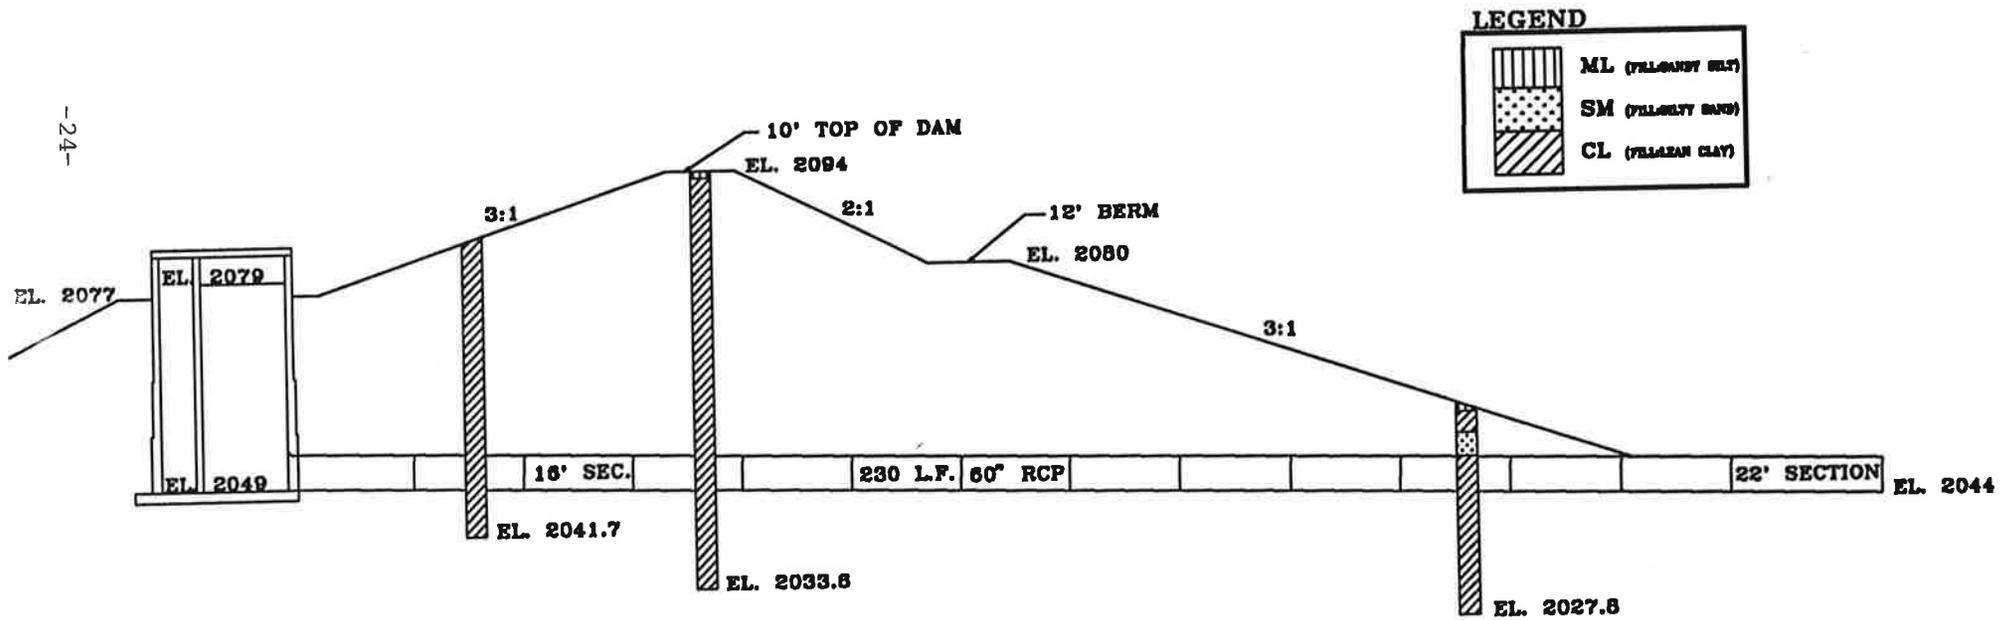
Figure 8 - Transverse Profile
of Dam at Principal Spillway

The present principal spillway consists of 270 feet of 36-inch diameter RCP with a 5'x6'x6' drop inlet. The slope of the pipe is approximately 14 percent. The relatively steep slope of the pipe prevents it from reaching full pipe flow. Although problems with the existing spillway have not occurred in the past, the potential for slugging and possible dam failure exist. In addition, the pipe is not capable of handling the design flow required for a Class IV dam. Table 5 gives the inflow, outflow, and stage for the different precipitation events for the existing conditions generated by the HEC-1 model. This data shows that the water surface elevation exceeds the elevation of the emergency spillway (2086 msl) for the 50-year 12-hour rainfall, as well as the 50-year 10-day snowmelt and rainfall.

Modifications to the existing principal spillway must be performed. The present spillway consists of a 36-inch diameter RCP with a 5'x6'x6' drop inlet. The slope of the spillway is approximately 14 percent. The relatively steep slope of the pipe prevents it from attaining full pipe flow with orifice flow controlling. This could lead to slugging and possible dam failure. The present spillway should not remain in service due to the potential hazard accompanying it. The recommended alternative for dealing with the present spillway is to take it out of service by grouting the intake of the pipe.

The existing 36-inch RCP spillway is a potential hazard and it is recommended that it be taken out of service. The proposed alternative for dealing with the existing spillway is to grout

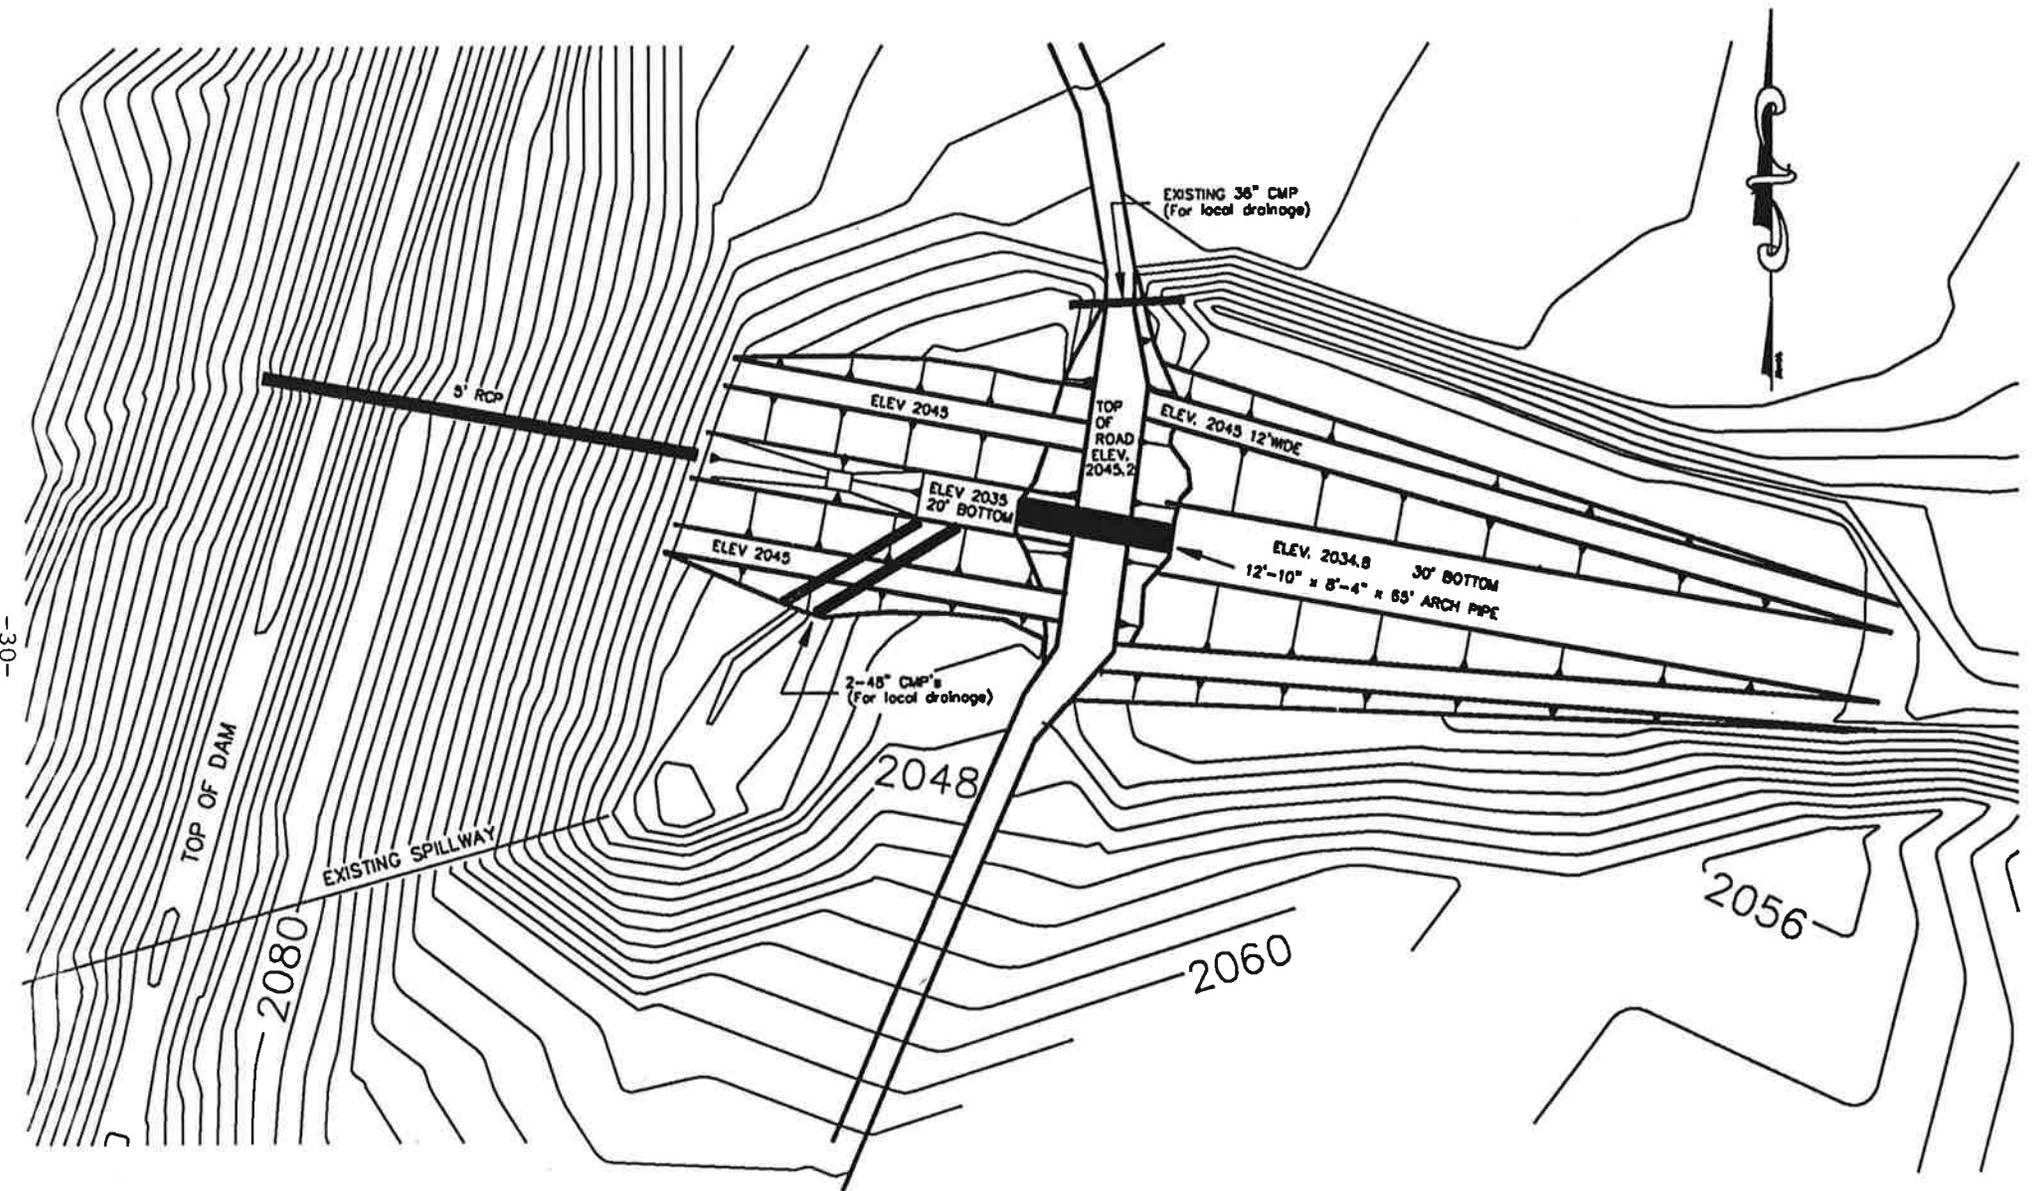
Figure 10 - Downstream Modifications

The maximum outflow from the proposed principal spillway is 664 cfs for a 50-year precipitation event. The present crossing is only capable of passing a flow of 275 cfs, based on a Bureau of Public Roads culvert nomograph with inlet control. This means that overtopping of the road will occur when flows greater than 275 cfs are encountered. Overtopping is not desirable since the road has washed out in the past when water passed over it. A Bureau of Public Roads nomograph, based on inlet control, was also used to size the new roadway crossing. A 65' long 12'-10" by 8'-4" arch pipe is recommended as a new roadway crossing. The arch pipe will pass flows of up to 700 cfs, with a maximum upstream water surface elevation equal to that of the top of the pipe.

Modifications to the downstream channel will be required in order to accommodate the proposed new spillway. The new location will eliminate the curved channel upstream of the road. A 20-foot wide channel paralleled by berms with 2:1 side slopes is recommended between the plunge pool exit and roadway crossing

It is recommended that 2 feet of cover be used over the arch pipe. This will require that the roadway be raised for a length of approximately 200 feet. The two 48-inch diameter CMP culverts

in the existing crossing can be relocated in the south berm of the outlet channel to pass flows due to local runoff. The 36-inch diameter CMP should remain at its present location to pass runoff from the north.

The channel downstream of the roadway should also be modified to allow for the new roadway crossing. A 30-foot wide channel paralleled by berms with 3:1 side slopes is recommended. This channel will be approximately 300 feet in length and will tie in with the existing channel (Refer to Figure 10).
