PRELIMINARY ENGINEERING REPORT
NIAGARA DAM
SWC # 464
GRAND FORKS COUNTY

PRELIMINARY ENGINEERING REPORT

**Niagara Dam
SWC Project #464**

July 1991

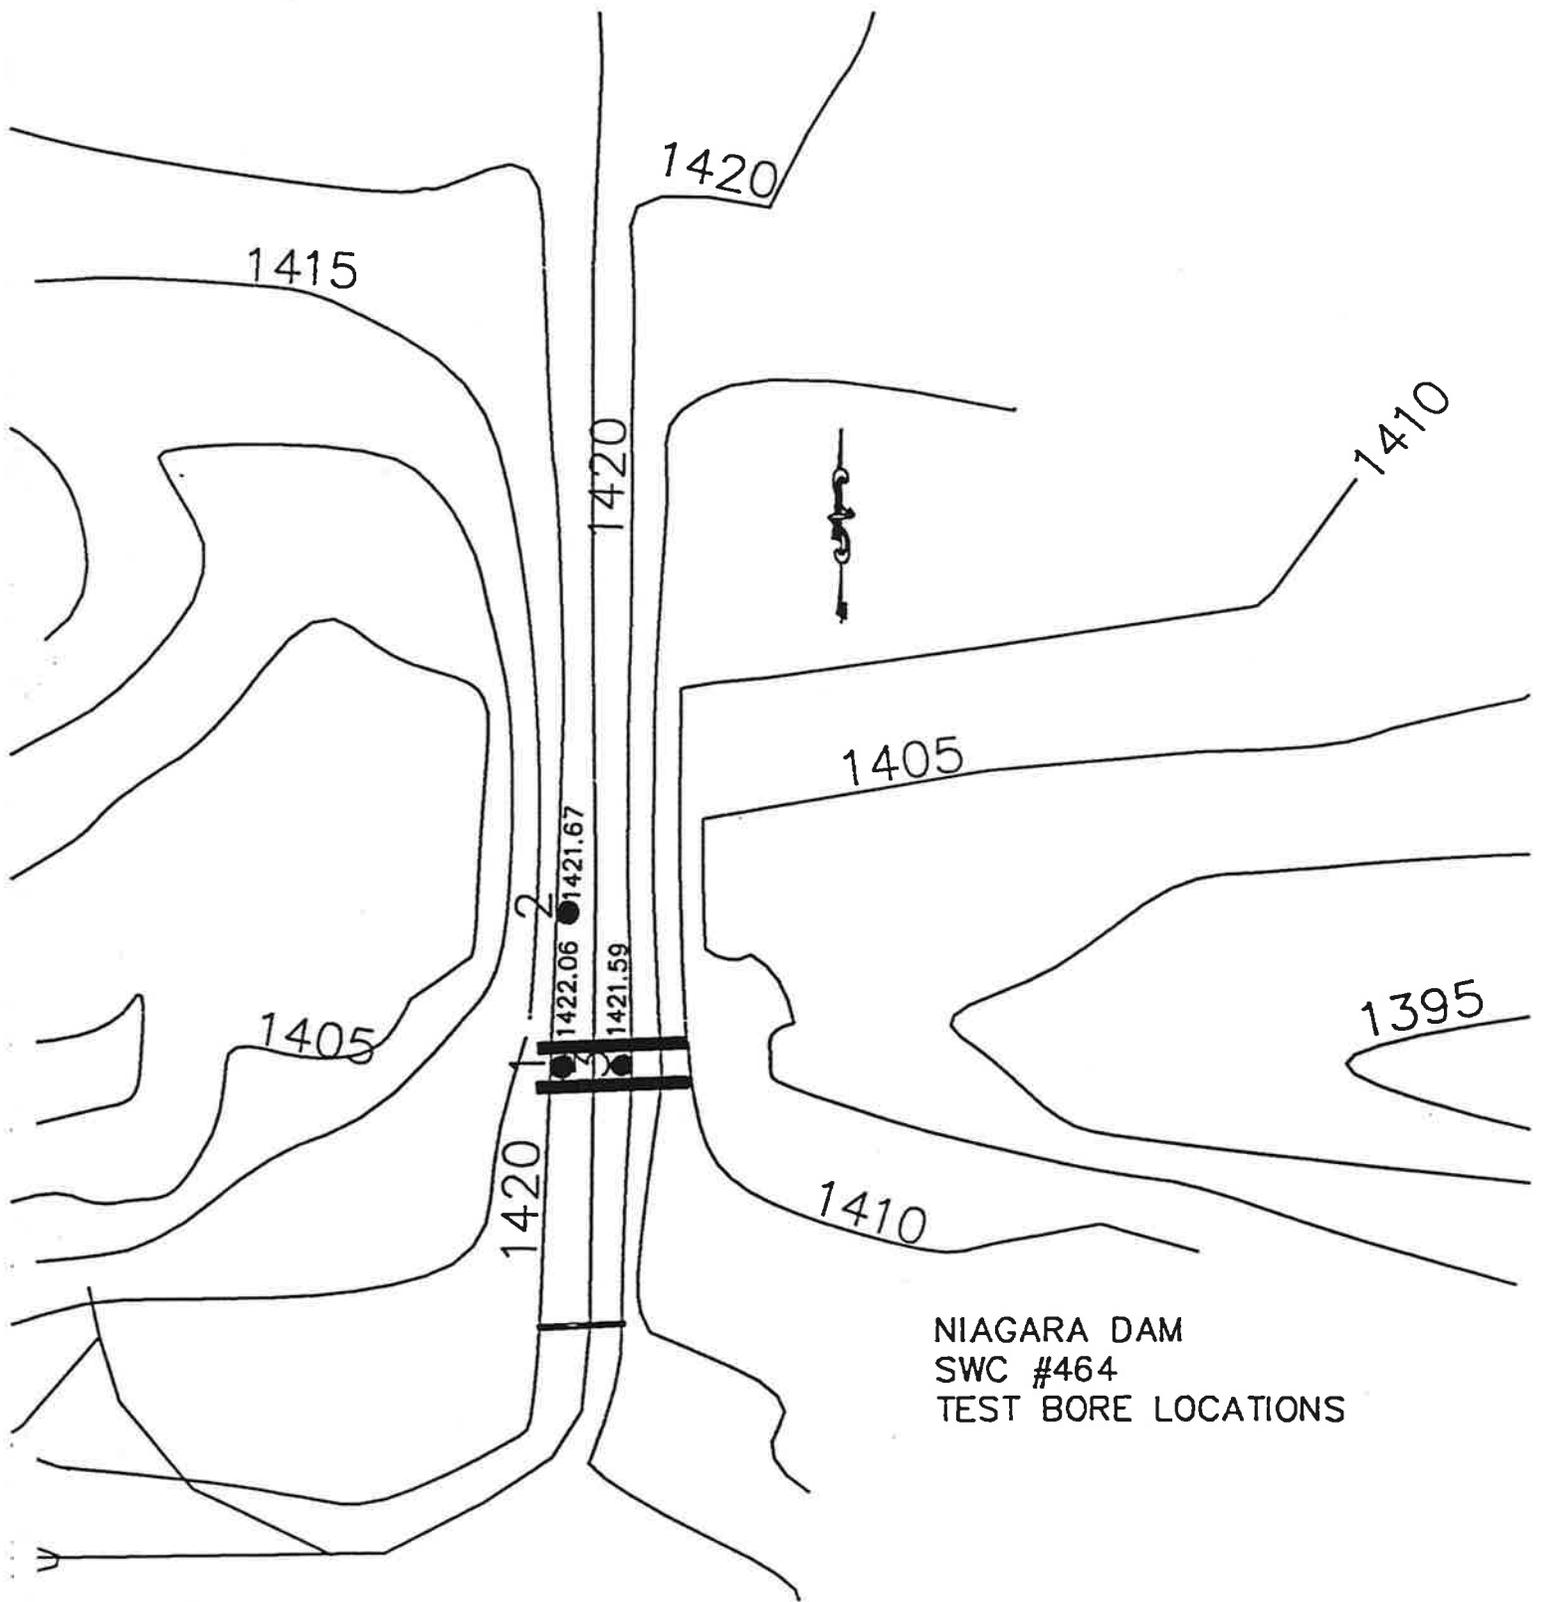
Figure 2
Location of Test Borings

The borings indicate that the original embankment was constructed of fill material consisting of sandy lean clay. Test boring number 2 was taken north of the existing spillway where the embankment has been unmodified. This boring shows approximately 24 feet of sandy lean clay fill on top of a layer of organic clay with sand. This indicates that the embankment was constructed on the existing ground without any subsurface preparation. The penetration resistances, "N" indicated on the soil logs indicate that the embankment was constructed of relatively soft material. The water level data indicates that the embankment is relatively water tight.

Test borings number 1 and 3 were taken near the upstream and downstream ends of the existing spillway, respectively. These borings also show soft material in the embankment. This soft material could explain the undermining that has occurred. In all likelihood, the strength of the original fill was insufficient to

support the spillway, which resulted in slight movement of the pipes when vehicles passed over the county road over the embankment. This slight movement provided a seam for water passage around the pipes during higher water levels, causing the pipes to undermine. The test borings at the existing spillway indicate that when the spillway was repaired, it was backfilled with firmer material laid on the original fill. Even though the spillway was backfilled with firmer material, it appears that the underlying material still allows movement of the pipes. This movement has resulted in the continued undermining of the pipes.

The proposed method to alleviate the undermining problem is to excavate the soft fill material at the desired spillway location. The original ground surface beneath the dam consists of stiff sandy lean clay with shale fragments. This material should provide a sufficient base for a new spillway. After excavation to the original ground surface, the area should be backfilled with suitable fill material and the new spillway installed. It appears that the most suitable location for the new spillway is at the location of the existing spillway. The depth of excavation required at this location would be approximately 26 feet, while if the spillway were located farther to the north, excavation in excess of 30 feet would be required.

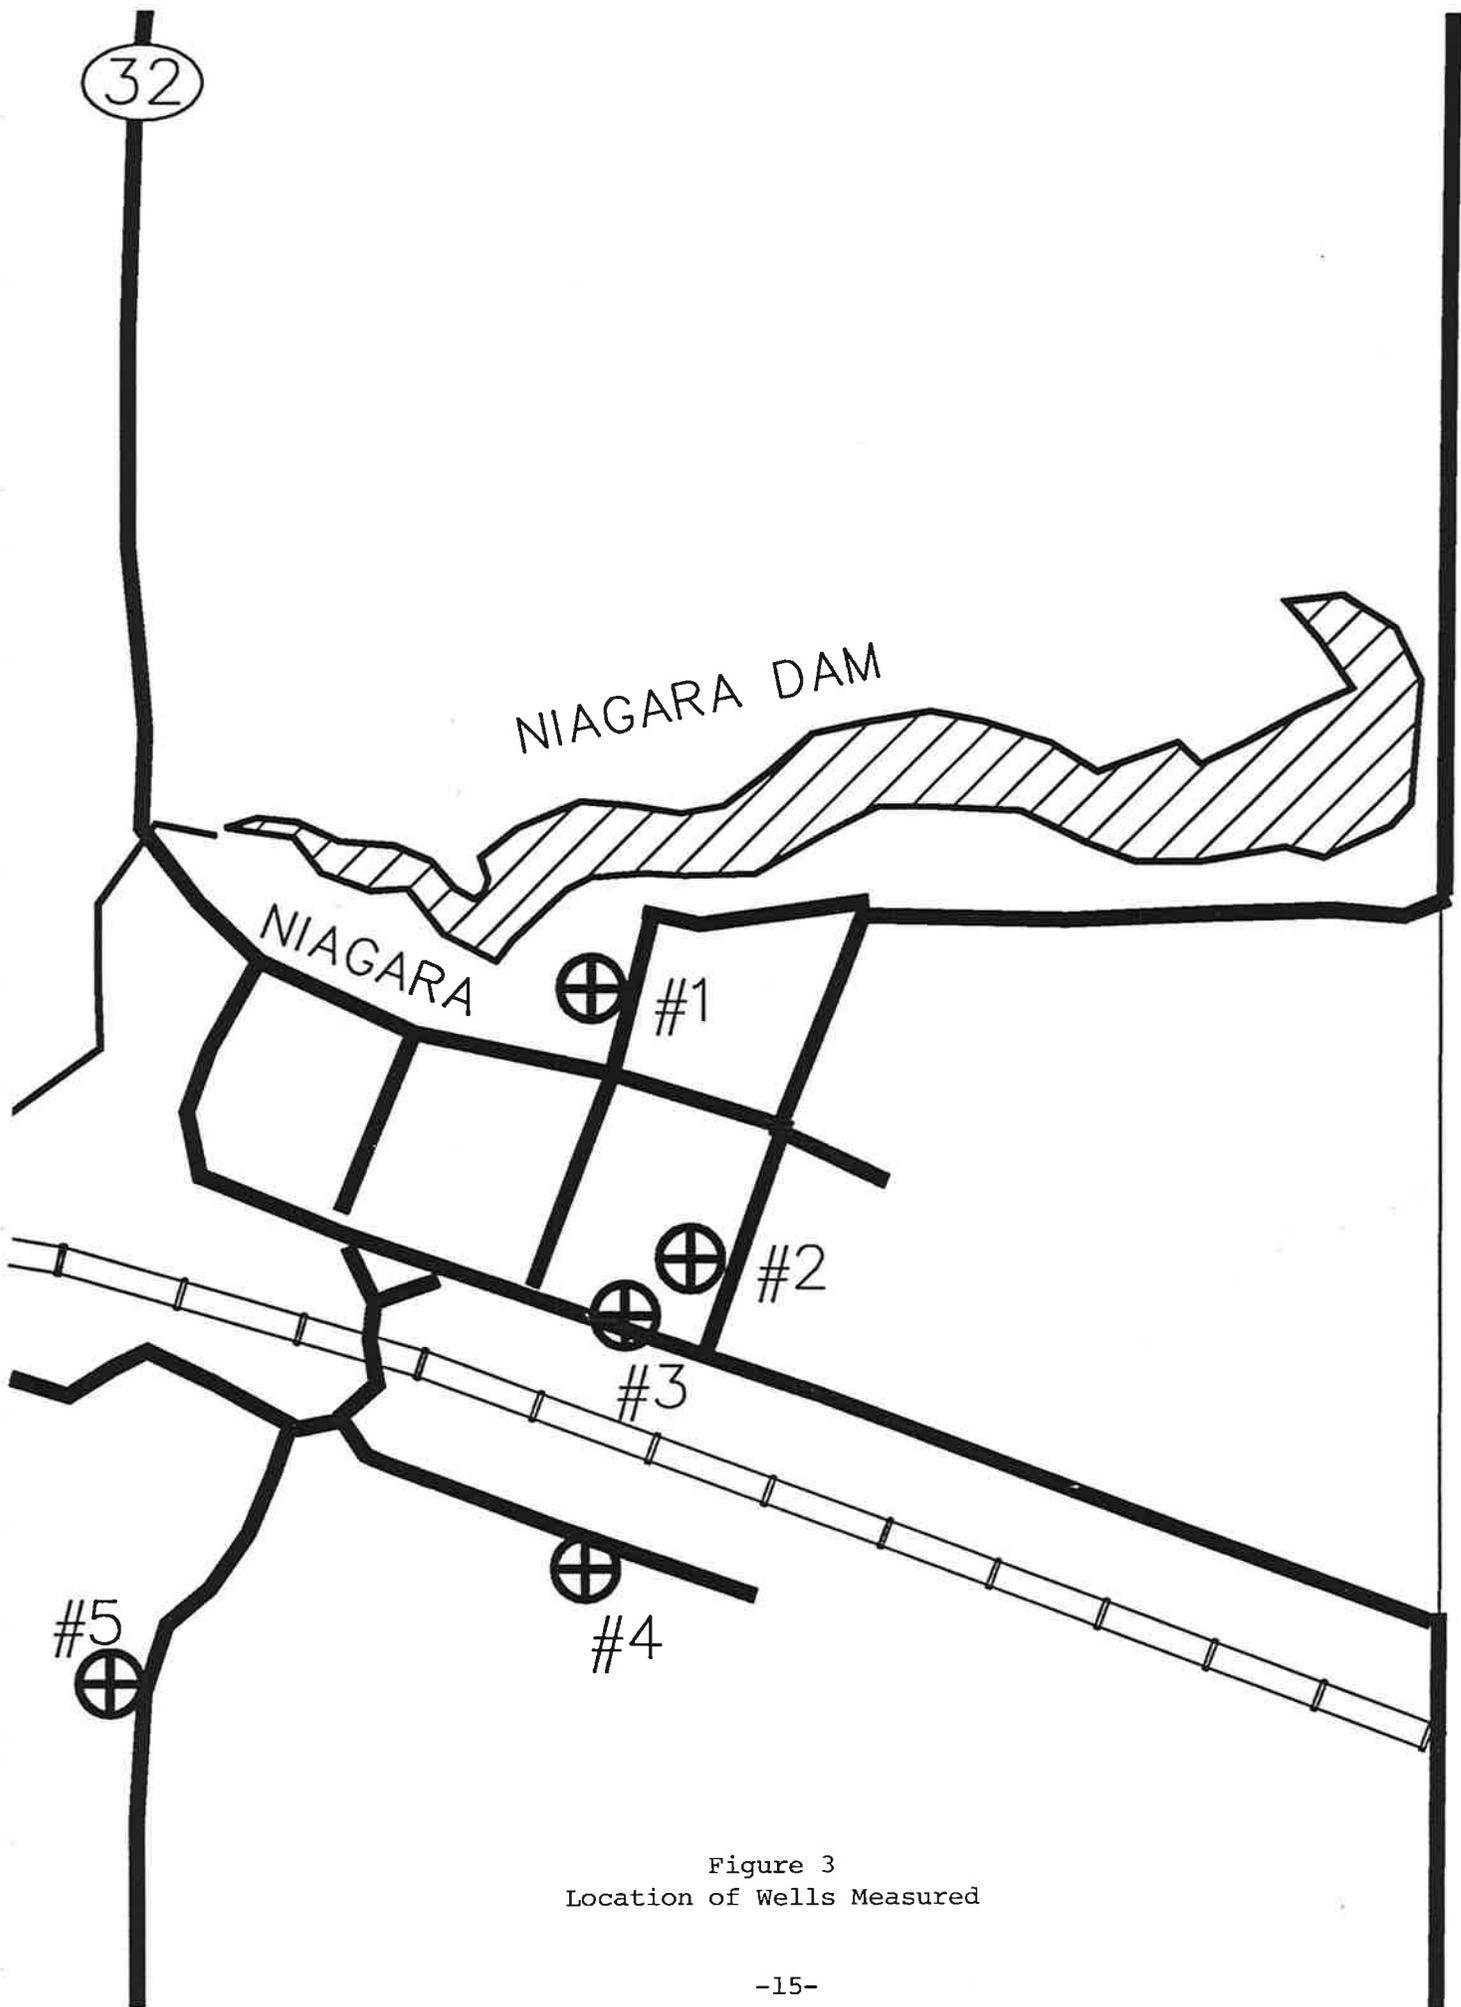
Figure 3
Location of Wells Measured

The water level elevations indicate that the groundwater is poorly connected to the surface water reservoir bordering the town on the north (downstream Niagara Dam). The water level in well #1, located a short distance from the reservoir, is 7.8 feet lower than the water level in the reservoir. The water level in wells 2 through 5, which are farther away from the reservoir, are 11.7 to 14.1 feet higher than in the downstream reservoir. The large difference in water level elevation indicates that there is not a significant amount of water moving from the groundwater into the reservoirs or vice versa.

The perception that the water levels in the wells are controlled by the levels of the two adjacent reservoirs probably stems from the fact that both the surface and the groundwater systems are dependent on precipitation and snowmelt to maintain their levels. In dry cycles, such as the one we have been experiencing for the past three years, the reservoir level has declined because of lack of runoff and the groundwater levels have declined because of lack of direct infiltration of precipitation and snowmelt.

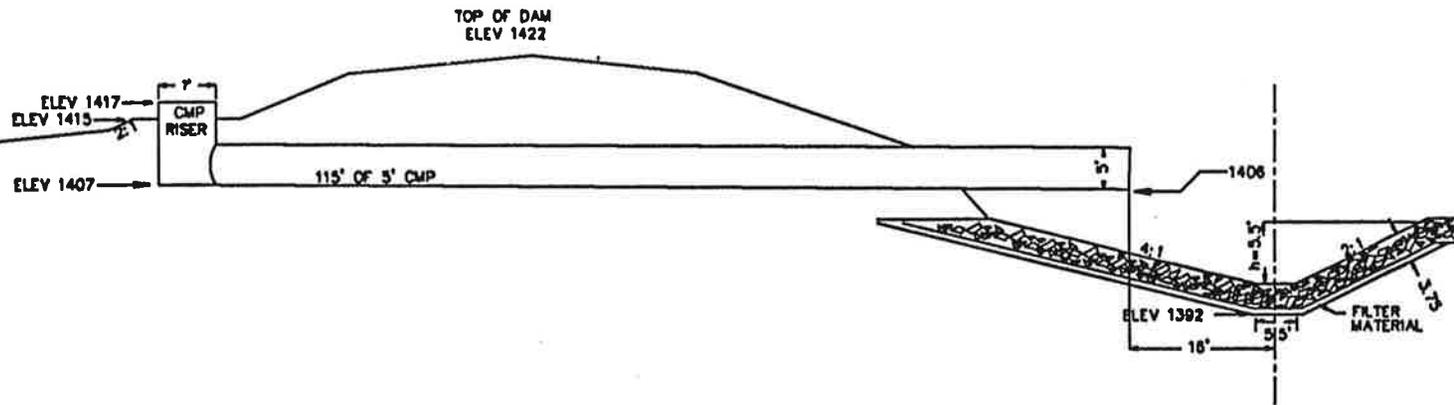
Figure 8 - Transverse Profile
of Dam at Spillway

The proposed 84-inch diameter CMP drop inlet will be set at a control elevation of 1417 msl. The entrance invert of the proposed 60-inch diameter CMP spillway pipe will be set at an elevation of 1407 msl. The pipe will be approximately 115 feet long with the outlet set at an elevation of 1406 msl. The spillway pipe will be epoxy coated to help reduce corrosion. Figure 8 shows a transverse section of the dam at the principal spillway. The control elevation of the proposed spillway will be 0.6 feet above the elevation of the existing spillway. Increasing the control elevation higher than 1417 msl will not be possible unless the embankment is raised.

A cantilever outlet and plunge pool will be sufficient to dissipate the energy of the water going through the spillway. The outlet of the pipe is designed so that the invert of the
