## SWC 2010 Construction Projects Summary

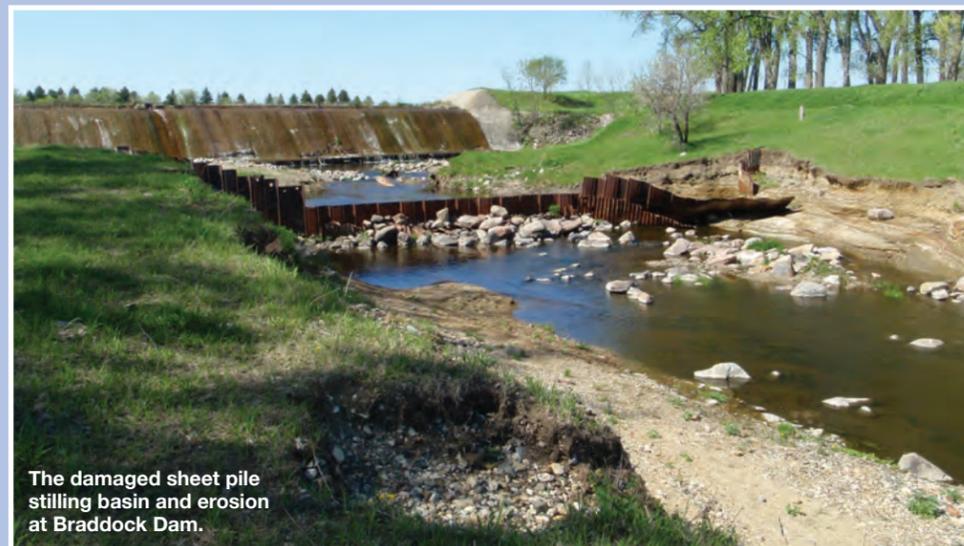
The 2009 spring runoff caused significant damage and erosion of the sheet pile stilling basin structure and surrounding soils downstream from the principal spillway (see photo). The erosion removed an estimated 600 cubic yards of material, including the riprap along the downstream

face of the structure. It appears that the flow may have completely overtopped the structure - starting the erosion around the ends of the structure. The scour removed the supporting soils from in front of the six-foot wings, causing the left side to fail.

The damaged sheet pile stilling basin and erosion at Braddock Dam.

The construction crew repaired the erosion by placing and compacting new clay borrow, replaced some of the existing sheet pile sections, and added some new lengths to extend the structure farther up the banks of the stream. Additional riprap was also placed around the structure, and repairs were made to the deteriorated/missing concrete with concrete repair mortar.

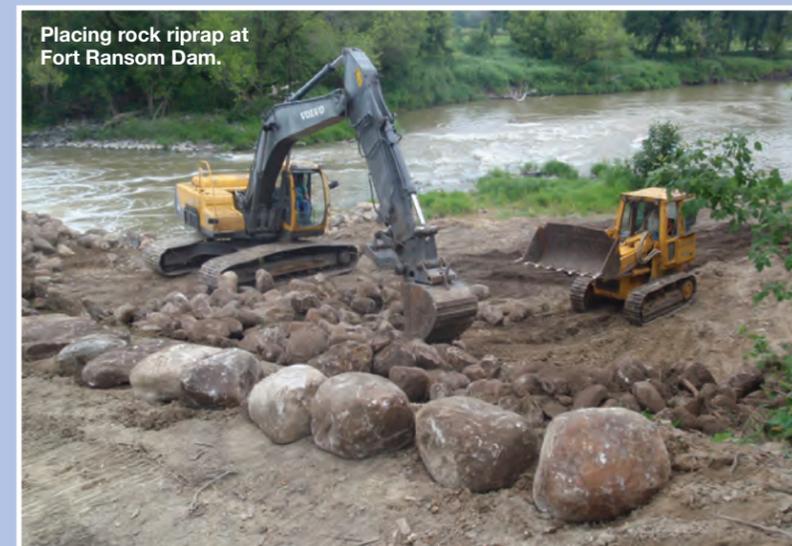
observed erosion around the right abutment. The erosion appeared to be the result of water overtopping the dam during the last two spring runoffs. The erosion consisted of both loss of riprap and head cutting of the earth fill around the end of the abutment.

Placing rock riprap at Fort Ransom Dam.

The Ransom County Water Resource District requested construction and technical assistance from the Water Commission, in addition to cost-sharing to repair the erosion. The Water Commission construction crew repaired the embankment by excavating and recompacting the existing material, adding new material as necessary, and placing new riprap over the fill.

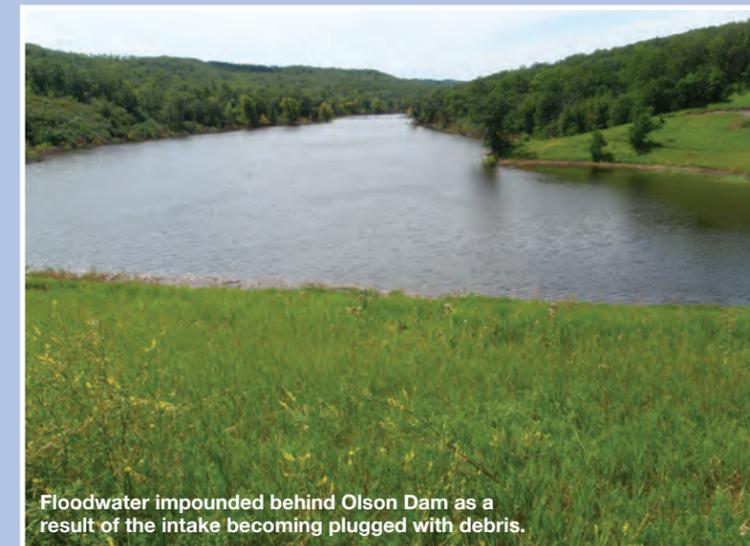
During the summer of 2010, the outlet structure intake became plugged with debris, preventing it from passing floodwater as intended. The Water Commission construction

Floodwater impounded behind Olson Dam as a result of the intake becoming plugged with debris.

crew worked with members of the water resource district and the USDA-NRCS to clear the debris from the trash rack. Initial attempts at clearing it with hooks and rakes were ineffective. Finally, compressed air was used to blow the debris loose.

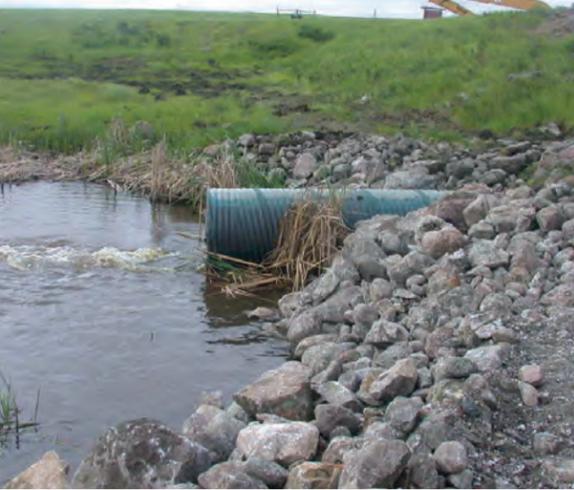
The downstream section of the new corrugated metal pipe spillway at Sarnia Dam.

During 2009 and 2010 inspections, Water Commission personnel observed erosion around the inlet of the principal spillway structure. The principal spillway conduit is a 42-inch diameter by 102-foot long corrugated metal pipe with a flared end section at the upstream end. The

erosion appeared to be the result of soil entering the conduit through a rusted-out hole in the bottom of the flared-end section. The erosion progressed outwards, ultimately to the surface of the embankment. It then progressed up the slope of the embankment along each side of the spillway conduit.

The construction crew repaired the embankment by excavating and recompacting material where erosion occurred, and replaced the flared-end section.

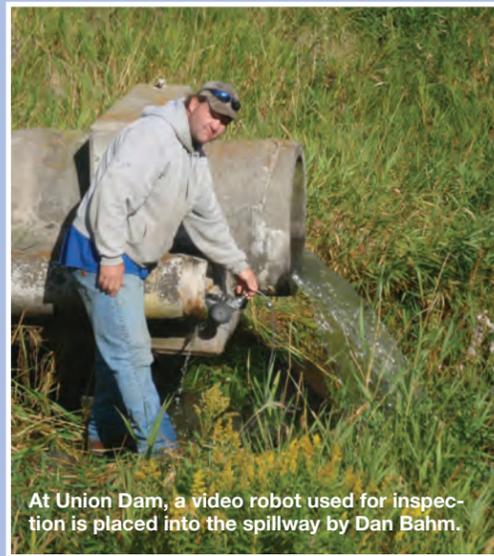
At Union Dam, a video robot used for inspection is placed into the spillway by Dan Bahm.

sinkhole over the outlet end of the principal spillway conduit was observed. The size of the sinkhole continued to increase over time. Video inspection of the pipe from July 2008 showed separation at two joints, where embankment material was entering the pipe and causing the sinkhole.

The Walsh County Water Resource District requested Water Commission cost-sharing and construction assistance to repair the conduit and the sinkhole. The construction crew repaired the conduit by exposing the conduit, installing sheet pile anchors along each side of the conduit to prevent further separation of the joints, and then filled the joint with a concrete repair mortar. The joint was then covered with geo-textile fabric before backfilling to prevent soil material from entering the conduit in the future if the joint opens again.

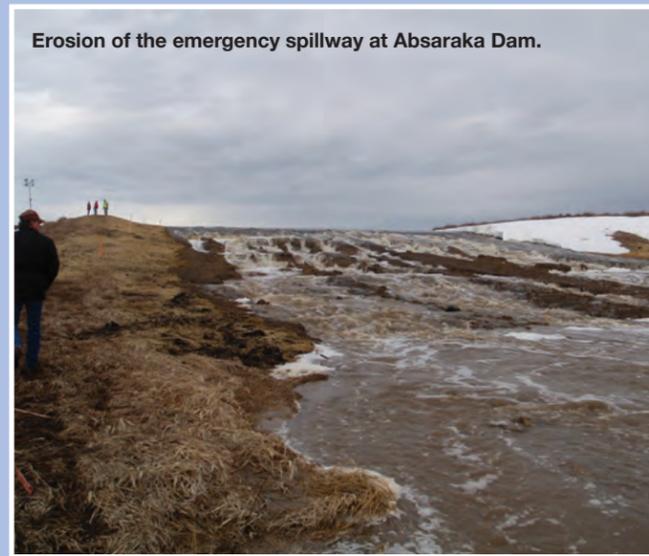
Erosion of the emergency spillway at Absaraka Dam.

Both of these projects suffered severe erosion in their emergency spillways during the 2009 and 2010 spring runoff events. The emergency spillways at these projects are grass-lined channels that experienced high flows for long periods of time, resulting in erosion and head cutting of their channel bottoms. The emergency spillways at Absaraka and Cottonwood Creek Dams were repaired during 2009 and then subsequently severely eroded again in 2010. Following the second round of damage, it was decided that rather than simply repairing the spillways to their pre-damage conditions, they would be reconstructed by armoring with cable-tied concrete block mats to prevent them from being damaged again.

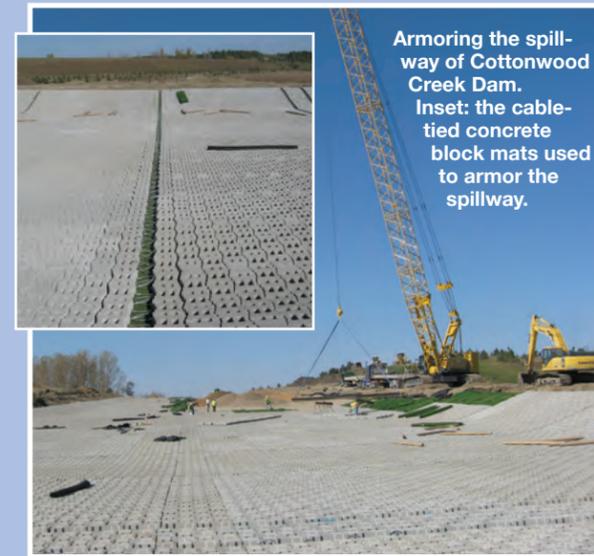
Armoring the spillway of Cottonwood Creek Dam. Inset: the cable-tied concrete block mats used to armor the spillway.

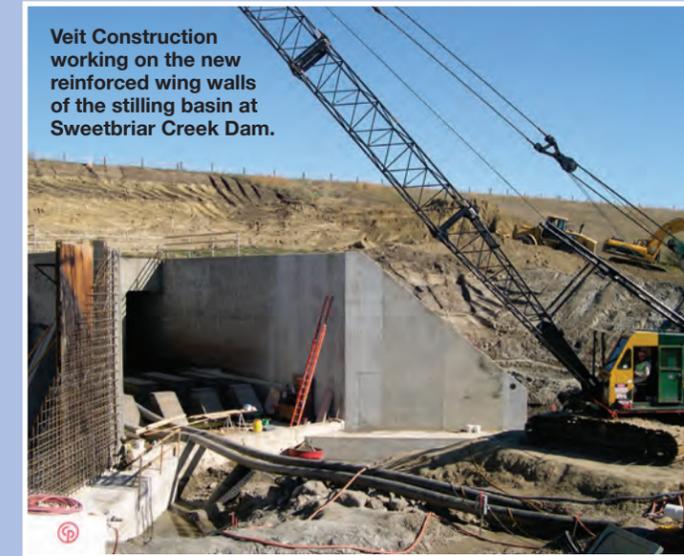
Veit Construction working on the new reinforced wing walls of the stilling basin at Sweetbriar Creek Dam.

Since its first inspection as part of Phase I of the U.S. Army Corps of Engineers dam inspection program, there have been concerns about uncontrolled seepage around the spillway structure and the potential for internal erosion piping of the embankment material. This summer's project was designed to address these concerns. The project involved the construction of a filter collar around the spillway structure, along with the installation of toe drains and filters along the toe of the dam. Also, the stilling basin's reinforced concrete wing walls were reconstructed due to extensive cracking, and the access ladder that had become dilapidated was replaced with a new design that incorporates fall protection.
