2017 STATE WATER COMMISSION *Construction Season*

The State Water Commission Construction Crew was busy in 2017, working on a wide range of projects.

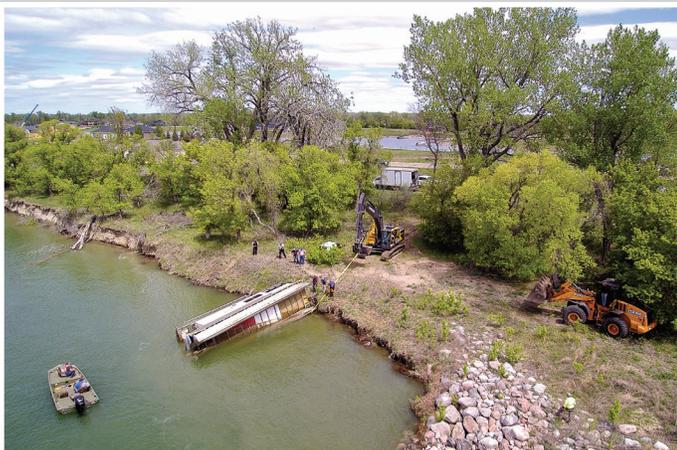
In fall 2016, a pontoon was left tied up on the Missouri River, just north of the Misty Waters boat landing north of Bismarck. Over the winter, ice action damaged the boat and capsized it. Because the boat represented an environmental hazard on sovereign land, in May 2017, the Construction Crew removed the boat, holding it for 30 days in case the owner could be found.

Preparing to pull the pontoon out in May, 2017.

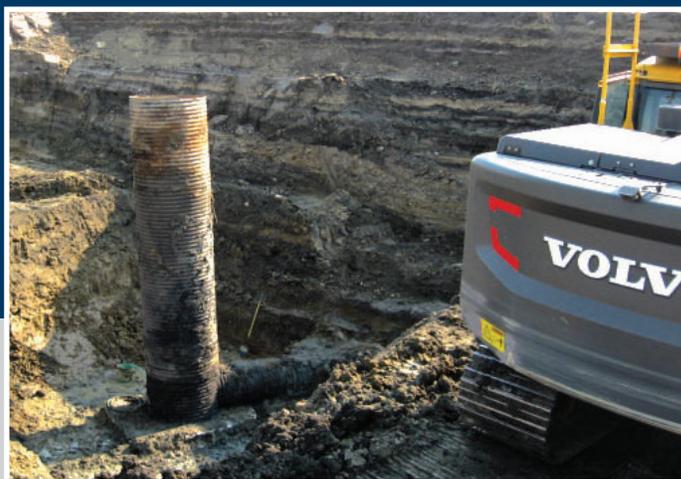
Kulm-Edgeley Dam is an earthen embankment dam, with a concrete drop structure intake. From the intake structure, a 30 inches reinforced concrete pipe (RCP) conduit runs through the dam to the discharge point downstream. The first joint in the RCP conduit downstream from the intake structure had separated, allowing embankment material to be washed away through the opening. This washing away of material resulted in a sinkhole in the embankment, creating an ever more unsafe condition for the dam.

The Construction Crew built a coffer dam around the intake structure to keep their work area dry. The structure was excavated to expose the separated conduit joint, and concrete collar was then constructed around the pipe to seal the joint. The excavation was then backfilled and the coffer dam removed.

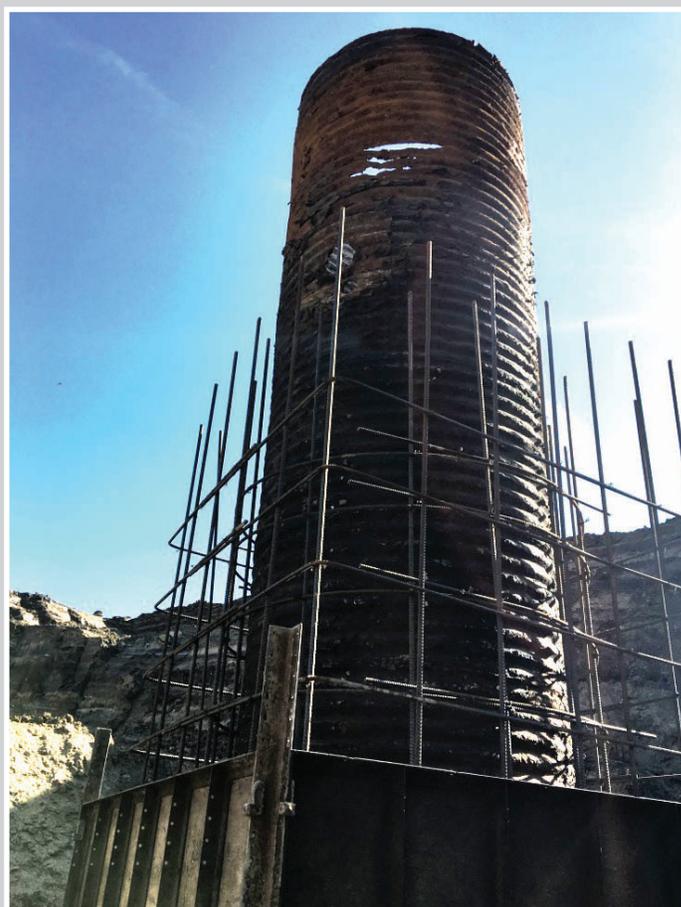
The CMP riser had rusted through in several spots, and the upper and lower sections of the CMP riser were out of alignment. This allowed water and soil to leak through the riser, creating a sinkhole around the structure, and causing the reservoir to lose water. The valve on the low-level system had been in service for 29 years, and was heavily rusted.

The original CMP at Schlecht-Thom Dam riser before repair.

Repairs began in August 2017, with the construction of an earthen coffer dam, followed by excavation of the principal spillway riser. The riser was realigned with a new band connection on the upper and lower sections. Forms were placed around the existing CMP riser to create a reinforced concrete drop structure, while using the existing CMP riser as the inside form.

New fittings for the low-level drawdown were cast into the new concrete, and a new valve and stem were fitted inside the riser. The structure was then backfilled, the low-level drawdown pipe was reattached, and a new trash rack was installed. The final steps were removal of the cofferdam, reclaiming the borrow site, seeding, and site cleanup. With these repairs, Schlecht-Thom Dam will be home to happy anglers again in 2018.
