1985 REVALUATION
OF
CAMEL HUMP BUTTE DAM
SWC PROJECT NO. 1382
GOLDEN VALLEY COUNTY

INTRODUCTION

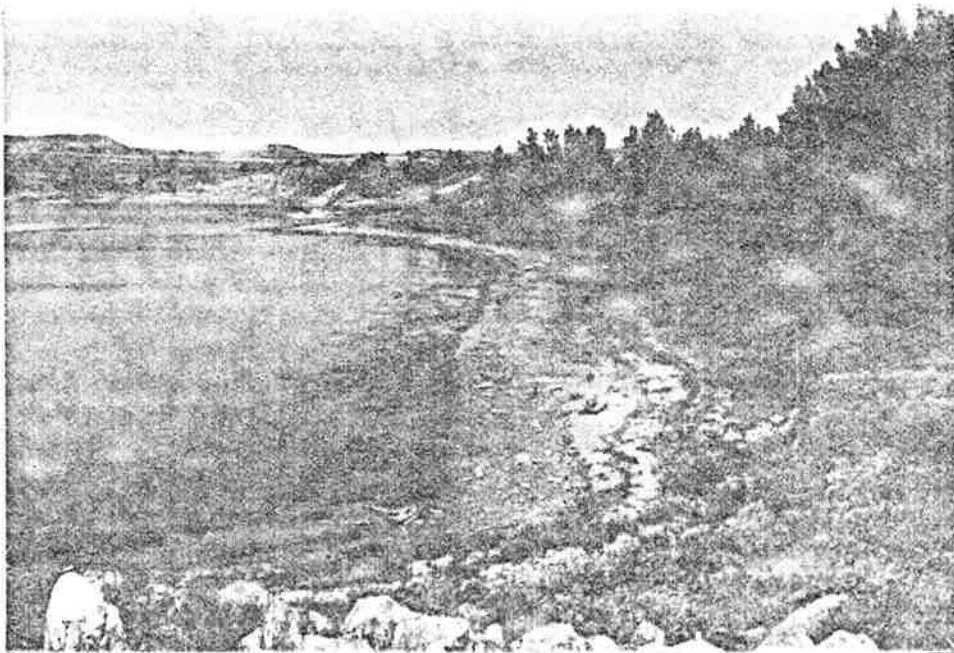
Photo #1
Looking Upstream
Along Eastside
of Reservoir
July 9, 1985

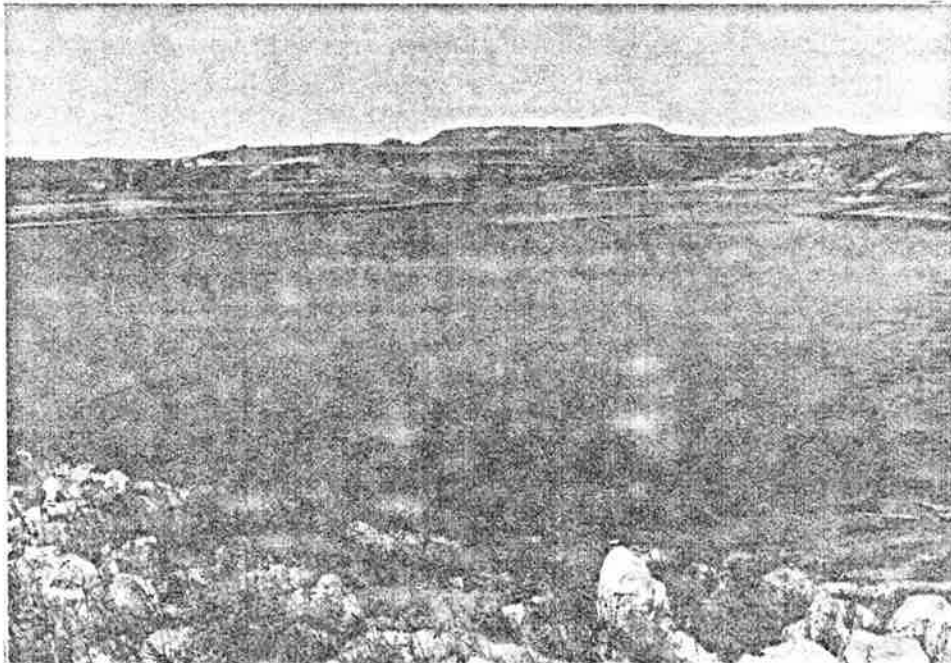
Photo #2
Looking Upstream
of Embankment
July 9, 1985

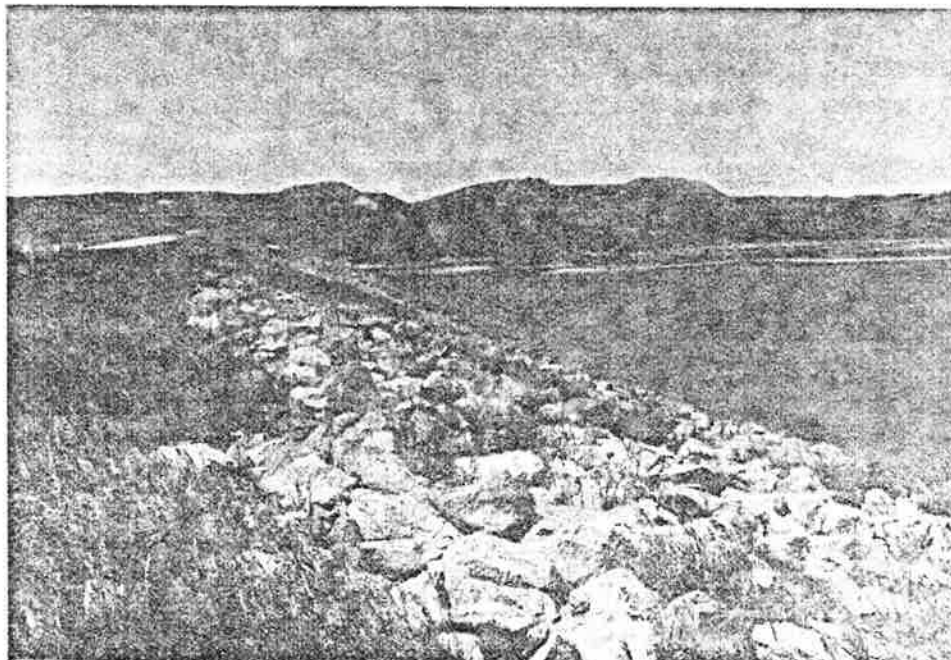
Photo #3
Looking West
Along Upstream
Slope of Dam
July 9, 1985

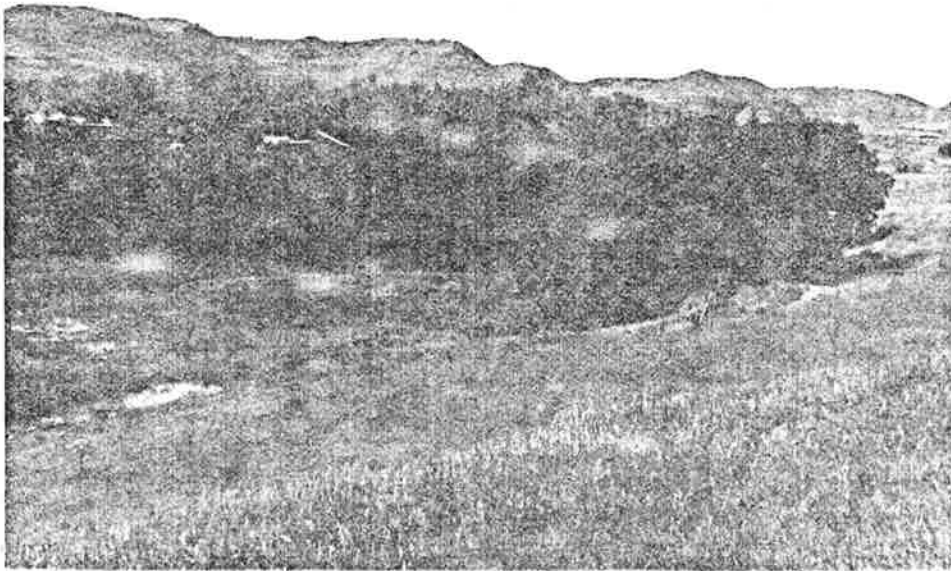
Photo #4
View of Downstream
Area Looking
Southwest
July 9, 1985

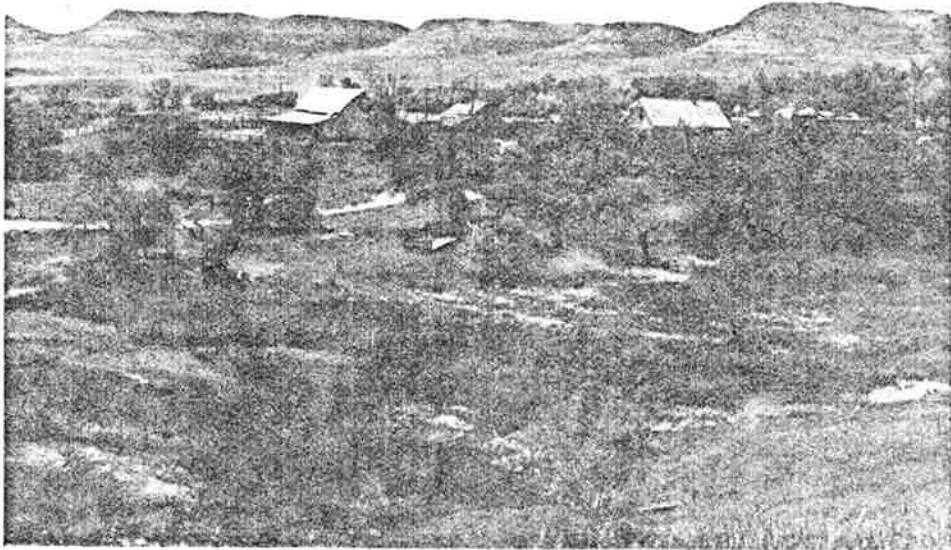
Photo #5
View of Downstream
Area Looking
South
July 9, 1985

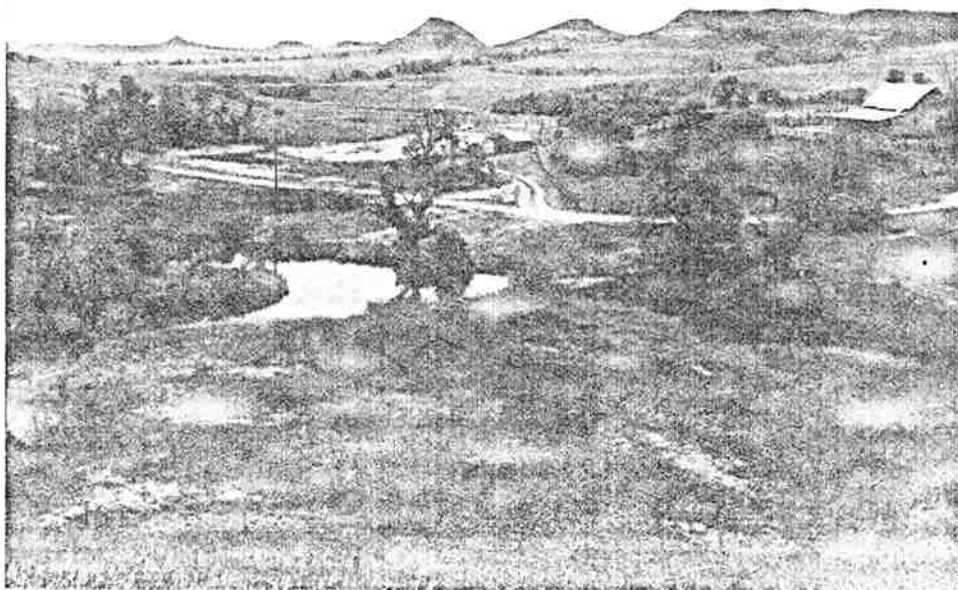
Photo #6
View of Downstream
Area Looking
South-Southeast
July 9, 1985

The downgradient valley area consists of the creek channel and an adjacent meander scar to the west. The meander scar represents a former channel of the creek. Water stands in a bend in the channel 200 feet downgradient from the dam dissipator structure. At the time of a photograph taken in July of 1985 water was backed up in the channel to the dissipator structure. The meander scar and the low lying ground within the arc of the meander scar has a land surface level six to seven feet higher than the water level in the channel. The meander scar is topographically lower than the surrounding area except for an outlet to the water filled bend in the creek channel. The meander scar is in a low area presumably once occupied by an oxbow lake. The trees lining the meander scar indicate a historic high water table.

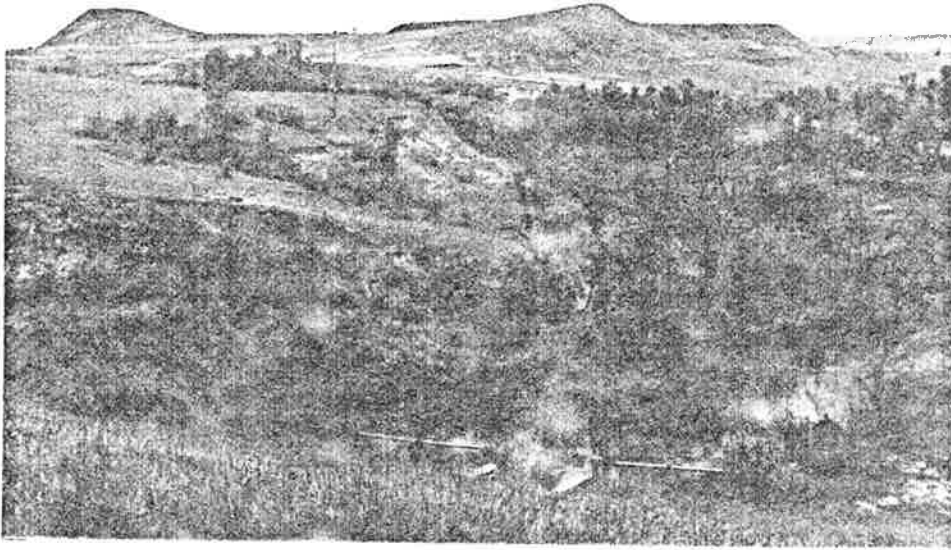
Photo #7
View of Downstream
Area Below
Outlet Structure
July 9, 1985

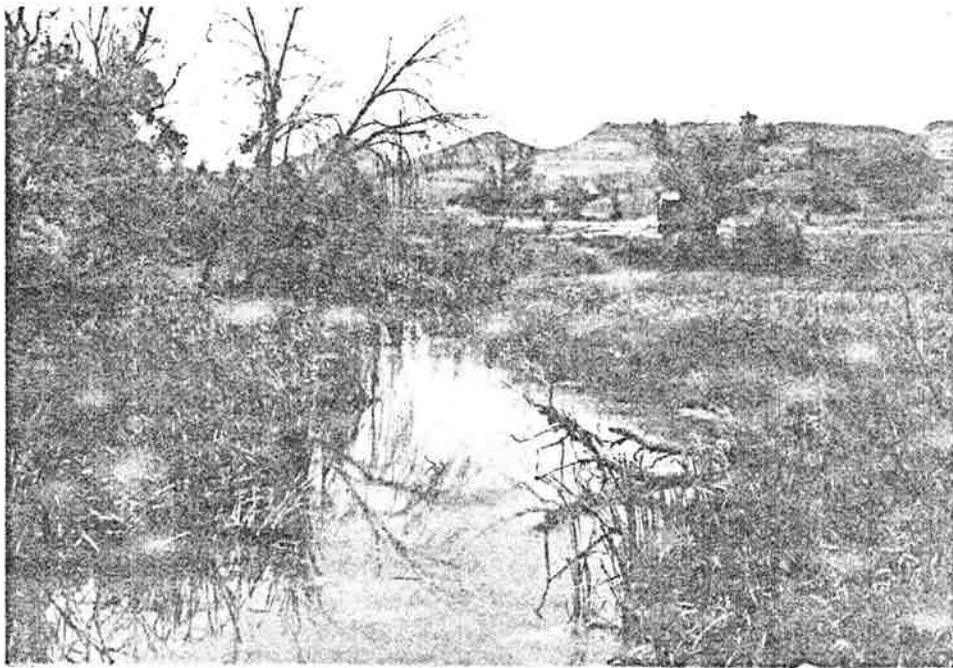
Photo #8
View of Channel
Below Outlet
Structure
July 9, 1985

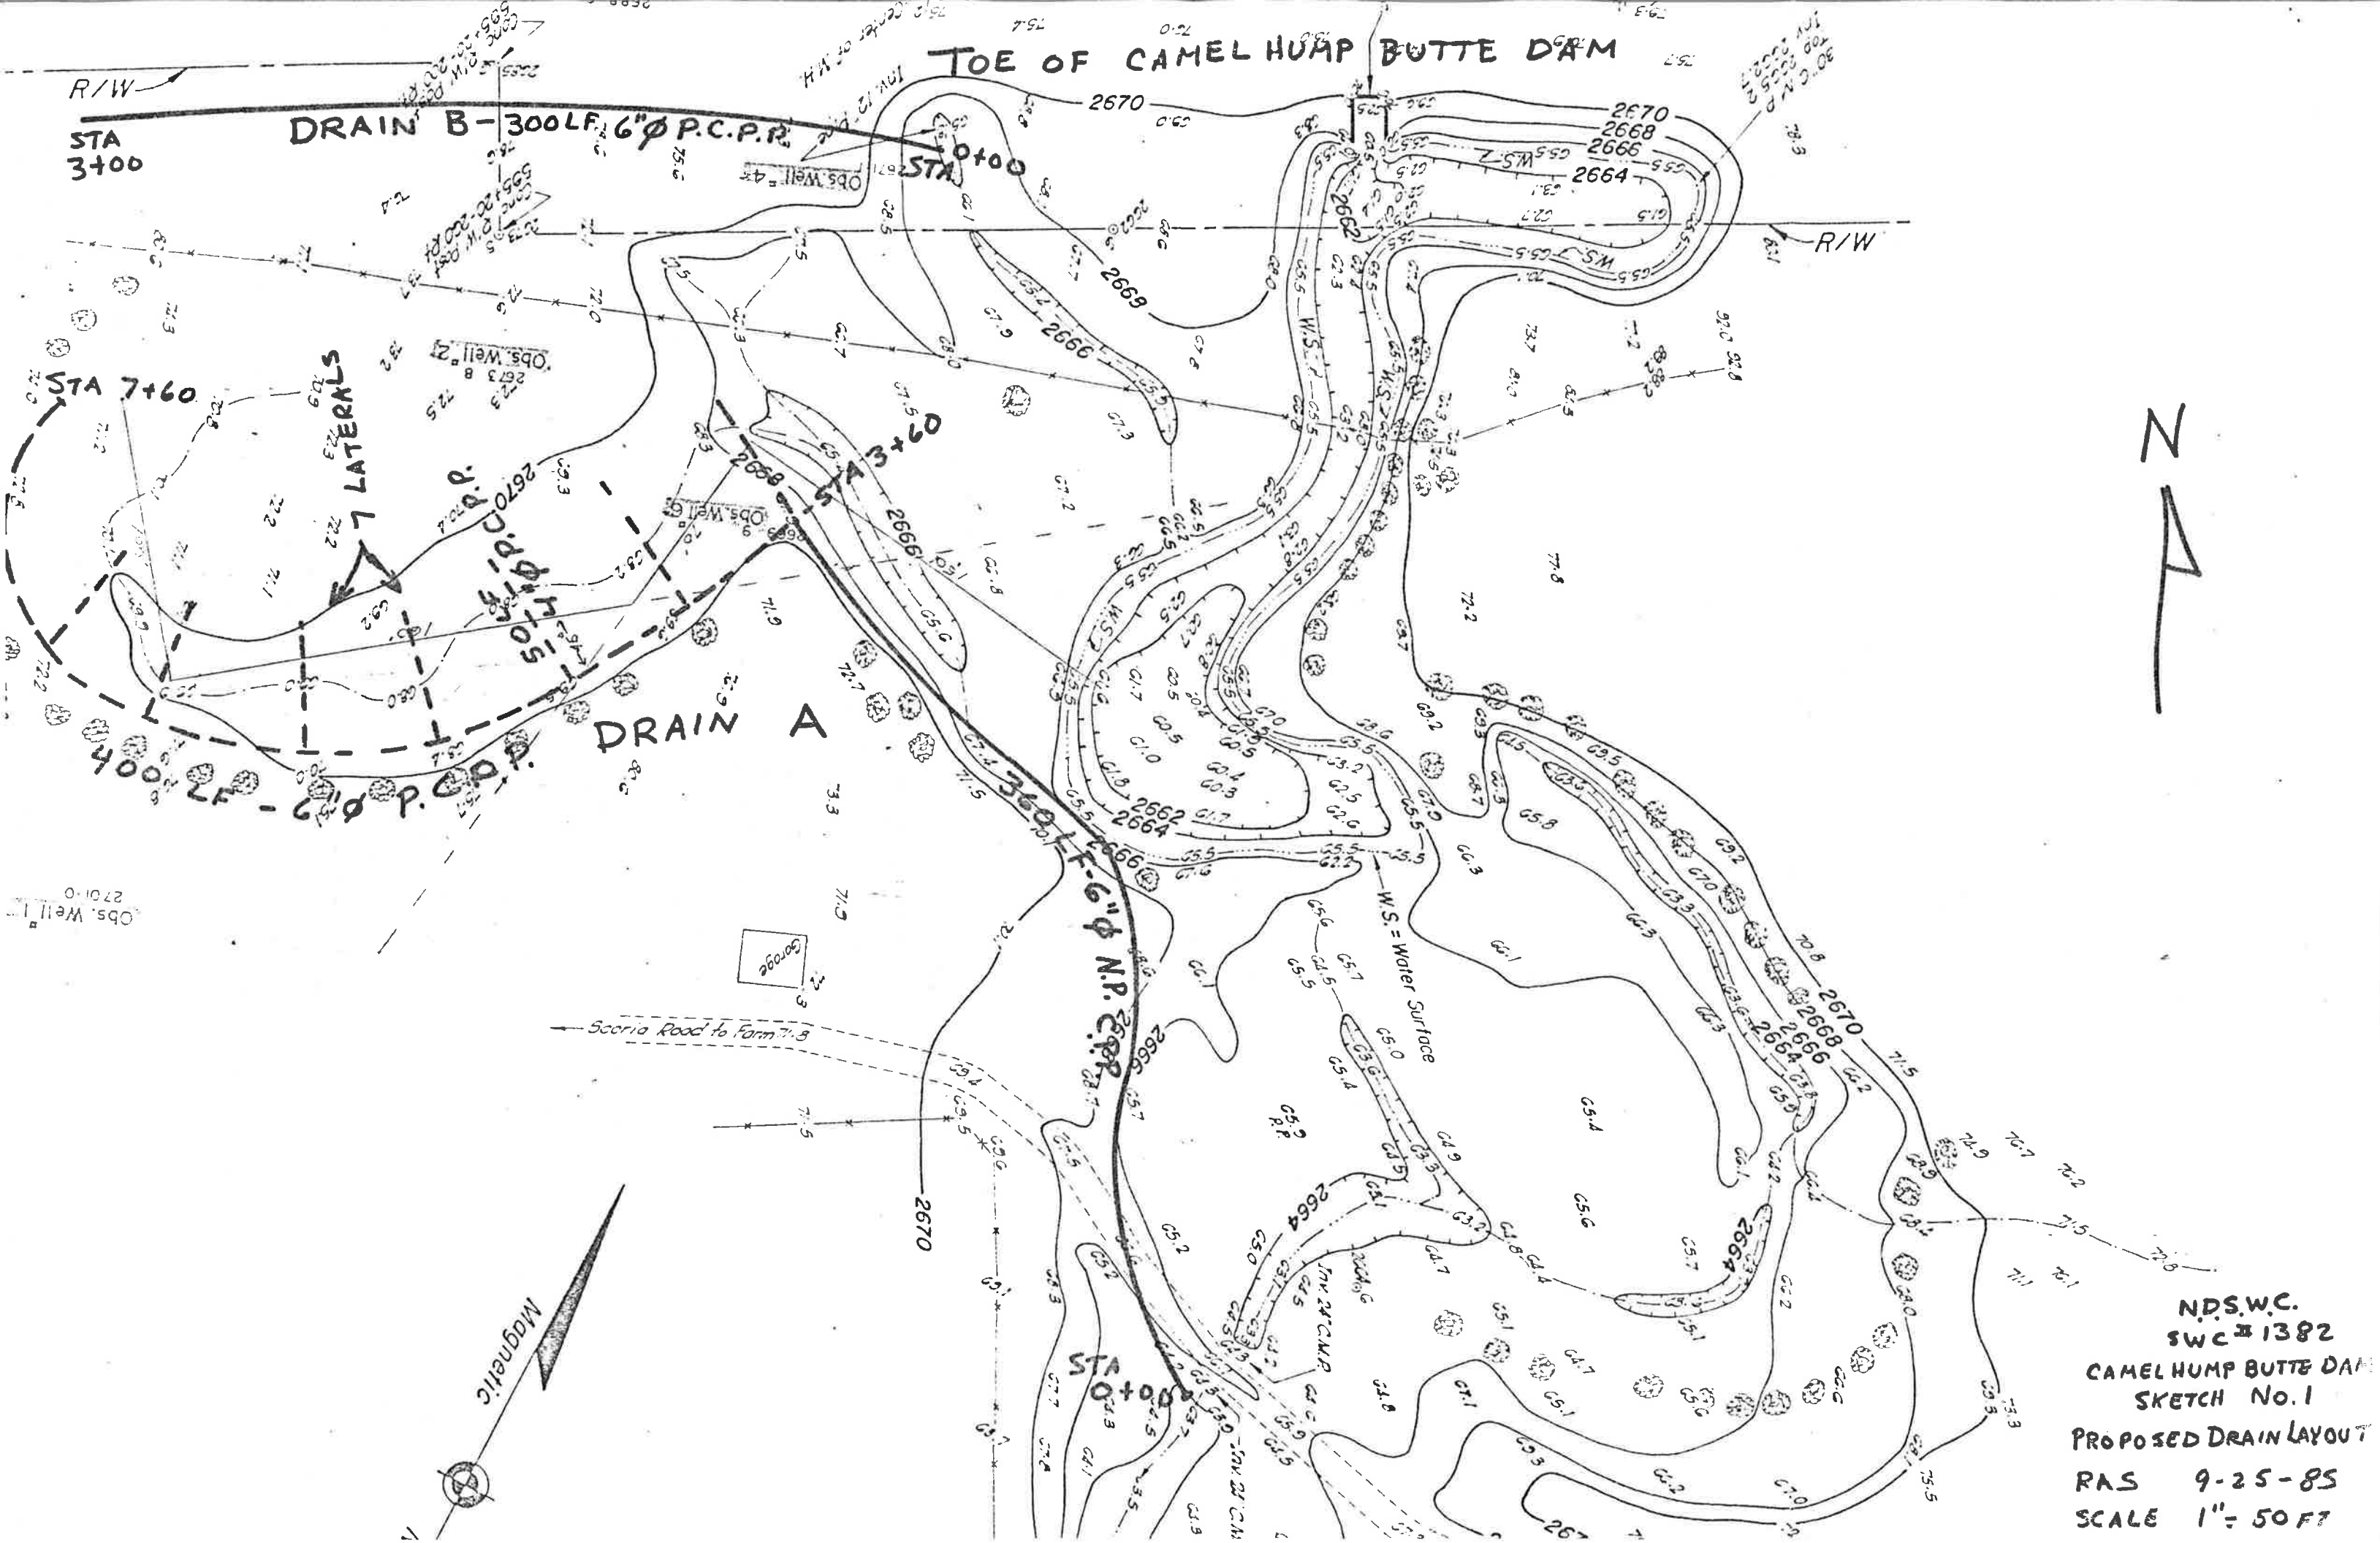
N.D.S.W.C.
 SWC # 1382
 CAMEL HUMP BUTTE DAM
 SKETCH No. 1
 PROPOSED DRAIN LAYOUT
 RAS 9-25-85
 SCALE 1" = 50 FT

A drainage system may be needed to carry off the excess ground water that is saturating the soil downstream of Camel Hump Butte Dam. The plan for the proposed drainage system is shown in the attached Sketch No. 1 and the profiles of the proposed drains are shown in Sketch No. 2.

The drains would be constructed of a corrugated plastic pipe installed in a narrow trench with a granular filter material enclosing the pipe. The two drains (A and B) would be located as shown in Sketch No. 1.

Drain A would consist of 360 LF of non-perforated 6-inch \emptyset CPP, 400 LF of perforated 6-inch CPP and would have seven laterals of perforated 4-inch \emptyset CPP, each 50 feet long.

Drain B would consist of 300 LF of perforated 6-inch \emptyset CPP.

The drainage piping would be layed out to conform as much as possible with the topographical contours of the existing ground condition in order to keep the amount of ditch excavation to a minimum, while at the same time, placing the pipe at the proper gradient to ensure proper drainage.
