INVESTIGATION AND REPAIR
OF THE
CHANNEL "A" CONTROL STRUCTURE
STARKWEATHER WATERSHED

NORTH DAKOTA
STATE WATER COMMISSION

NOVEMBER 1984

INVESTIGATION REPORT
OF THE
CHANNEL "A" CONTROL STRUCTURE
RAMSEY COUNTY
SWC PROJECT NO. 842

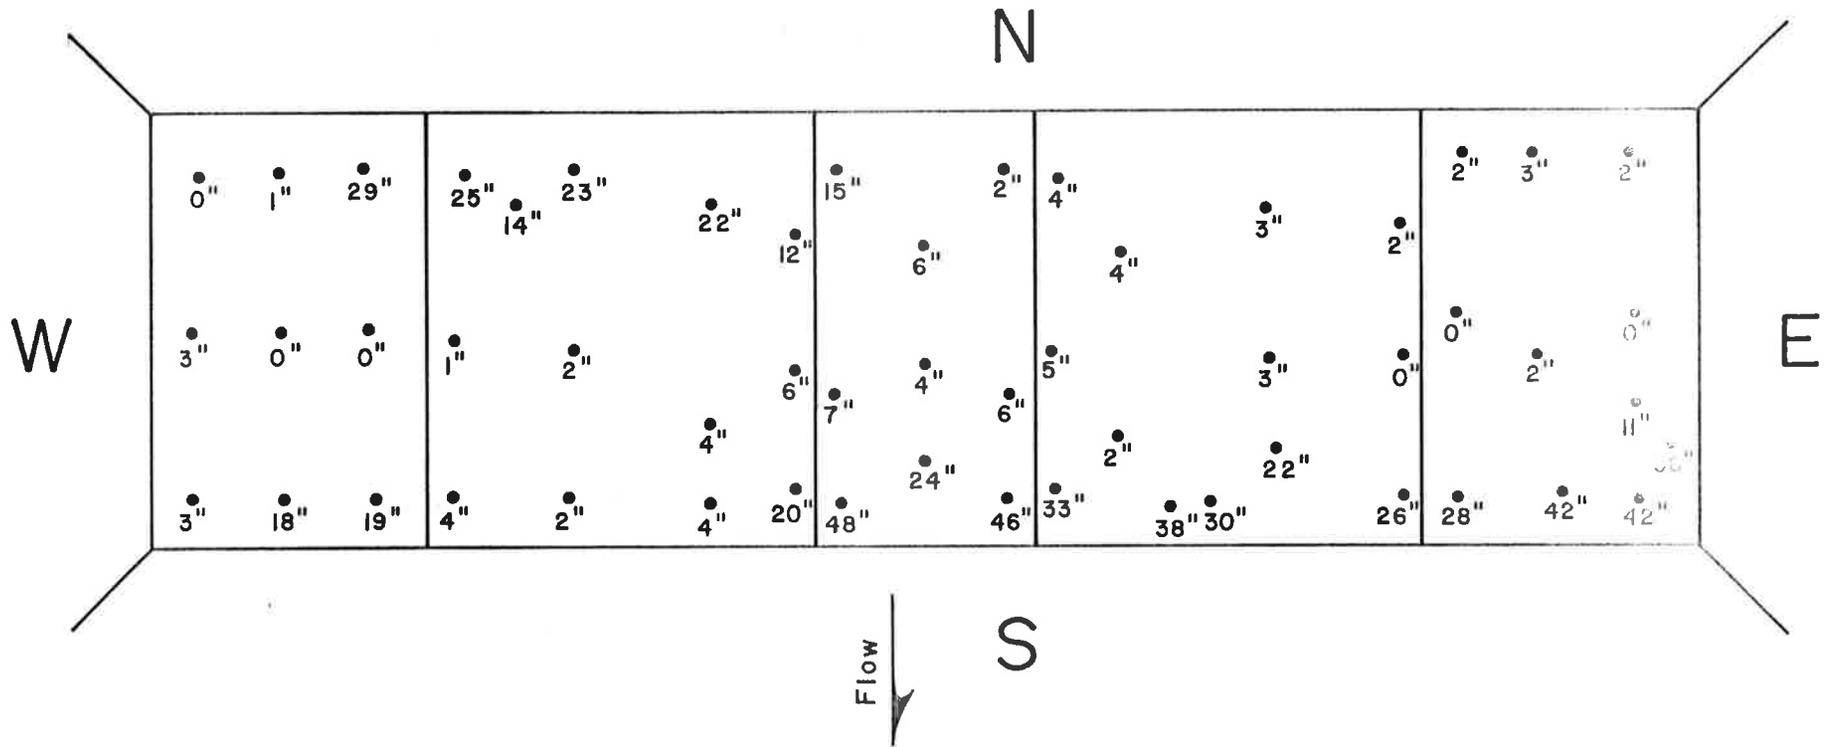
STRUCTURAL PLAN
 SHOWING DRILL HOLES & VOID DEPTHS

Also, the relative locations of the reinforcing steel were determined to be significantly different from that shown on the plans. There were two types of discrepancies observed. First, the bars were supposed to be positioned so as to provide 2 inches of cover over the top layer of steel and 3 inches of cover below the bottom steel. The actual cover was 4 inches in both cases. Secondly, some of the bars appeared to be mislocated horizontally by as much as 6 inches.

The concrete appeared to be good quality and consistency. No voids were observed in core samples or in holes. The concrete was observed by the drillers as being dense and hard to drill. The downstream area next to the south edge of the structure was saturated and all core holes were full of water. All holes were sounded and the bottom seemed to consist of a soft gravel into which a stick could easily be pushed several inches.

The structure was only partially bearing on material which may be mostly saturated and may be in a condition of near failure. The sooner that the undermined areas can be filled with grout or concrete the better things will be.

Don Dahl proposed to pump the concrete into the structural foundation and then to top it off with more concrete which would be tamped and

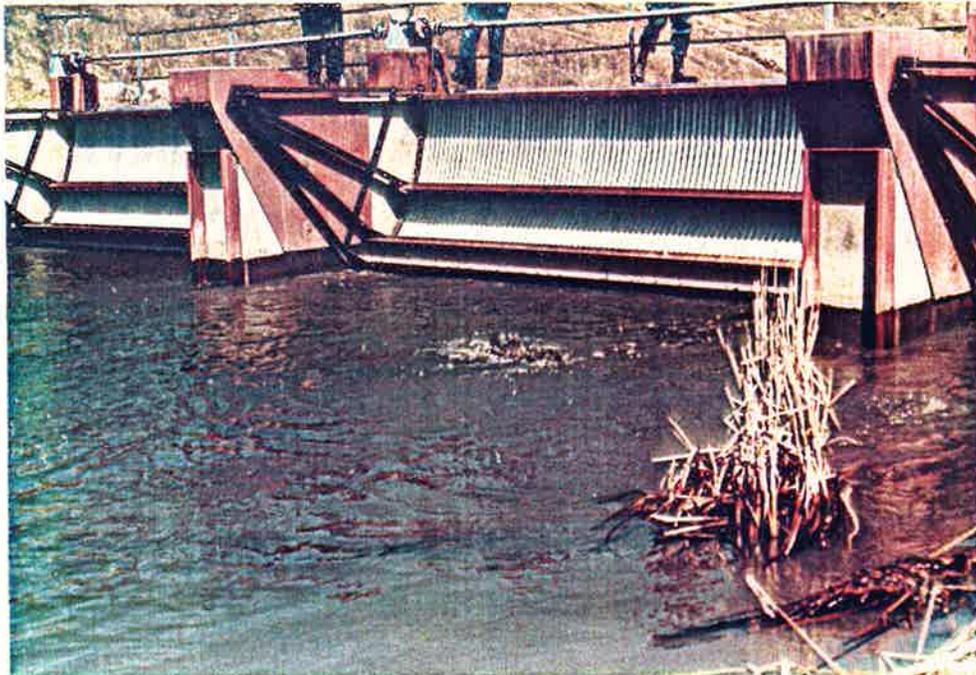
With the gates closed, two (2) pronounced boils were evident immediately downstream from the structure which indicated to me movement of water underneath the structure (See Photos E and F). The larger of the two boils was located near the center of the channel. Pieces of rock which appeared to be shale about the size of a thumb nail were being pumped from underneath the structure and were visible in the boil (See Photos G and H). There was also a visible flow of water along the east downstream wingwall (See Photo I). Undoubtedly, the flow of water has been partly responsible for the erosion and slumping of the channel slope adjacent to the soil side of the wingwall (See Photo J).

Photo D - The Structure Viewed From
Downstream. Note the Closed Gates and
the Boil Near the Center of the Photo
May 2, 1984

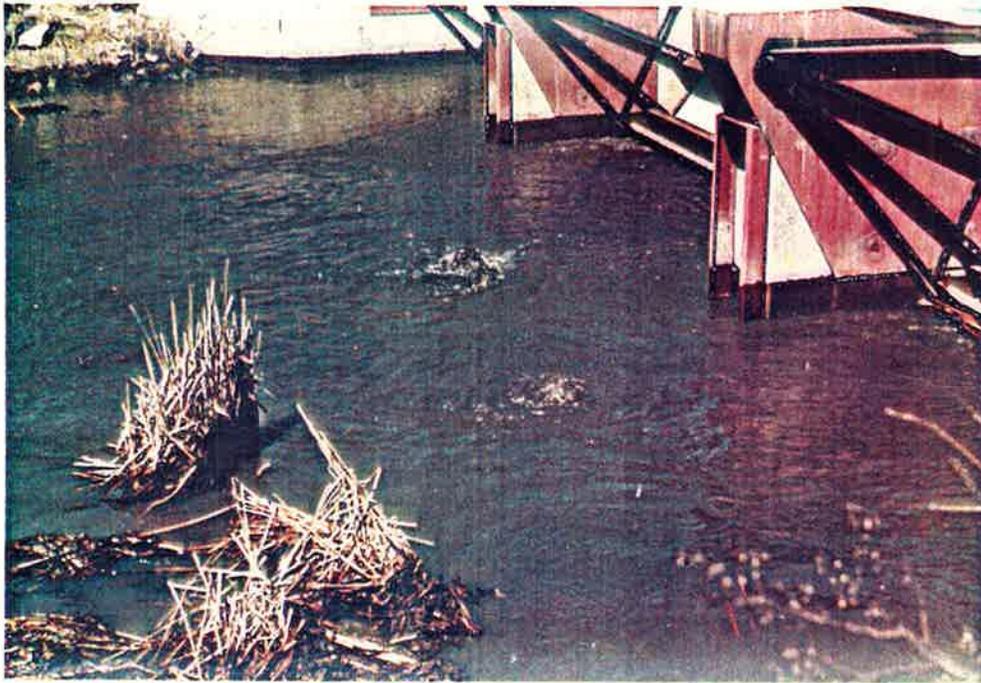
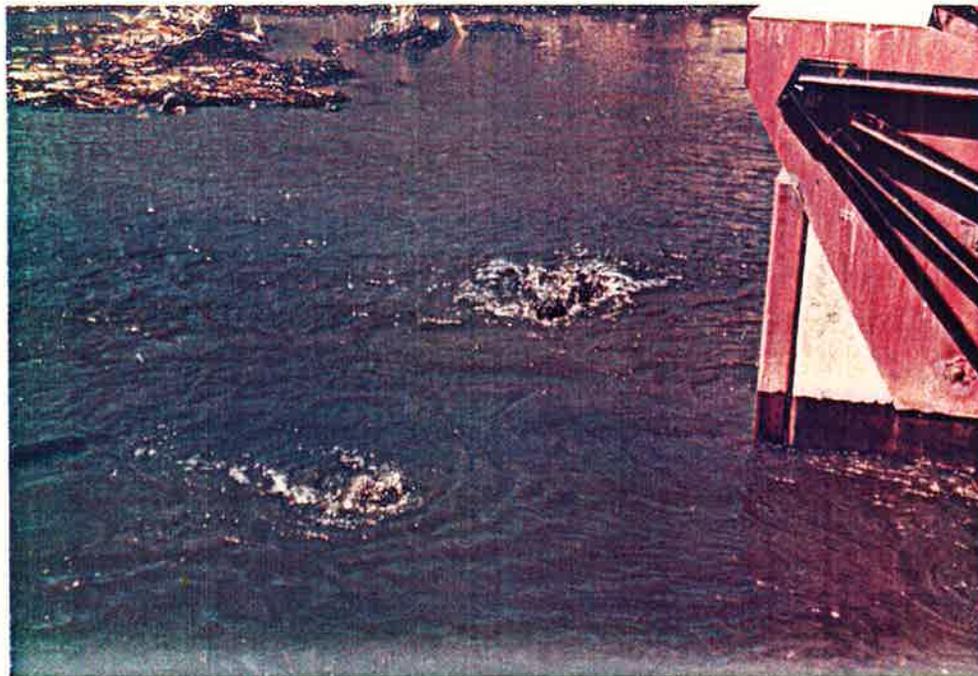
Photo F - May 2, 1984

As previously discussed, the formation of boils immediately downstream of the structure, accompanied by intense and visible agitation of soil particles from within the boils, are indicative of unstable foundation conditions due to uncontrolled underseepage. The discharge of a mixture of soil and water, instead of clear water, is a warning in itself of deteriorating foundation conditions. In most cases of seepage and underseepage or a combination of both, it must be recognized that uncontrolled development of erosion and cavitation are conducive to piping, boils and other conditions which may endanger the entire structure.

Photo E - May 2, 1984
The Upper and Lower Photos Show Two
Pronounced Boils Immediately
Downstream of the Structure

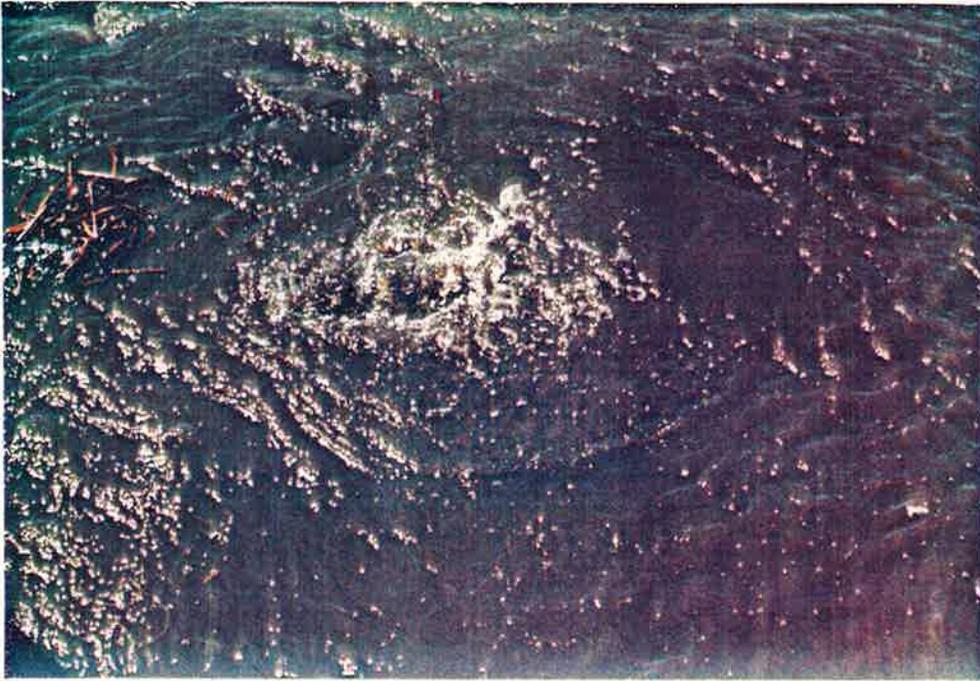
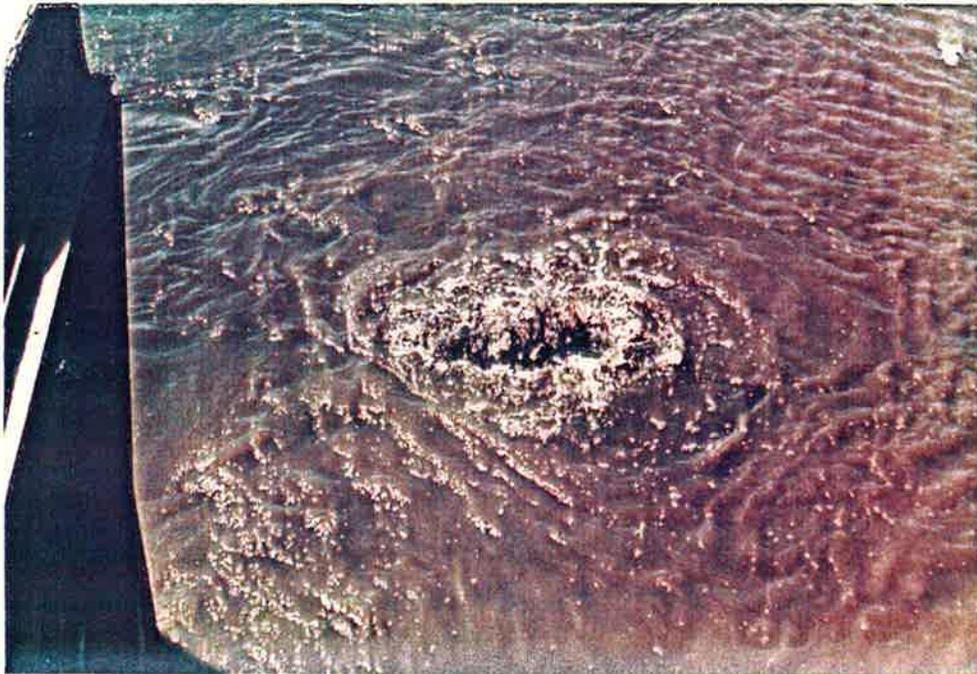
Photo H - May 2, 1984

Photo G - May 2, 1984
The Upper and Lower Photos Show a
Close-up View of the Two Pronounced
Boils. Note the Absence of Clear Water
Near the Boils, Especially Photo "G".

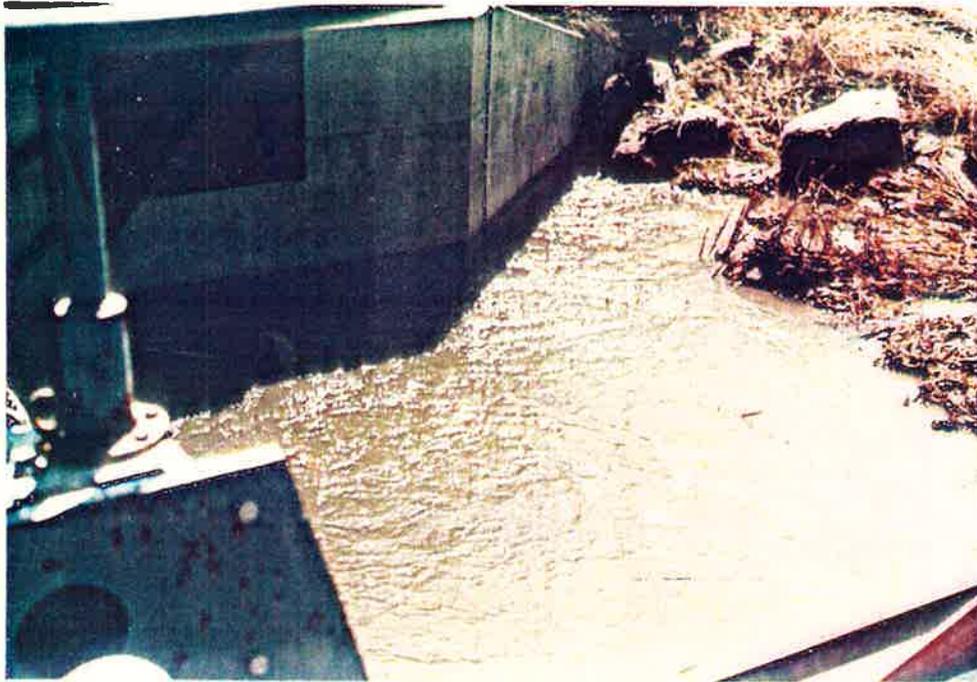
Photo I - View of the East Downstream Wingwall
Water was Reportedly Flowing Along
the Soil Side of the Wingwall and
Emerging in the downstream Pool
May 2, 1984

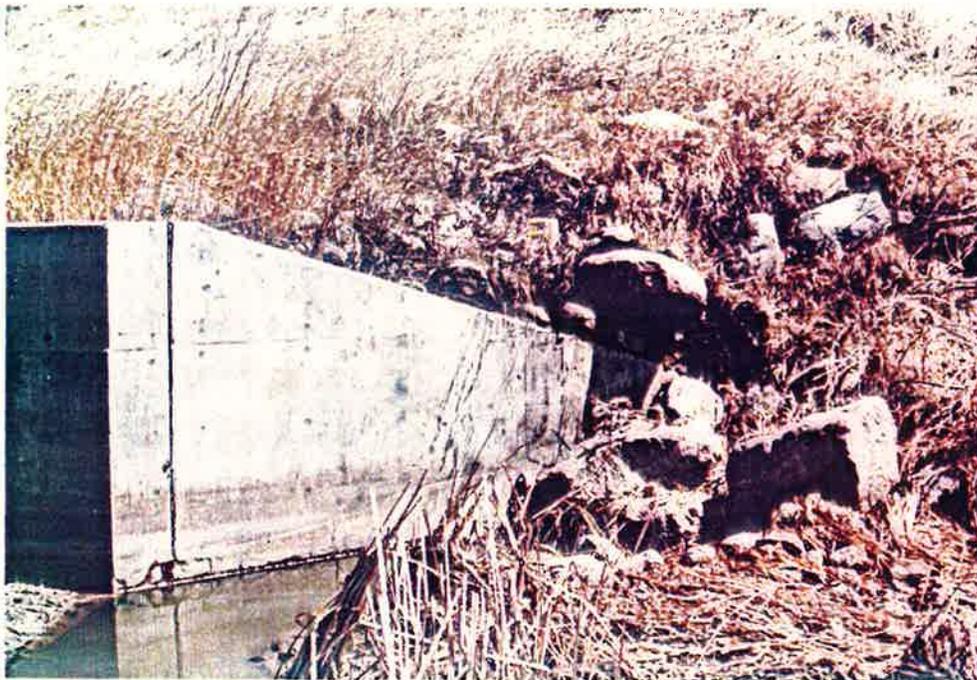
Photo J - Close-up View of East Downstream Wingwall
Note the Area that has Slumped Due to
Seepage Adjacent to the Wingwall
May 8, 1984

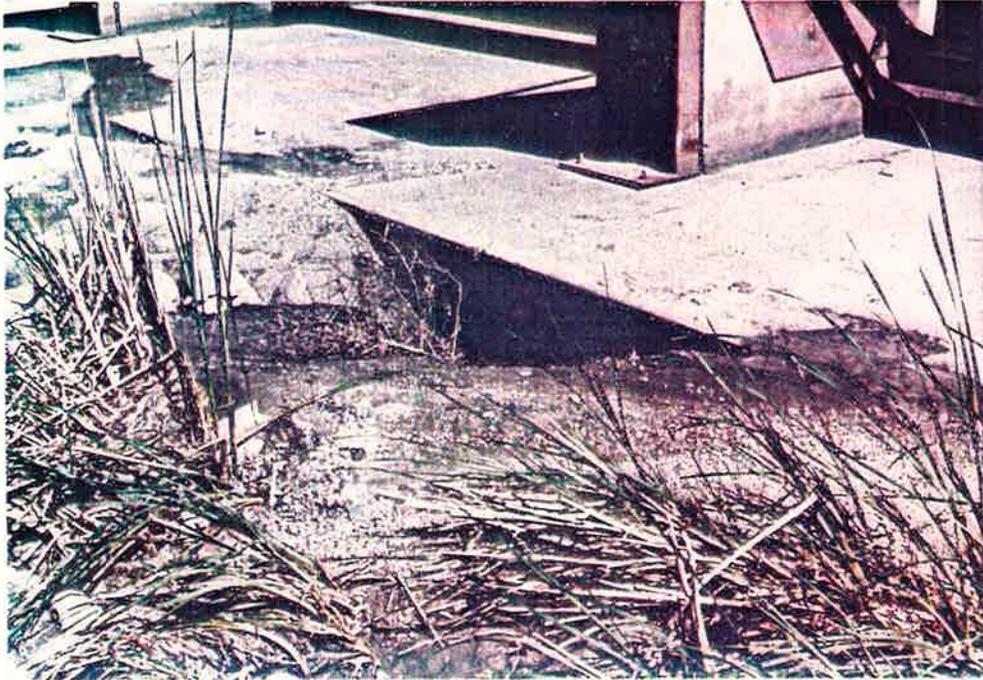
An earthen cofferdam had been constructed about 12 feet upstream of the structure. The sediment build-up on the downstream was partially drying out. There was one pronounced sinkhole about 2 feet x 1 foot at the downstream edge of the structure slightly east of the mid-point (See Photo 1). This appeared to be caused by the continuing flow of water and suspended material carried by a very small differential of head from the upstream face of the structure, under the upstream cutoff wall, underneath the slab, under the downstream cutoff wall and up through the sediment deposit.

Photo No. 1 - Sink Hole Downstream of Structure
6-27-84

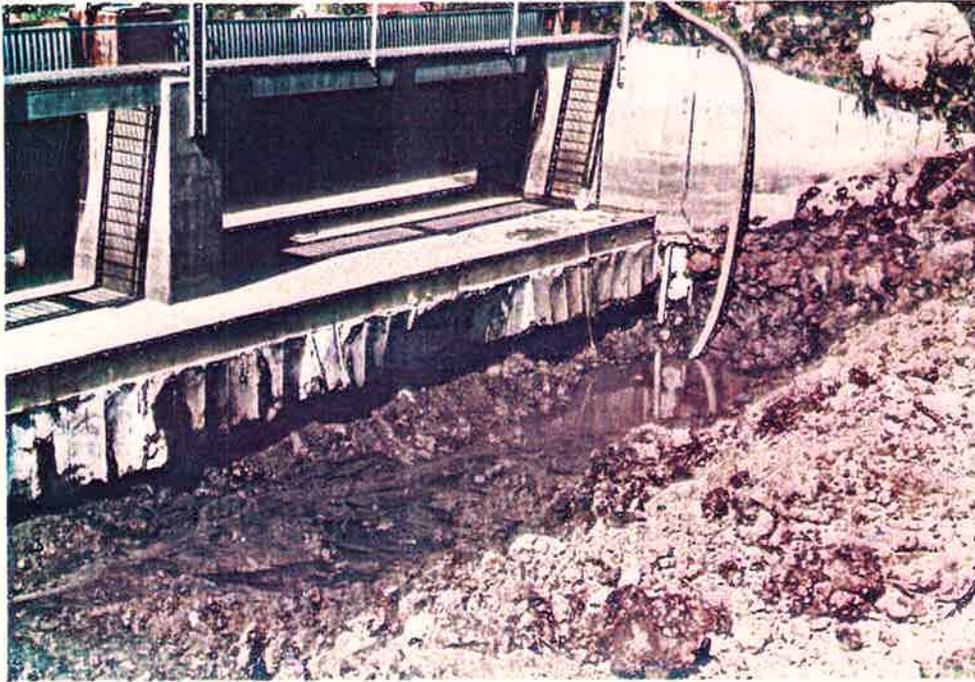
The irregularity of the concrete wall indicated the forms were not properly tied or supported (See Photo 5). The face of the concrete was very uneven and in several places large concrete chunks protruded beyond the normal facing (See Photos 6, 7, 8, 9 and 10). Rebar was exposed, both along the face of the wall and at the bottom of the wall (See Photos 11 and 12).

Photo No. 5 - View of Upstream Wall
Note the Apparent Lack of Good Work,
Improper Forming and the Irregularity
of the Concrete Wall
6-27-84

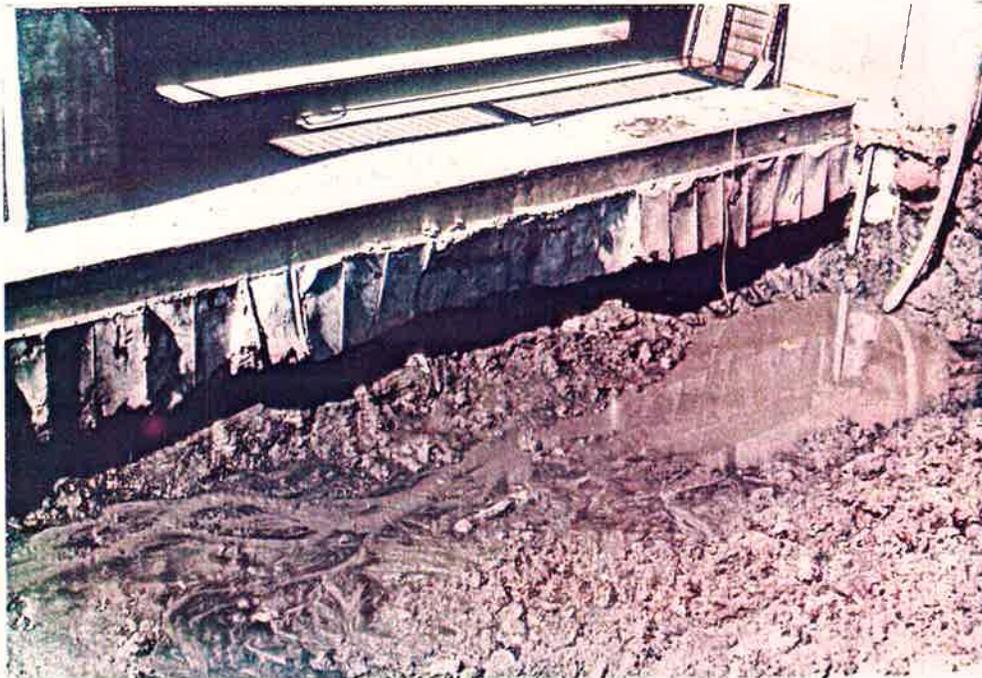
Photo No. 6 - Close-up View of Upstream Wall
West Portion of Structure
6-27-84

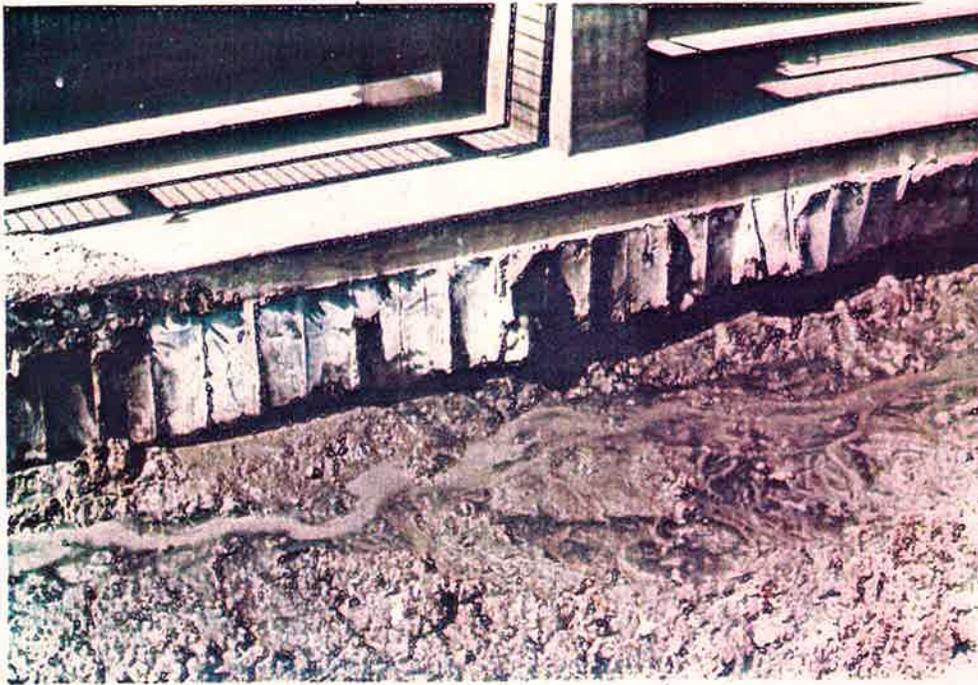
Photo No. 7 - Close-up View of Upstream Wall
Middle Portion of Structure
6-27-84

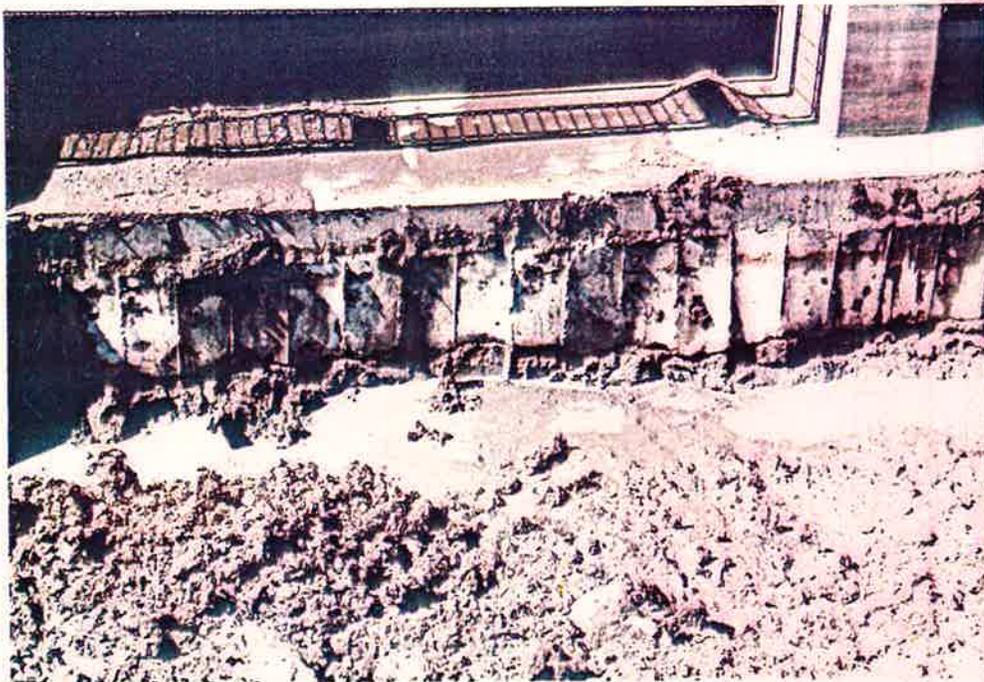
Photo No. 8 - Close-up View of Upstream Wall
East Portion of Structure
6-27-84

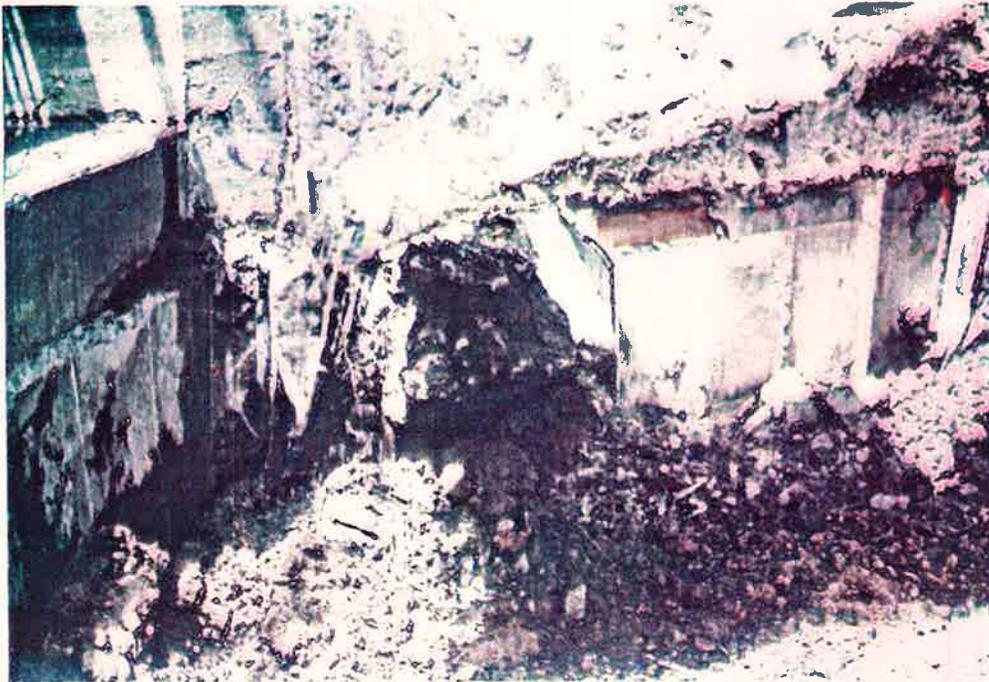
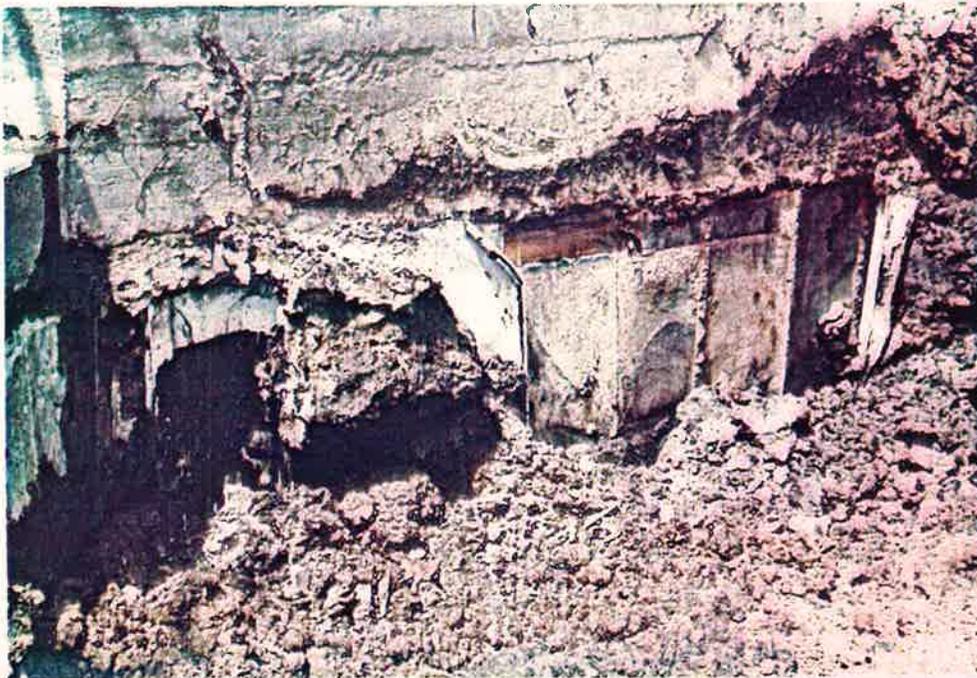
Photo No. 10 - 7-2-84

Photo No. 9 - 7-2-84
The Upper and Lower Photos Show Further
Evidence of Poor Workmanship and
Improper Construction Methods. Note the
Large Chunk of Concrete Protruding
Beyond the Face of the West Upstream
Wingwall and the Wood Framework Left Inplace

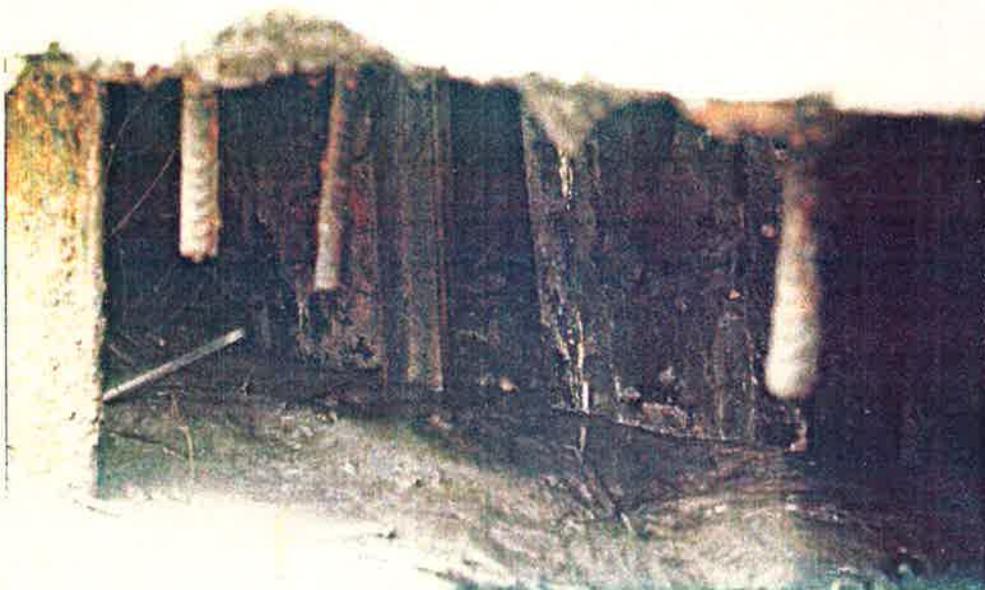
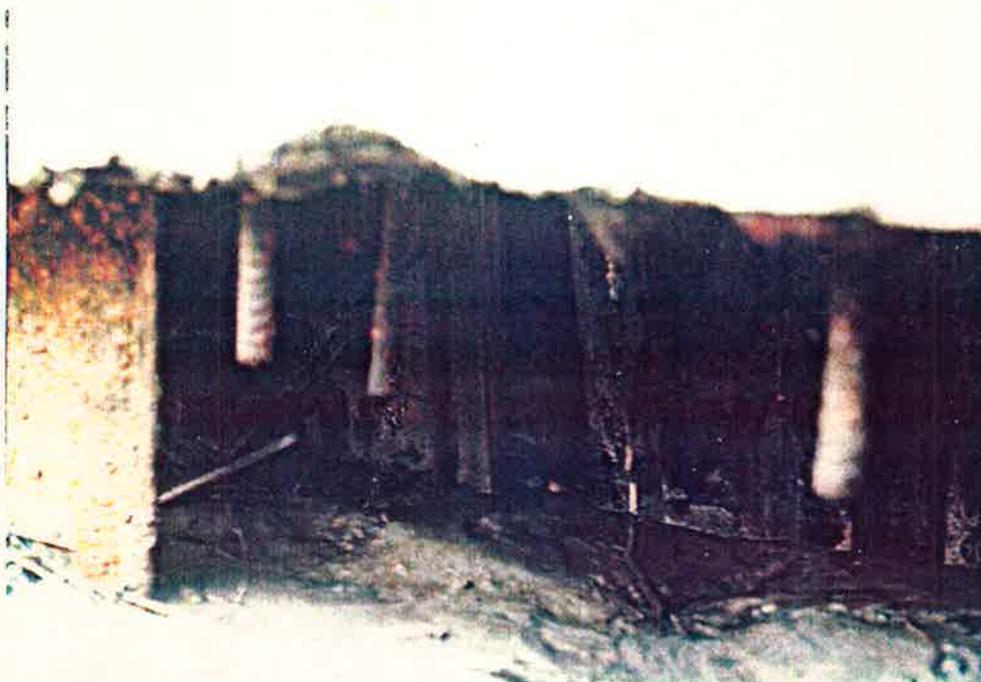
Photo No. 12 7-2-84

Photo No. 11 7-2-84
The Upper and Lower Photos Show
Exposed Rebar and Cavitation
Beneath the Structure

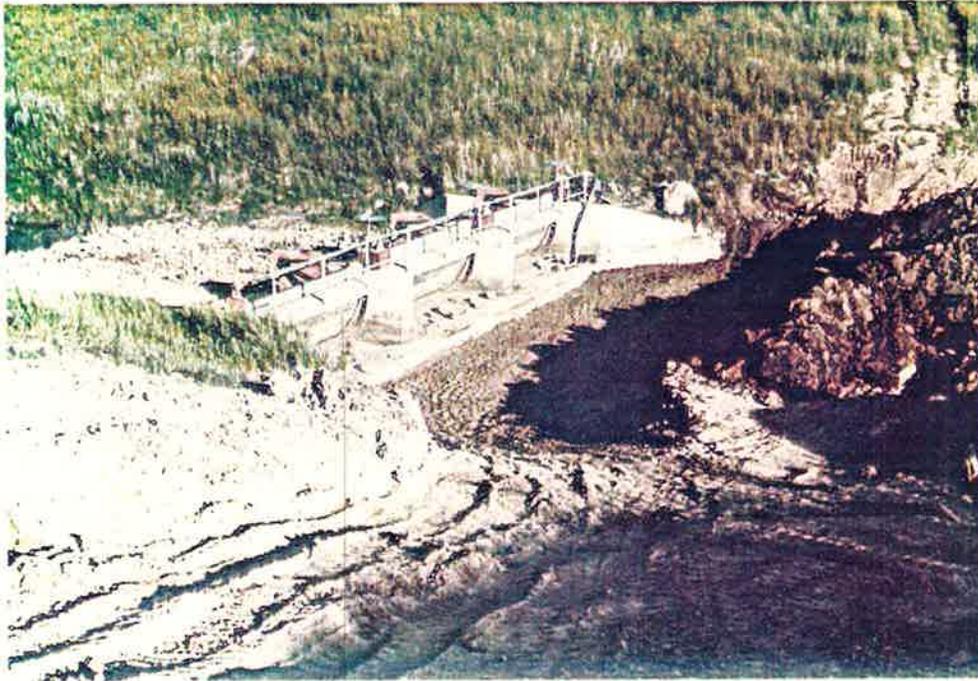
We arrived at the project site about 8:00 a.m. Much to our satisfaction the entire backfilled area was dry and firm (See Photo 19). We checked the upper surface for wet and spongy conditions, but discovered none.

Photo No. 19 - Tuesday 8:00 p.m. 7-3-84
View of Structure & Completed Earthen Backfill
Note the Dry Condition of Entire Area After
Completing Backfill Operations the Previous Day

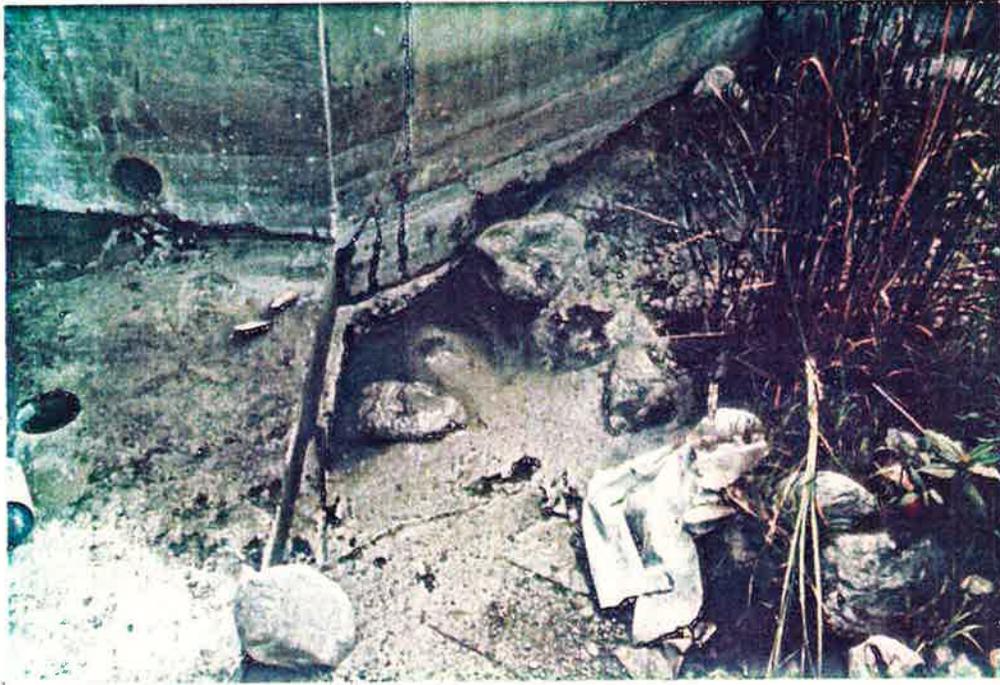
Photo No. 27 8-2-84
Close-up View Showing Inspection Hole
On East Wall and an Eroded Area Near
The East Downstream Wingwall
