INVESTIGATION REPORT  
**FORT CLARK IRRIGATION**  
SWC PROJECT NO. 287

NORTH DAKOTA  
STATE WATER COMMISSION  
NOVEMBER 1998

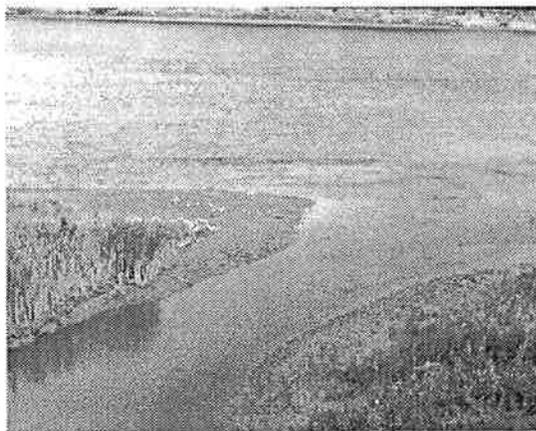
The supply works can be broken down into three separate topics. One is the river access, another are the pumps, and the last part are the electrical components. Beginning with the river access, we observed a large sandbar located directly in front of the inlet. Due to a shift in the thalweg, or deepest part of the river, silting has occurred on the bend, creating this sandbar. The

sandbar extends approximately 100 ft into the river and continues upstream for about one mile. The sandbar could prove to be detrimental to the system for several reasons. One reason is, as water is pulled through the pumps, it carries with it large amounts of sedimentation. These sediments could damage the impeller or other parts of the pump. Also, the sediments are deposited in the channel, creating flow problems for the system. Finally, during low flows, the water level may be too low to flow past the sandbar well enough for the pump to receive adequate water. This sandbar is an issue that should be addressed if the system is going to operate with any efficiency.

The State Water Commission recommends periodic dredging of the sand bar because it is the least costly and it has been proven to be beneficial in the past. A structure could be built downstream of the sandbar, giving access for a backhoe or long boom excavator to clean away the sandbar. The other alternatives may prove to be the better in the long run, but the costs will be much greater, and due to the small size of the district, available funds is the major issue.

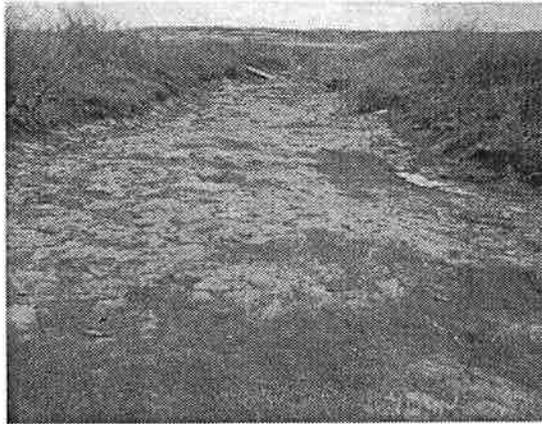
First of all we found that a large number of deposits have settled along the bottom of the channel, with a majority found at the beginning of canal B. The reason for this is the sand bar located in front of the inlet station. The deposits are transported from the inlet through the transmission pipe and then deposited along canal B as the water slows down enough for the sediments to settle out. Also, a large amount of these deposits were found in front of various structures located in the canal. These structures are used to slow the flow of the water and then back the water up to maintain a water surface elevation that is high enough to flow through a particular turnout. These structures do what they are designed to do, but they tend to create a large amount of deposits, due to the low velocities. In time these deposits can drastically affect the flows in the channel. These deposits may have to be removed in order to return the system back to its original design and shape. The deposits that are removed can be used in restoring parts of the channel that have been worn away or damaged.

The actual cleaning could be done with the use of a channel dredge or some other form of digging machinery. This process could be done by the irrigators or be contracted to a local company. By doing it themselves the irrigators could save a considerable amount of money. The

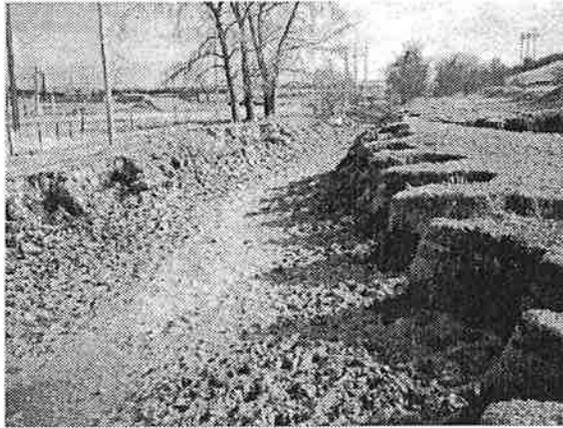
Some of these areas are the ones that have been destroyed by cattle. The cattle are allowed to walk up and down certain stretches of the channel, and because of this, the channel's banks have been severely damaged. These stretches of canal need immediate improvements if the system is

to operate properly. The hydraulic properties of these stretches are extremely inefficient. As the water flows into one of these areas the energy is dissipated, and the velocity is greatly reduced. This makes it extremely difficult to route the water to the first relift station. Measurements were taken on the area, and the volume of soil needed to restore the channel was determined. These calculations can also be viewed in the appendix. As mentioned before, the soil removed from the channel in some areas could be used to restore the channels in others.

The State Water Commission recommends repairing parts of canal B that were mentioned in the report as being damaged by cattle introduction. Once these areas have been repaired, we recommend constructing a fence around these areas to prevent this sort of damage from happening again. The fence could be either electric or possibly barb wire, whichever serves the District best, and is most cost effective. If some of the local irrigators insist on providing their cattle with water from the canal, a separate pump could be purchased and a stock tank could be supplied and placed outside of the fenced area.

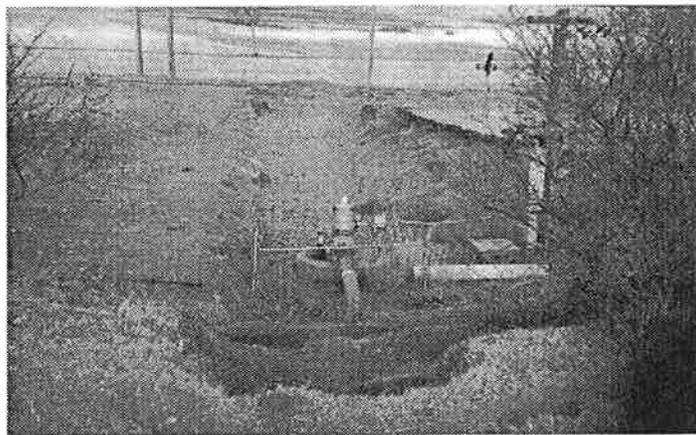
The final part of the system that was investigated are the two relift stations. The first one is located on the upper third and serves lateral #2, and the other one is located on the lower third and is used to service the last part of canal B. The first relift station has a capacity of 5 cfs, and has been out of service for more than four years. The pump located at the station was making a loud noise, and will need some repairs if future use is desired. Cattle have destroyed the approach works associated with the relift, and also the fencing around the pump.

As mentioned before, restoration is needed to the surrounding banks and inlet, if the pump is going to adequately receive any water. Lateral #2 is approximately 7,500 ft long and can serve

The first item that must be addressed when discussing the relift stations are the channels servicing the pump stations. The areas have been destroyed by cattle and erosion and need to be built up in order to adequately route water to the pumping station. The soil needed can be used from the soil removed from the cleaning of other parts of canal B. Most concern is for a 300 yard stretch of canal B upstream and downstream of Relift #1. This stretch of channel has been destroyed by cattle, and the flow characteristics are extremely inefficient. In order for the system to operate correctly, this stretch of canal should be built up to its original size and shape. After this stretch is repaired a fence should be constructed to prevent cattle from entering canal B any causing damage to the channel. If the water users in the District want to see water supplied to cattle by the irrigation canals, a separate pump and stock tank could be purchased and placed outside of the fenced area.
