*THE SUMMER STORM  
OF JUNE 24, 1985*

# **MOUNT CARMEL DAM**

**SWC Project No. 1346  
Cavalier County**

THE SUMMER STORM  
Of JUNE 24, 1985

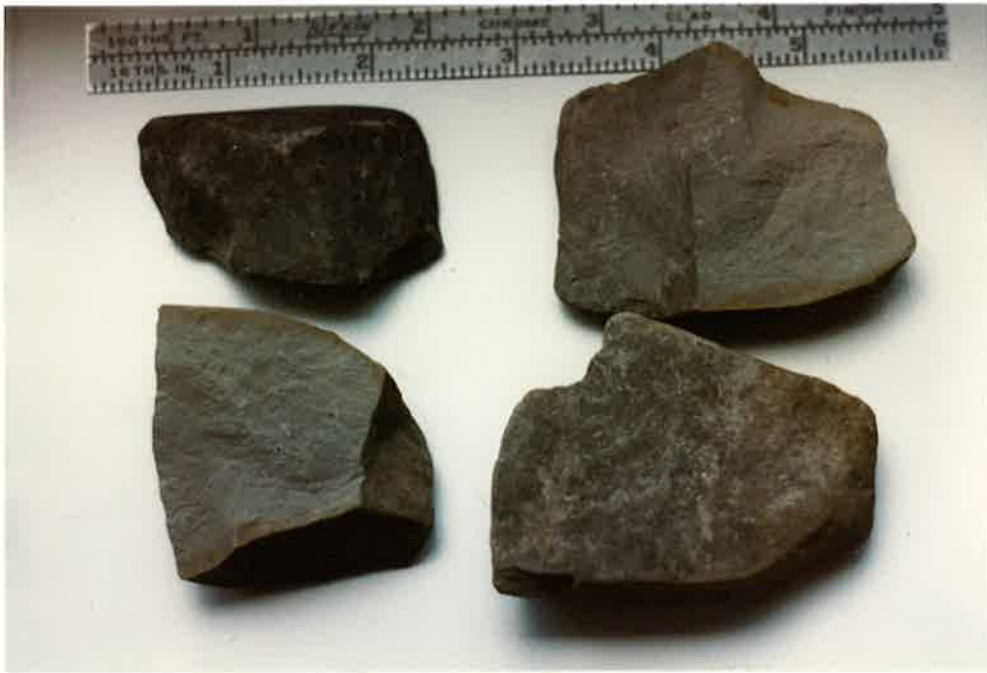
- 6) Based on the above, we can assume the following:
  - a. A tornado may have been directly responsible for depositing the shale into the reservoir.
  - b. The source of the shale was believed to have come from a wave cut cliff, located approximately 600 feet in a southwesterly direction from the inlet structure (See Photos 10 and 11). The unstable cliff is adjacent too and directly north of the emergency spillway inlet. The face of the cliff is constantly exposed to westerly winds, causing the fractured shale to erode and fall into and along the reservoir shoreline. From here, it could be transported by wave action to the embankment shoreline. During the storm, the tornado probably removed a portion of the cliff. In time, the combination of high winds and wave action carried a large portion of the shale mass across the reservoir. Turbulence and violent agitation of the reservoir water continued long enough to deposit significant amounts of shale into the inlet box. A small shale dune is now exposed to the south of the inlet structure (See Photos 12 and 13). Other than that and scattered shale fragments along the shoreline, no physical evidence remains to support the aforementioned hypothesis.

Photo No. 1 - Close-up view of some of the larger, angular shale fragments.

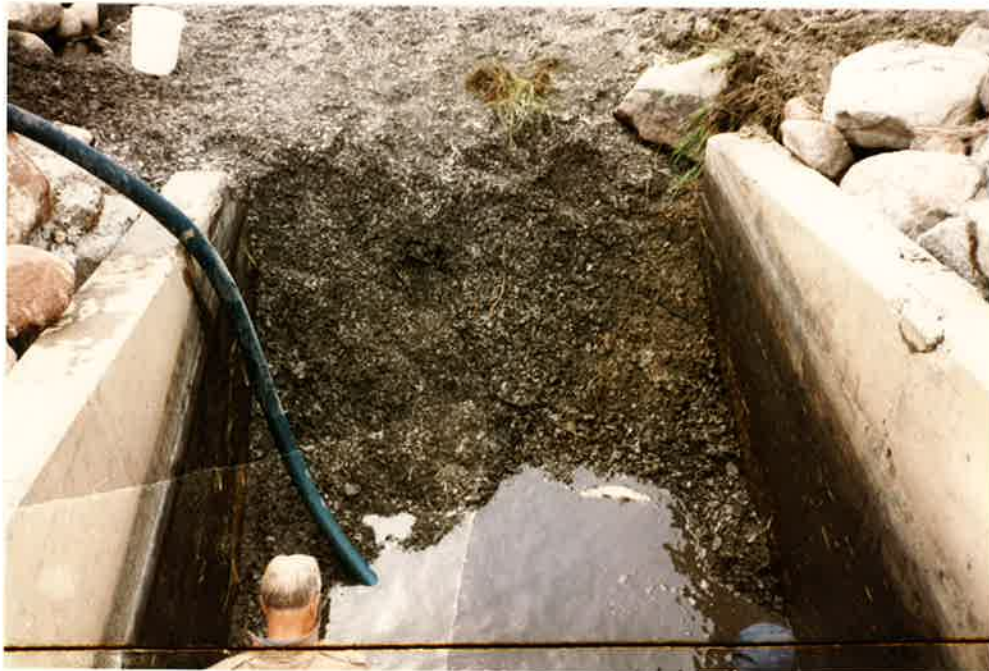
- 6) A backhoe arrived Tuesday morning, July 16th, and removed most of the shale from the stilling basin before Mr. Grunseth arrived at the site (See Photo 2).

Photo No. 2 - View of Stilling Basin after most of the shale had been removed the morning of July 16th.

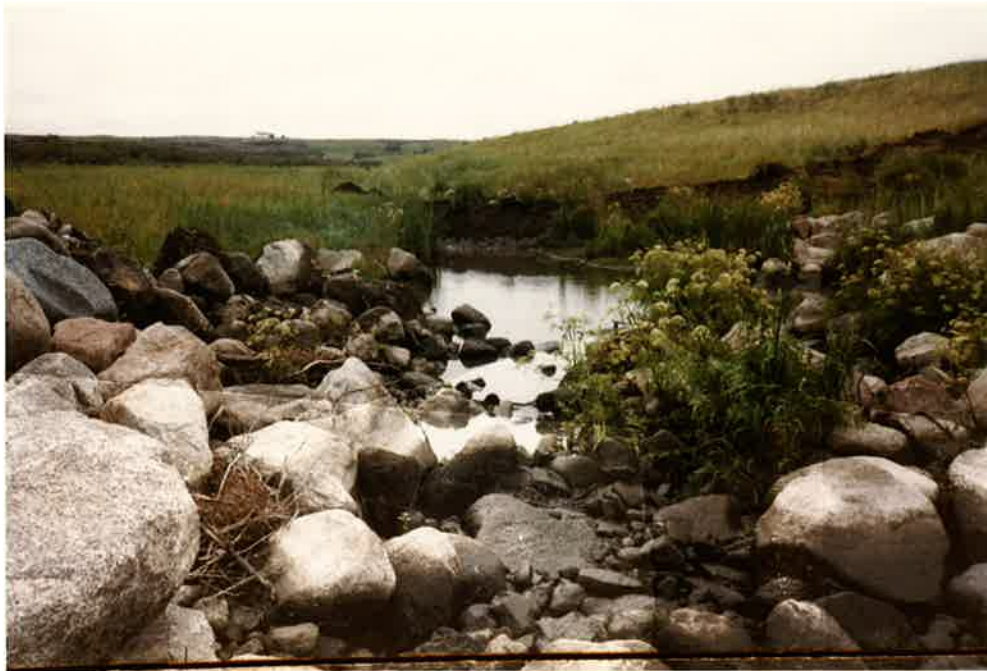
- 12) The low level drawdown was again closed on Wednesday morning, July 17th.
- 13) Another contractor from Langdon arrived on Wednesday morning, July 17th, with a 4-wheel drive front-end loader and installed a coffer dam about 100 feet downstream of the stilling basin. It was not possible to install the coffer dam any closer to the stilling basin because riprap would have allowed back flow through the voids in the riprap (See Photo 3).

Photo No. 3 - View of downstream area and Earthen Cofferdam.

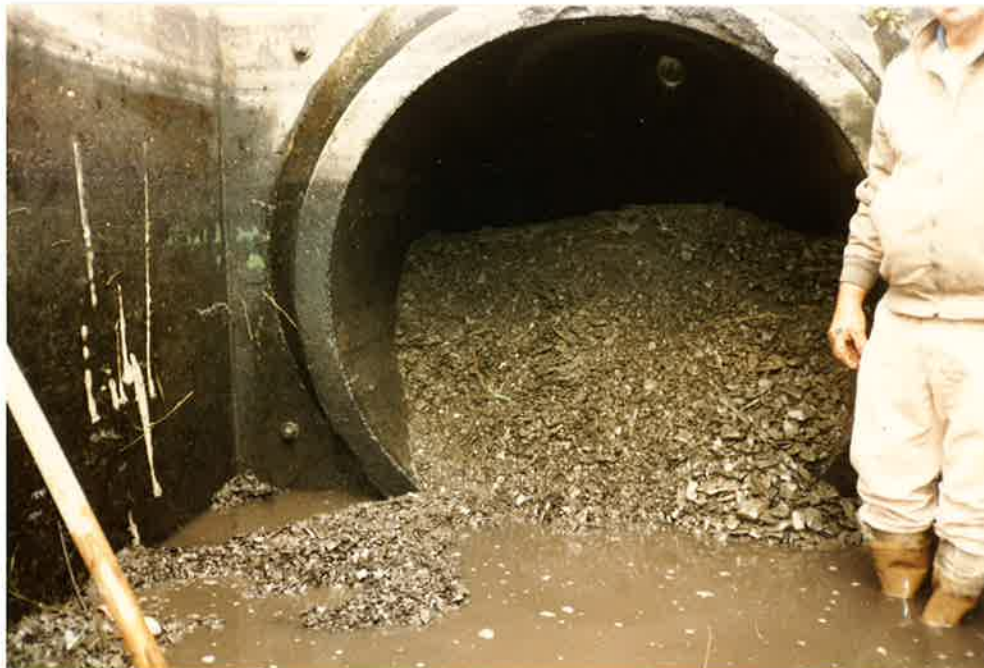
- 16) The pumps ran for about two hours before the water level was low enough to permit entrance into the stilling basin. The remaining shale was then removed manually from within the conduit and stilling basin. To assist the person working in the pipe, the planks were removed on the drop inlet. This helped to flush the shale out of the conduit (See Photos 4 through 6).

Photo No. 4 - Partial view of Stilling Basin and Conduit.  
Note shale remaining in Conduit that had to be removed manually.

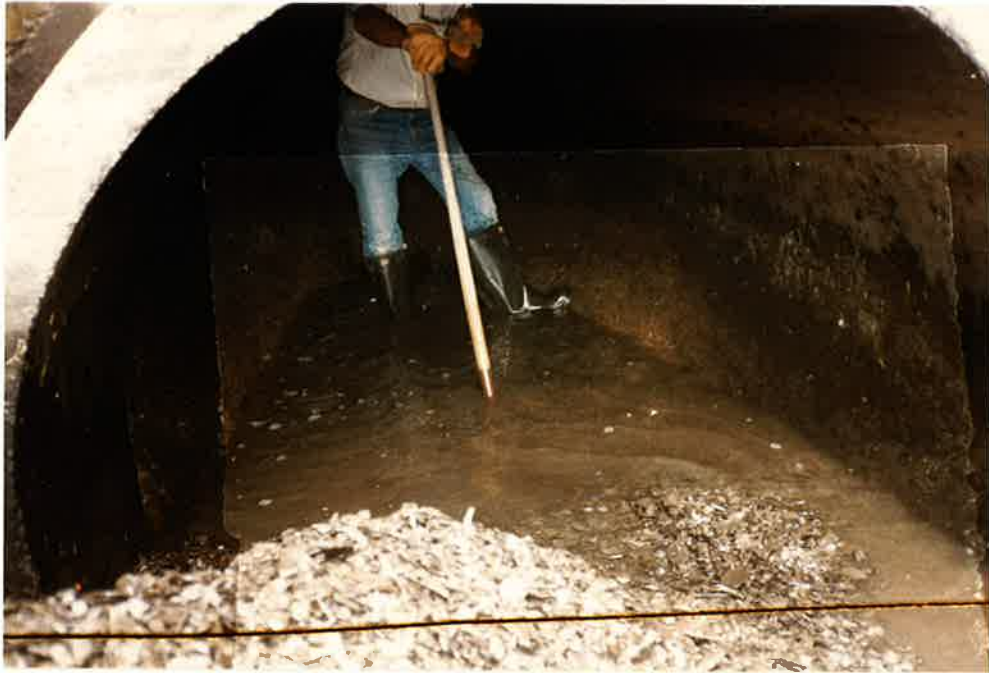
Photo No. 5 - View of Arland Grunseth inside of Conduit.  
To get the shale out - we had to shovel it out.

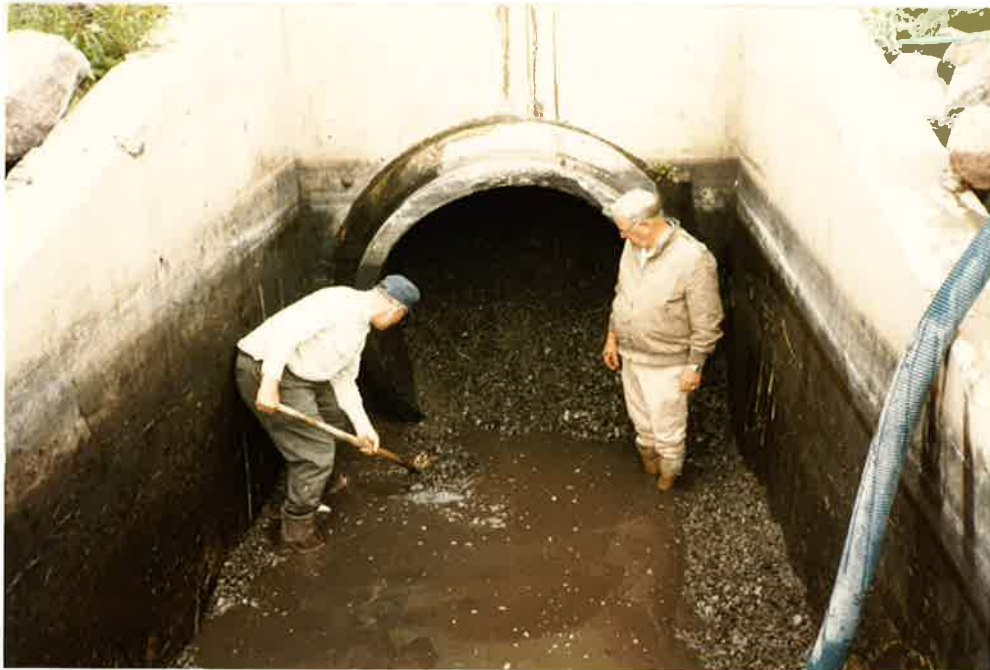
Photo No. 6 - Ed Schmidt and Russ Schroeder take turns on  
the shovel outside of Conduit.

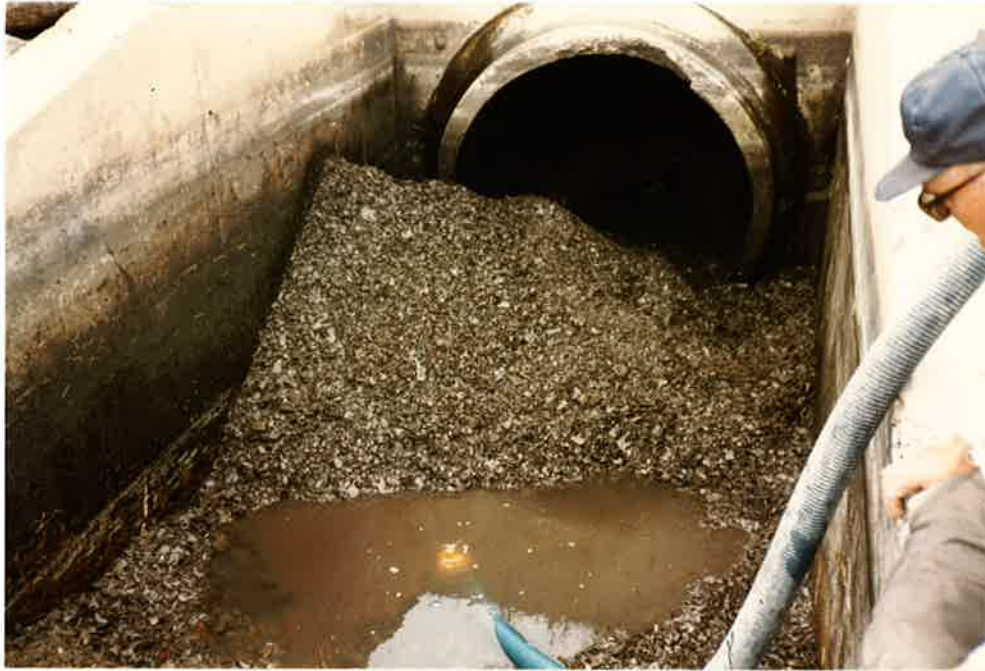
- 17) The last three downstream joints of the conduit were inspected about 12:30 p.m., Wednesday, July 17, and determined to be in good condition.
- 18) Upon completion of the pipe inspection, the backhoe removed the last of the shale from the stilling basin. The outlet structure was then inspected in its entirety and determined to be structurally sound, except for some surface abrasion to the concrete and the exposure of reinforcing steel (See Photos 7 and 8).

Photo No. 7 - The last of the shale after its removal from the Conduit.

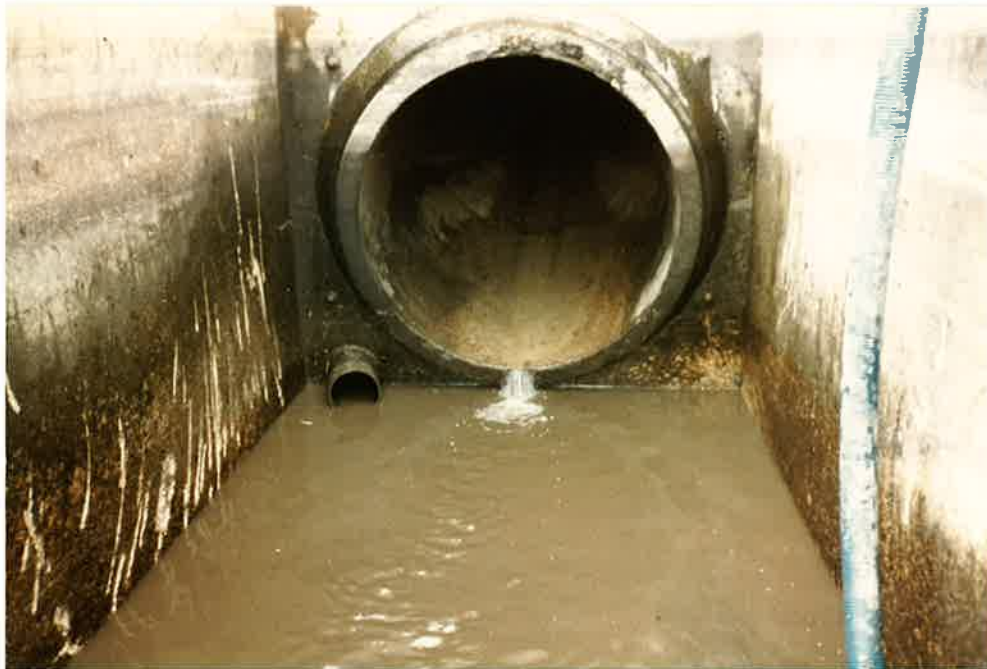
- 19) The end sill was worn down about 3 to 3 1/2 inches. Reinforcing steel was exposed by 1 1/2 to 2 inches on its upstream corner.
- 20) The side walls adjacent to the end sill were worn back approximately 1/2 inch deep. The surface abrasion areas ranged from 18 to 22 inches in diameter. The deepest abrasions were about 8 to 10 inches upstream of the end sill and 10 inches above the floor.

Photo No. 8 - Shale Removal Complete. Note view of Drawdown Pipe adjacent to Conduit.

- 1) The stilling basin end sill should be gunited or a new end sill should be installed at some future time. The walls may require maintenance also.
- 2) The service road on the downstream slope of the embankment could use some graveling.
- 3) Monitoring of the seepage areas should be continued.
- 4) Install a new weir to monitor the flows from the south abutment drain.

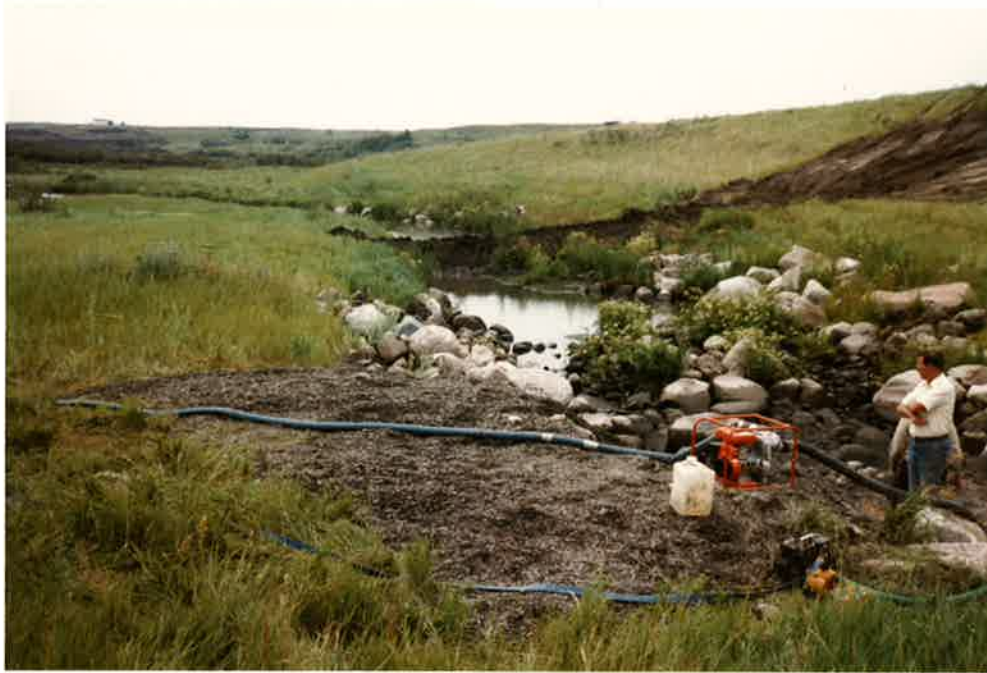
- 4) If the shale were an average of 5 feet deep there would have been about 20.7 CY in the stilling basin. The area below the stilling basin would have contained about 7.4 CY, while 2.7 CY were in the conduit. This would give a total of 30.8 CY. However, the spoil pile does not appear to be that large (See Photo 9). If the stilling basin averaged 4 feet deep, its volume would have contained 16.6 CY. If the area below the stilling basin was 1-foot deep, it would then contain about 3.7 CY, with 2.7 CY remaining in the conduit. The total volume would then equal 23.0 CY.

Photo No. 9 - View of downstream area showing leveled shale pile (Photo taken July 17, A.M.).

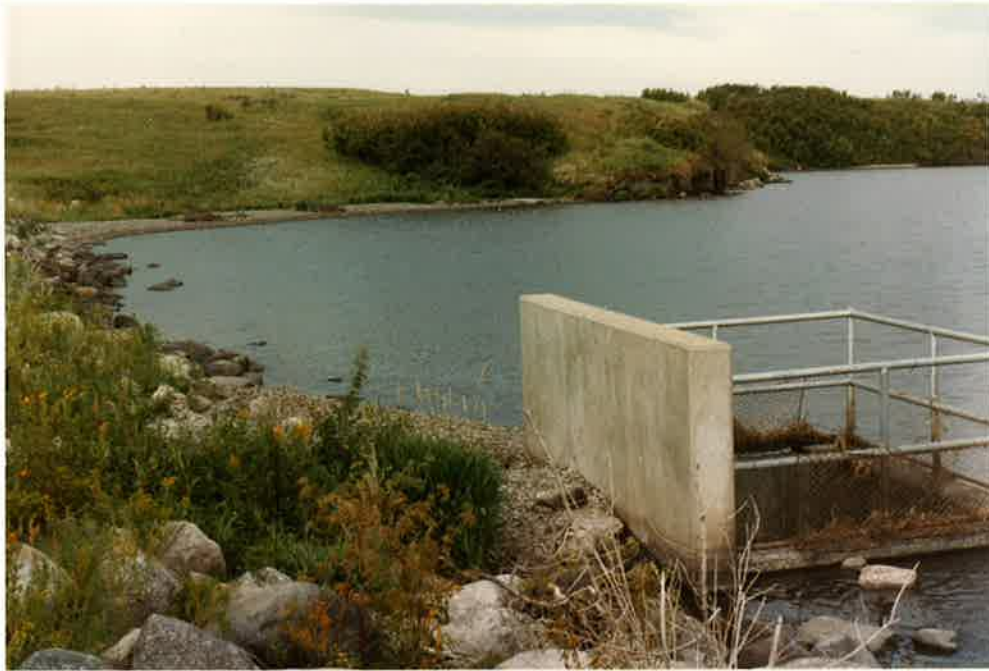
Photo No. 10 - View of Inlet Structure in relation to Wave Cut Cliff. Viewed from the Inlet Structure looking South-westerly towards the cliff.

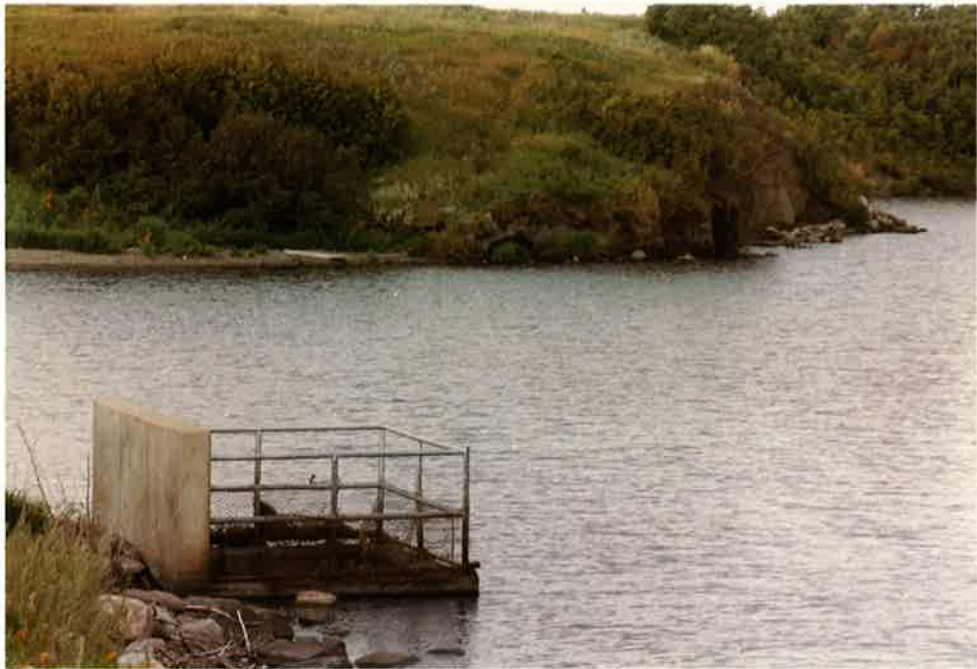
Photo No. 11 - Another view of Inlet Structure and Wave Cut Cliff. Photo taken with telephoto lens.

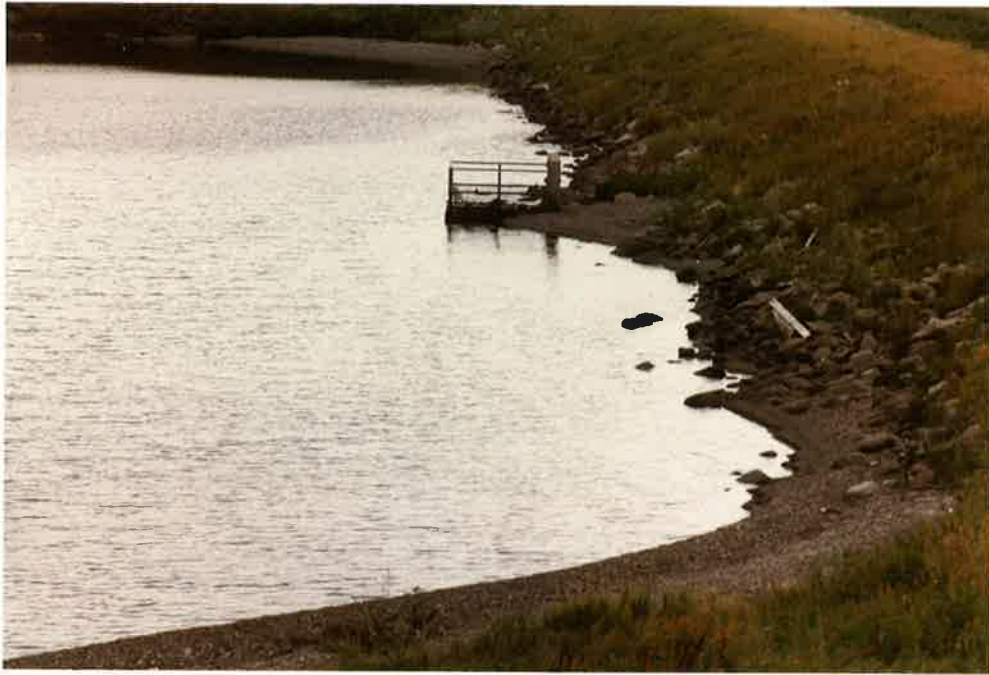
- 22) The upstream embankment slope was inspected and no serious erosion or scouring was observed. An abundance of shale particles were visible on the south side of the drop inlet. Shale particles to the north of the structure were observed, but seemed to be less conspicuous.

Photo No. 12 - View of Inlet Structure looking North. Note shale dune on South side of structure and along shore line. Another shale dune is exposed to the North of the structure.

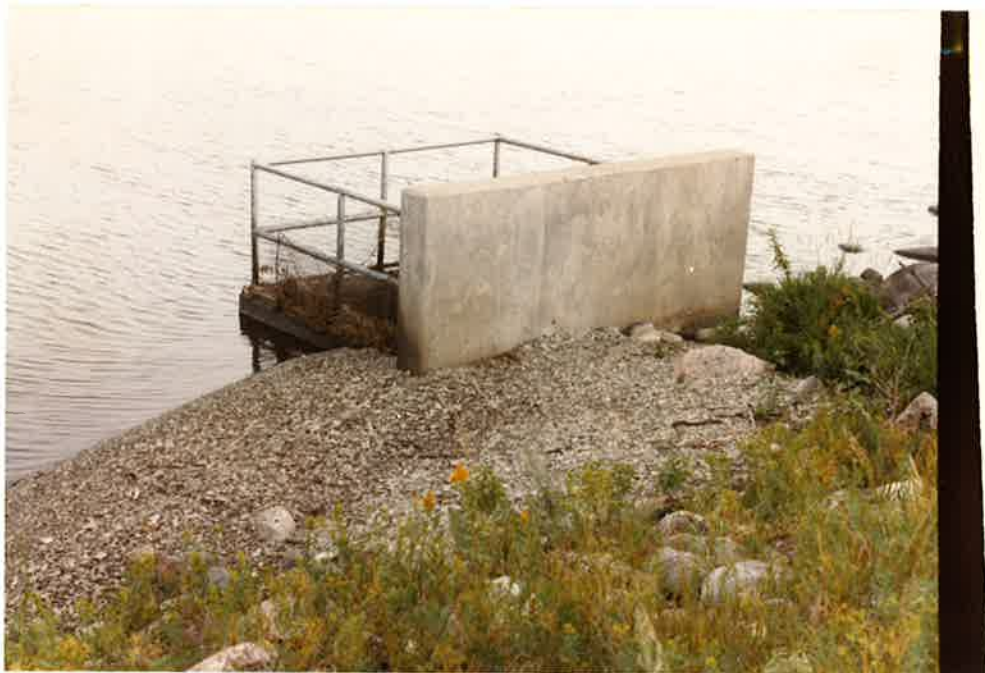
Photo No. 13 - Close-up view of Inlet Structure showing shale deposition on South and East sides of structure.
