PRELIMINARY ENGINEERING REPORT
THIRTY MILE CREEK DAM- BORROW EXPLORATION
HETTINGER COUNTY

S.W.C. PROJECT NO. 1497

PRELIMINARY ENGINEERING REPORT

THIRTY MILE CREEK DAM - BORROW EXPLORATION
SWC PROJECT # 1497

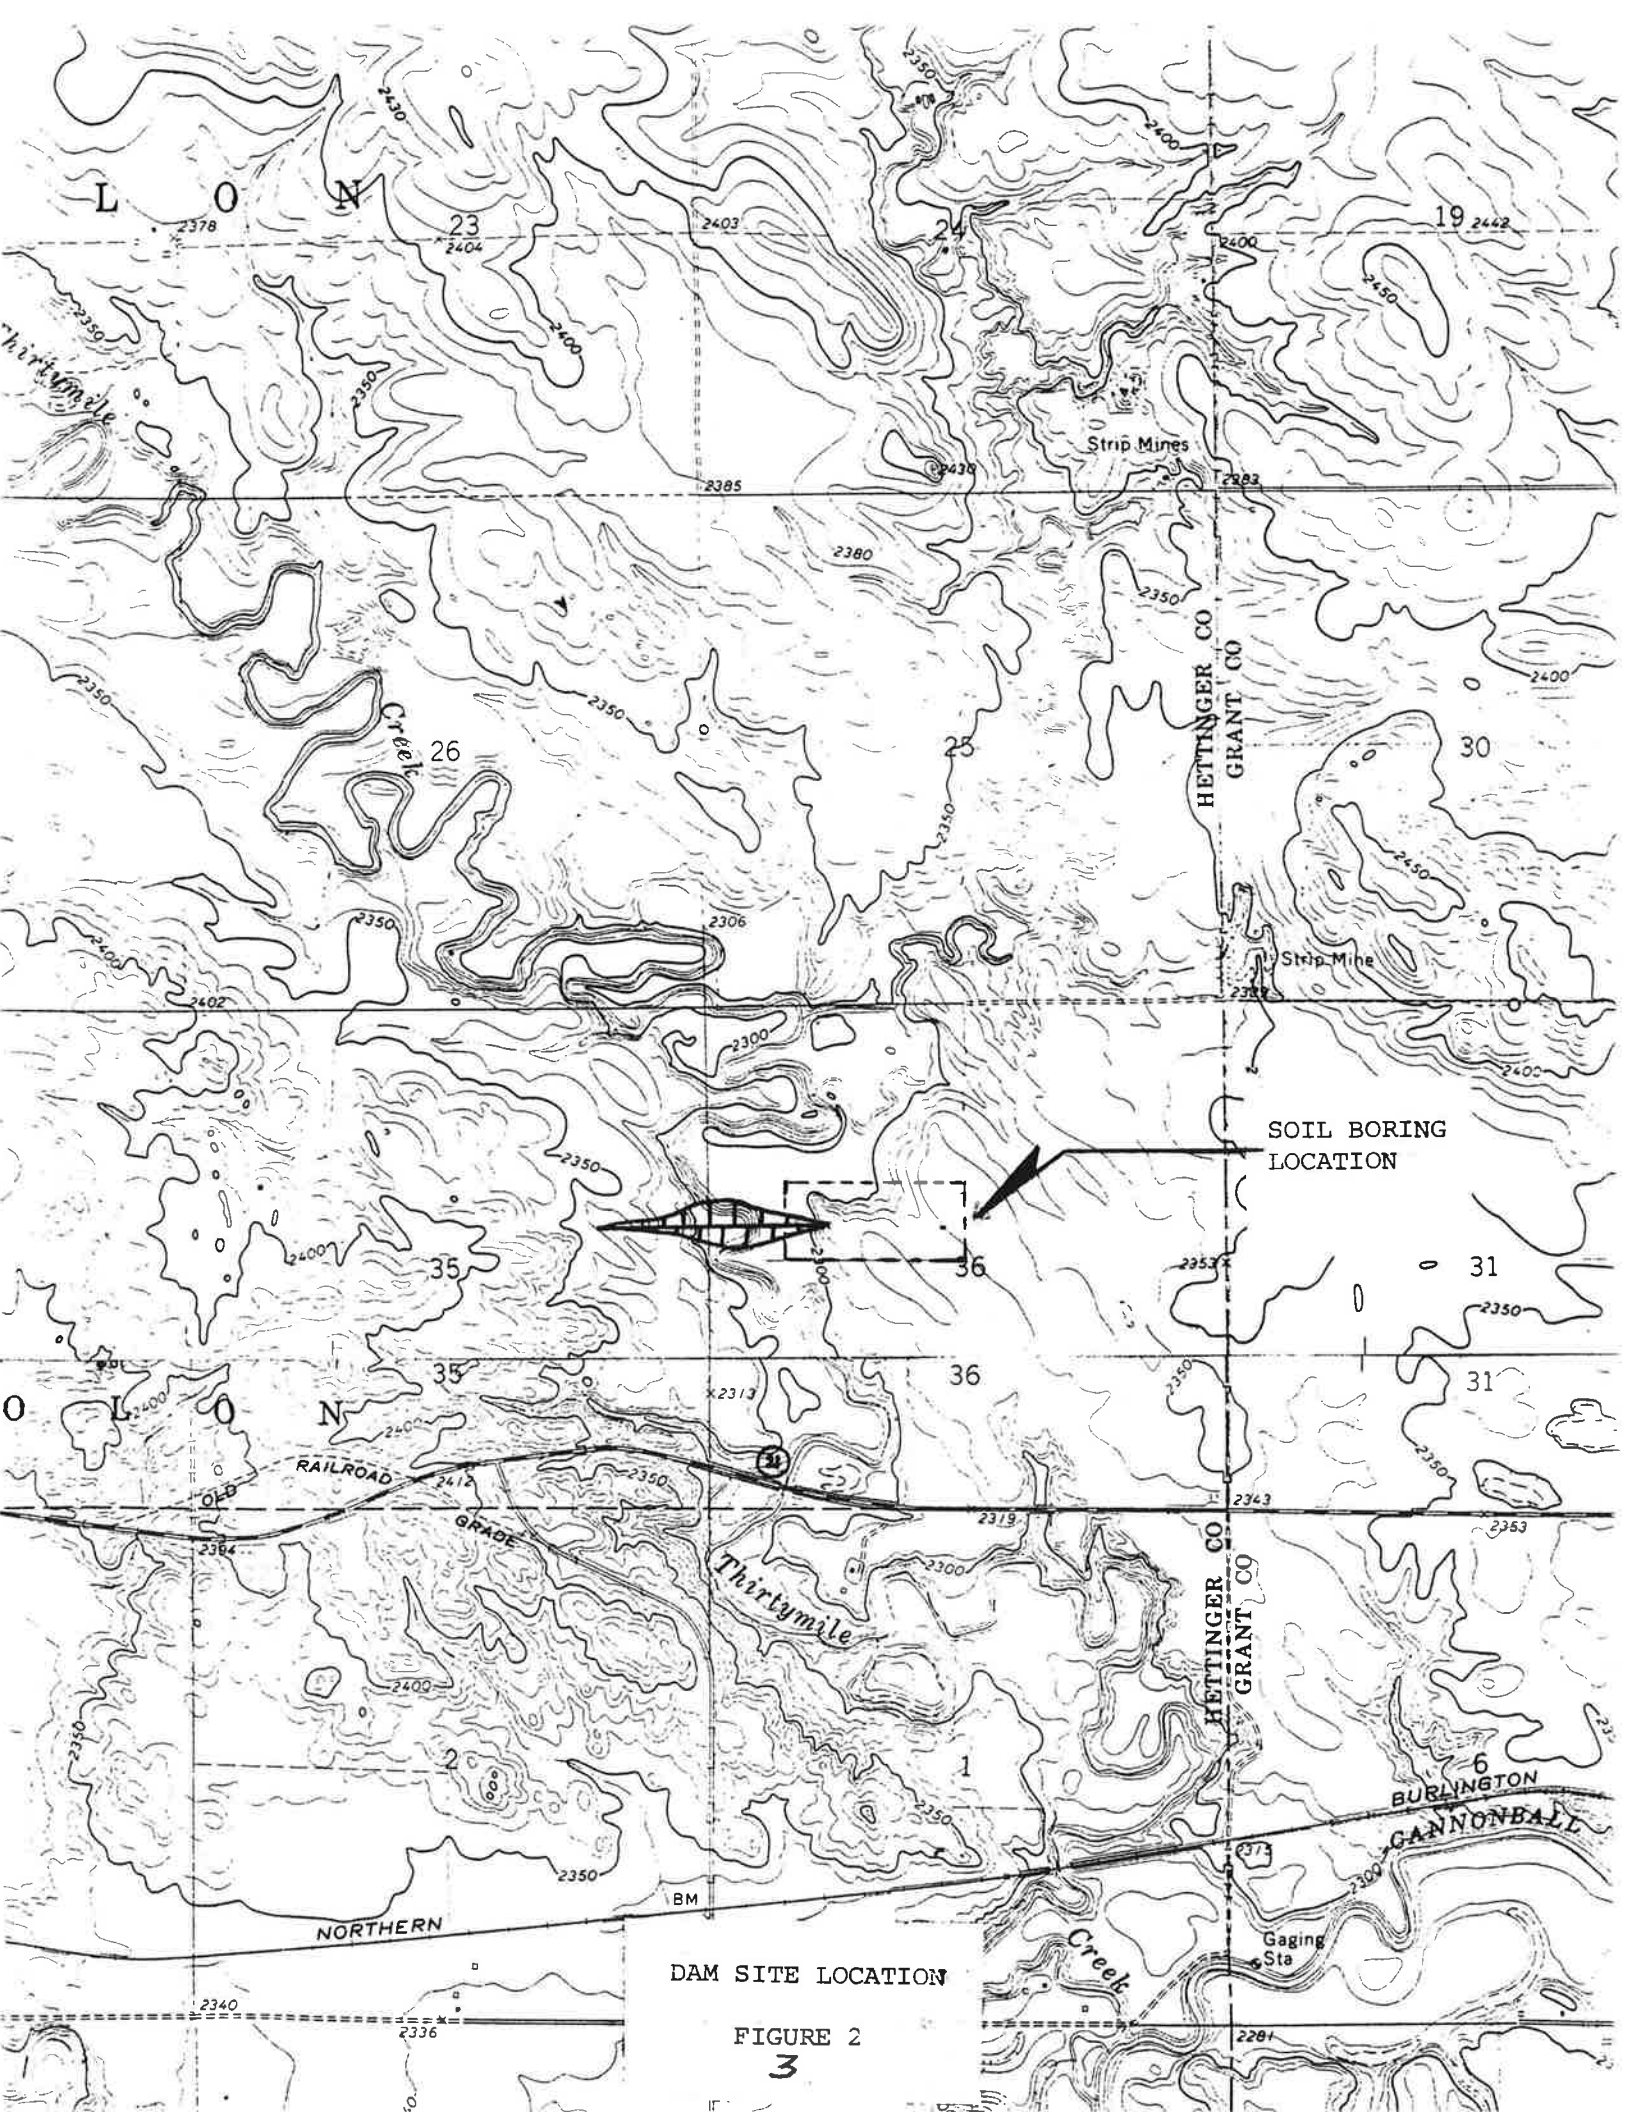
FIGURE 2

DAM SITE LOCATION

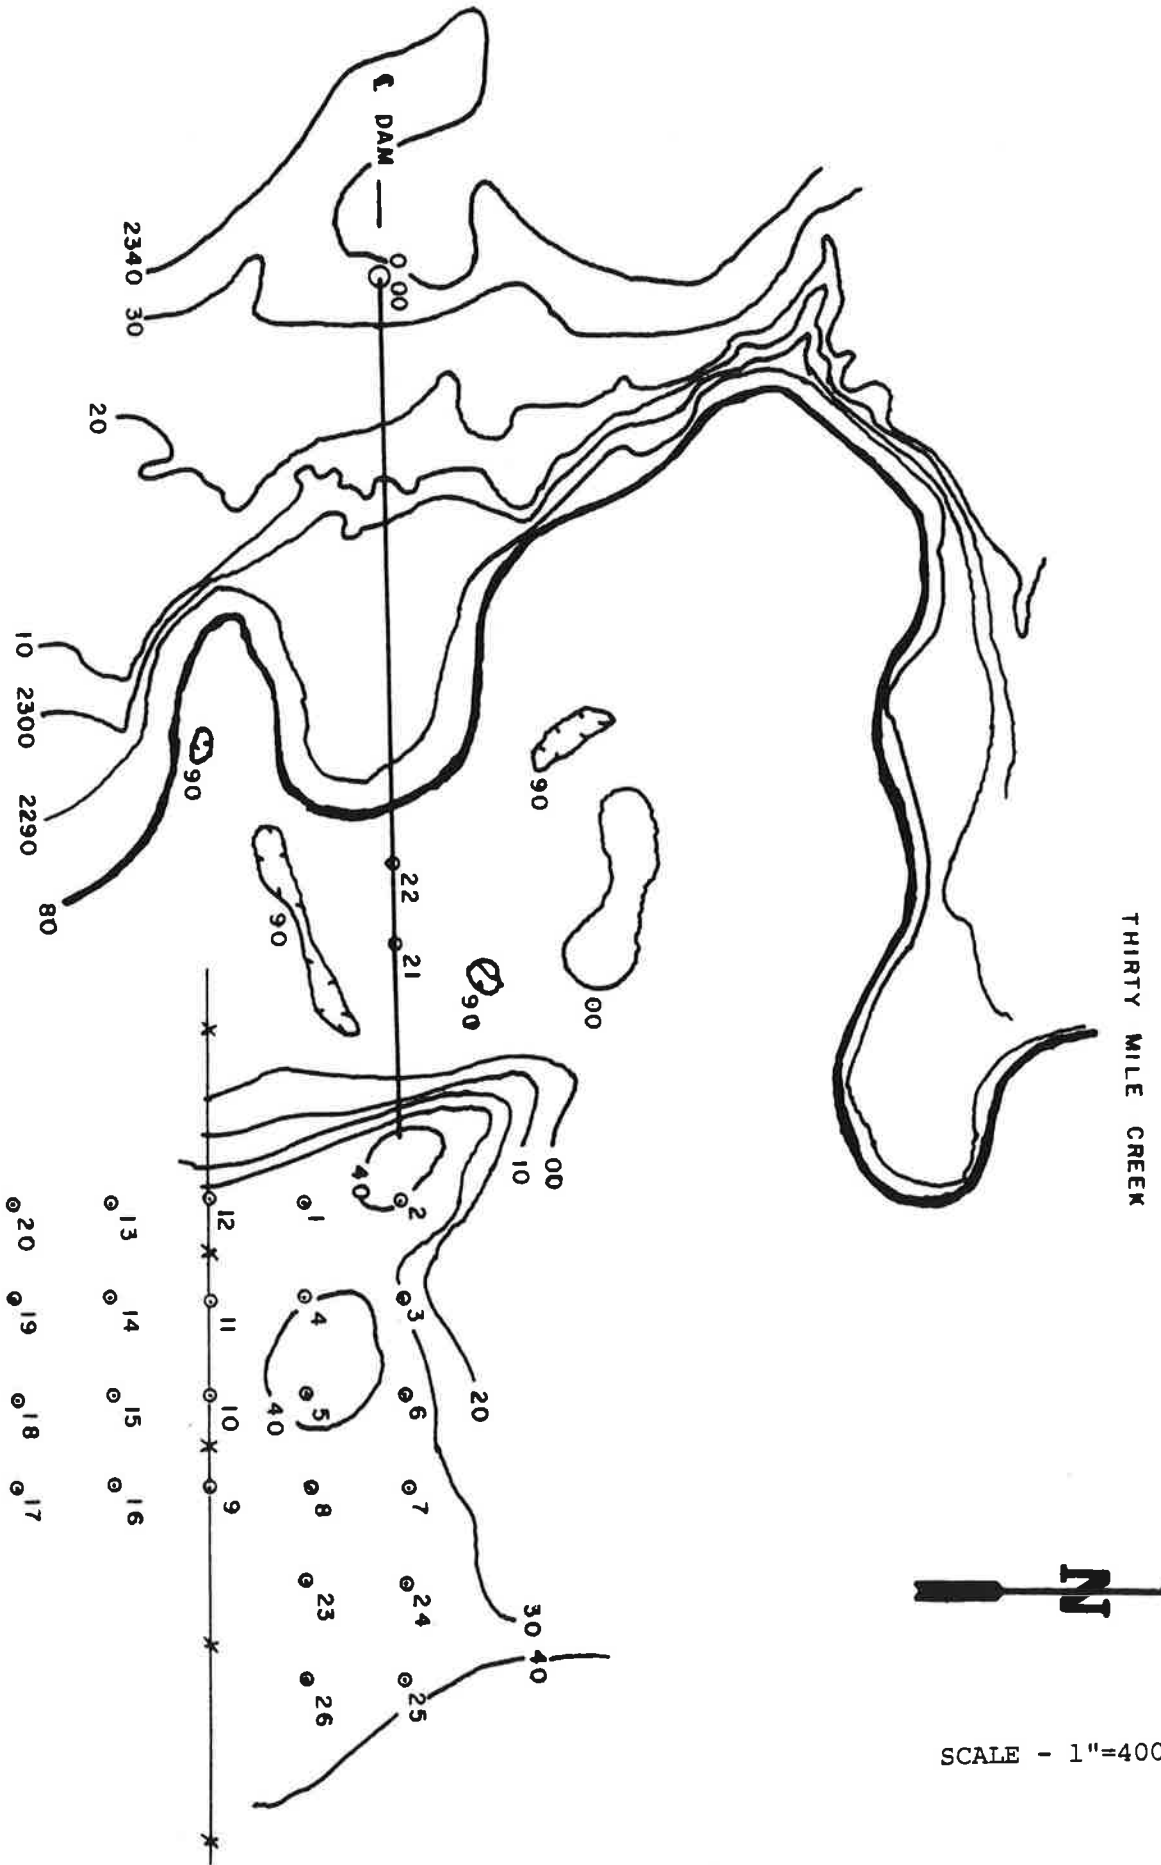
FIGURE 3

On December 8, 1982, Twin City Testing drilled test holes in an area on the east side of the proposed dam center line. Figure 3 is a map showing the location of the holes drilled. The holes were located in a grid system so quantities of material could be calculated.

Twenty-six holes were drilled. Twenty-four holes found no suitable material. Most of these holes showed a thin layer of silty clay at the surface but then encountered sandy material. Two holes showed thicker layers of clay. They were located on the valley floor. The appendix includes a copy of the boring logs.

MAP OF BORING LOCATIONS
