SWC 2006 Construction Season a Busy One

By Jason Boyle

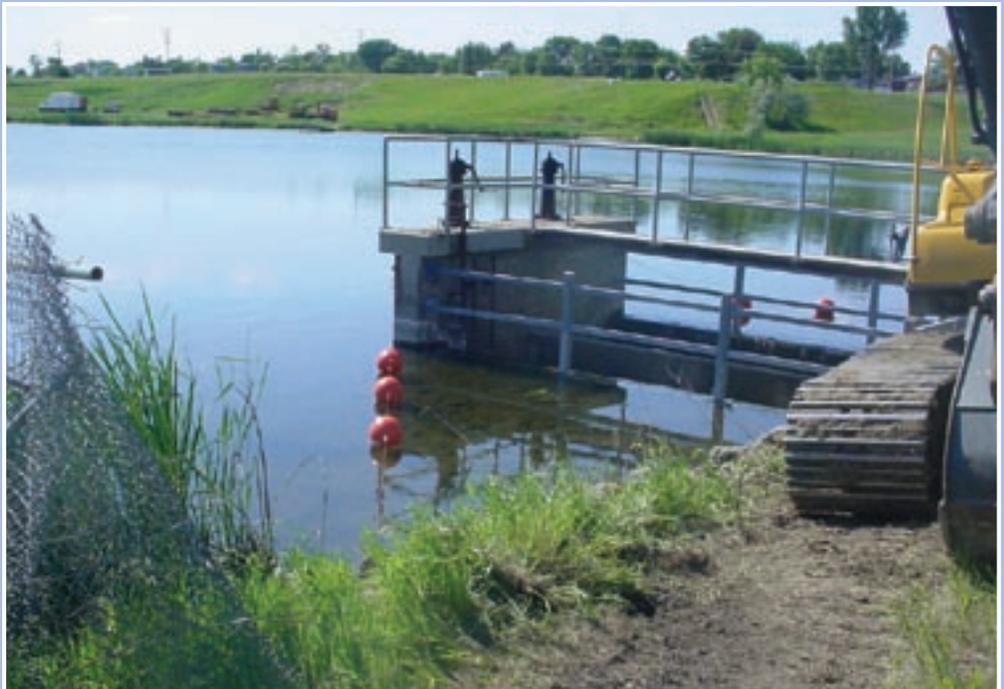
With a big 100th anniversary celebration planned for the City of Harvey last summer, the Wells County Water Resource District expressed concern for those who would be recreating near the drop inlet to the spillway at Harvey Dam. The dam is located at the south edge of Harvey on the Sheyenne River. At that time, no safety precautions were in place to prevent a wayward swimmer from accidentally falling 20 feet down into the drop inlet. A steel tube railing was installed around the inlet and a string of buoys was put up to warn of the impending danger. The construction crew also removed several trees from the downstream side of the embankment. And, because of the steep slope of the embankment, the maintenance work required special equipment.

The new steel railing and string buoys around the Harvey Dam drop inlet.

All of the work was scheduled and completed by mid-June, just in time for the centennial celebration. The cost of the work was approxi-

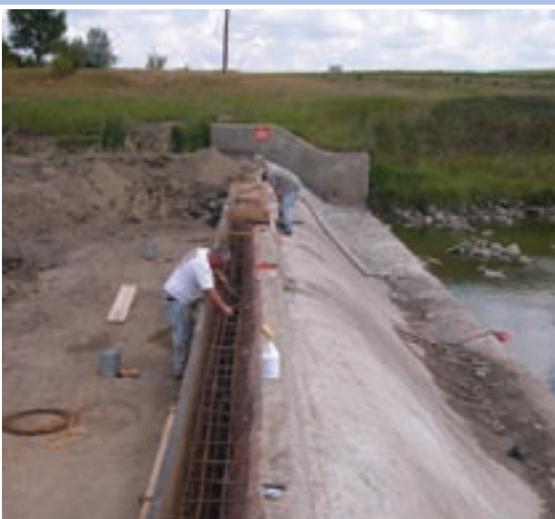
Long Creek Dam, also known as Crosby Dam, is located 5 miles north of Crosby on Long Creek near the Crosby golf course. The dam is a low head channel dam originally built in the 1930s. The dam was repaired in 1957 and again in 1980. In 2003, the Water Commission became aware of problems at Long Creek Dam, including seepage and deteriorating concrete. After several years of planning, discussing several design alternatives and gathering funding sources, the project was started in early July.

Above:
The construction crew makes preparations for the pouring of the concrete cap at Long Creek Dam.

A cofferdam was constructed upstream of the dam to divert the river to one side of the dam while work was performed on the other side. To address the seepage through the dam, the upstream face of the dam was exposed, cleaned, and the cracks were filled with an epoxy material. A geosynthetic clay liner was then placed against the upstream side of the dam. The liner consists of an expandable bentonite material sandwiched between two pieces of geosynthetic material. If the tough geosynthetic material happens to tear or get punctured, the bentonite material will expand upon contact with water, thus providing a watertight seal. A concrete cap was poured on the upstream side of the dam to tie the geosynthetic clay liner into the dam.

A thin layer of broken concrete on the downstream face of the dam was removed to expose the original dam. The face of the dam was cleaned and many cracks were sealed. A thin layer of concrete was then sprayed on the downstream face of the dam in a process known as guniting or shotcreting. This involves a dry sand-cement mixture that is sent through a hose under pressure where it meets with a spray of water at the nozzle. The construction crew sprayed a three-inch layer of this mixture on the downstream face of the dam in a

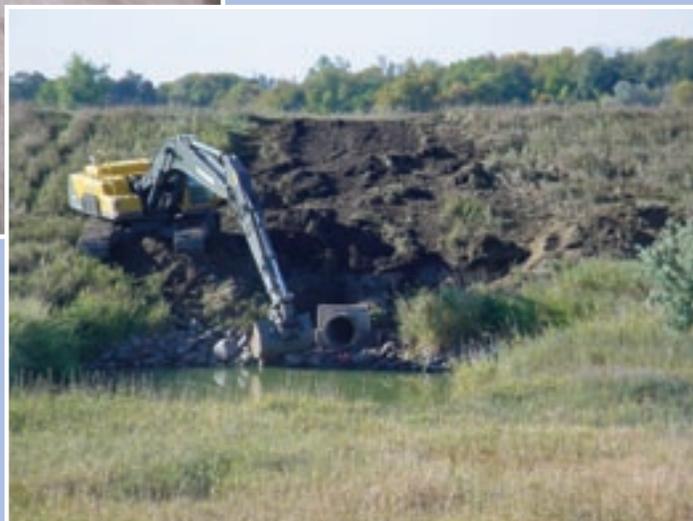
Elm River Dam #1 is an earthen flood control dam located in Steele County. It also provides flood control benefits to Traill County. The last construction joint on the downstream end of the concrete spillway pipe had somehow separated, allowing water to flow out of the pipe, which then eroded a large hole on the downstream side of the dam. Since it was unlikely that the construction crew could push the pipe back together, it was decided to install an expansion band in the inside of the pipe to seal up the joint. The expansion band proved to be a successful fix and the project was completed in September at a cost of \$7,000. Costs were shared between the Red River Joint Board, the Steele and Traill County Water Resource Districts, and the Water Commission.

At Right:
Placing rock at the downstream end of the spillway pipe at Elm River Dam #1.

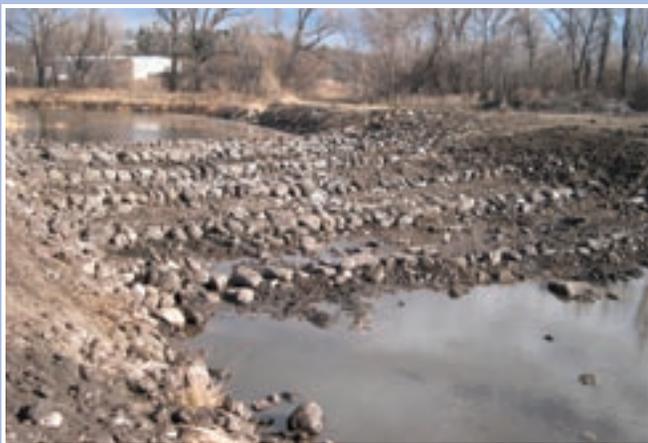
The new Enderlin Park Dam in Ransom County will allow for fish passage.

Enderlin Park Dam was a rubble masonry channel dam on the Maple River that washed out in the spring of 2004. Several years of planning resulted in a design for a new dam that would incorporate the passage of fish. This is one of only a few dams in North Dakota off of the main channel of the Red River that allows for fish passage. Previously completed projects on the Red River provided prototypes for the design of this dam.

A row of steel sheet piles were driven into the streambed across the Maple River. Several loads of rock and waste concrete were then hauled into the site. Much of the rock was hauled in by the City of Enderlin from rock piles in nearby fields, providing a cost savings for the project.
