2016

WATER COMMISSION CONSTRUCTION PROJECTS

MAJOR 2016 CONSTRUCTION PROJECTS

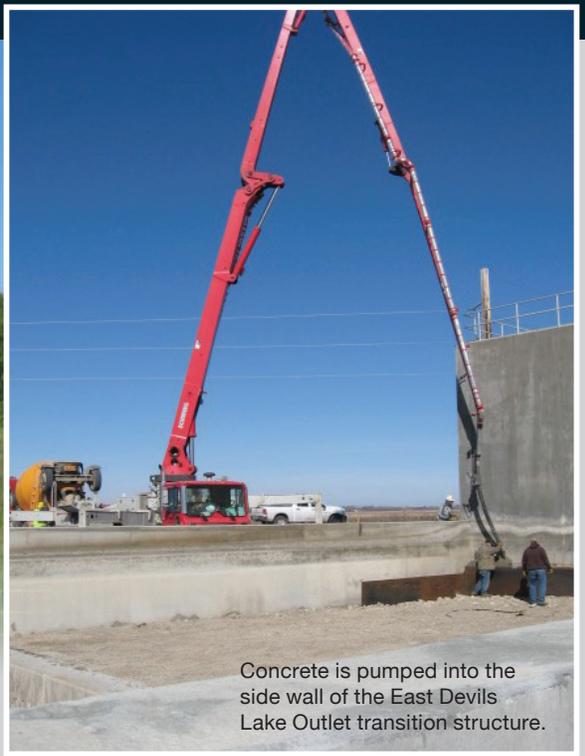
Concrete is pumped into the side wall of the East Devils Lake Outlet transition structure.

Following the 2014 operation season, damage was noticed on the upstream wall of the rock filter. In some areas, the wear was nearly six inches deep, exposing the reinforcing bars.

The repair involved bolting steel plates to the wall, and filling the space between the plates and the wall with concrete. The steel plates serve two functions; armoring against further abrasion, and as forms for the concrete repair. Steel reinforcing dowels were epoxied into the existing concrete to further anchor the repair to the existing wall.

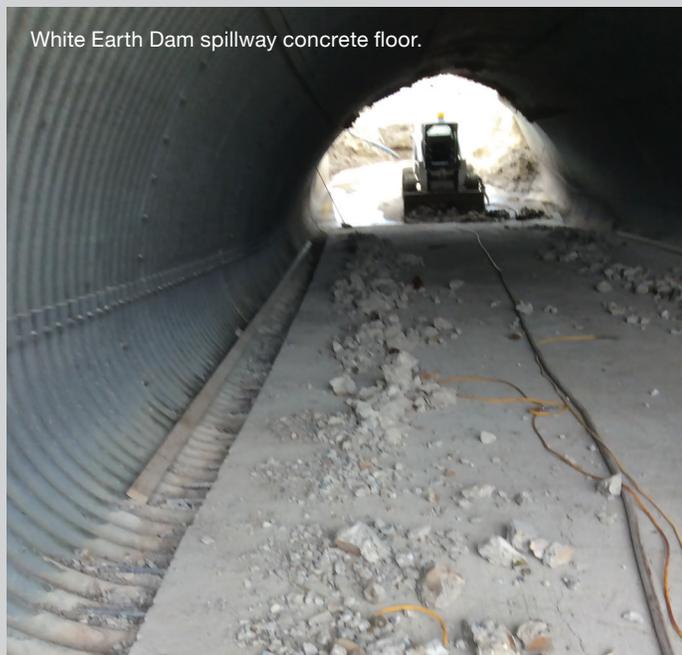
Over time, the concrete floor and CMP became separated due to settlement of the CMP arch. Because of the curved shape of the CMP, the concrete is thinner where it meets the pipe. This made the concrete edge susceptible to breaking off. The resulting space would fill with water when the spillway was active, which would then freeze during the winter, further damaging the slab edge, and creating a void within the slab.

White Earth Dam spillway concrete floor.

The edges of the concrete slab were cut back approximately one foot. Steel reinforcing dowels were epoxied into the remaining concrete and new concrete was placed. The new concrete was formed in such a way as to avoid the thin edge where it meets the CMP. A cement-like grout was then pumped into the slab to fill the remaining void, and a bituminous sealant was applied at the concrete/CMP transition to further waterproof the joint.

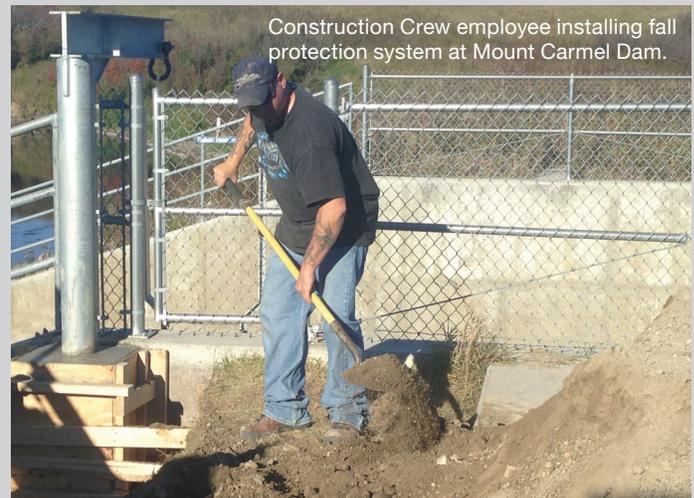
The previous fall protection system required a person to climb up or down several rungs of a ladder before hooking into the system. This system was improved to provide much safer conditions.

Construction Crew employee installing fall protection system at Mount Carmel Dam.
