The Oxbow

FROM THE NORTH DAKOTA
STATE WATER COMMISSION

WATER COMMISSION CONSTRUCTION SEASON OVERVIEW

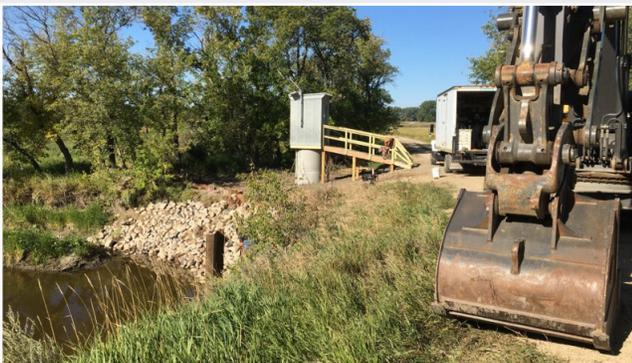
Construction of a new gage-house at Willow Creek in Bottineau County.

At the request of the U.S. Geological Survey (USGS), a new gage-house was constructed at Willow Creek. The Willow Creek gage, located in Bottineau County, was gradually deteriorating and needed updating. The SWC construction crew constructed a new gage-house on the opposite bank of the creek, utilizing materials provided by the USGS. The SWC assisted on various other maintenance and improvements of the USGS's stream gaging sites across the state during the 2020 construction season.

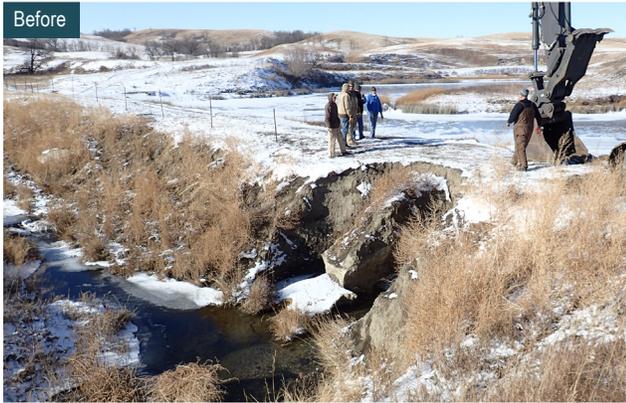
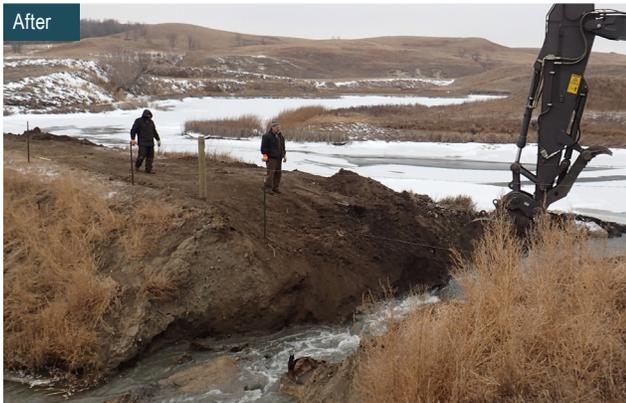
Mattson Family Trust Dam was reconfigured to no longer hold water in order to help ensure public safety.

The Mattson Family Trust Dam is a privately owned, high-hazard earth embankment dam located just upstream from an occupied farmstead in Williams County. Upon inspection, the dam was found to be in extremely poor condition and presented a high risk to residents located downstream. Due to safety concerns, the Office of the State Engineer (OSE) ordered the dam to be breached.

The dam is approximately 10 feet high and 300 feet long. The downstream portion of the spillway pipe was heavily corroded and leaked water that led to internal erosion of the embankment. Seepage was also observed along the downstream toe of the dam. If allowed to progress, these conditions could have led to failure of the dam and flooding to the farmstead.

The SWC construction crew proceeded to excavate a portion of the embankment at the principal spillway. Ultimately, the breach was taken down to the elevation of the bottom of the reservoir and widened, leaving the dam in a configuration where it could no longer hold water.

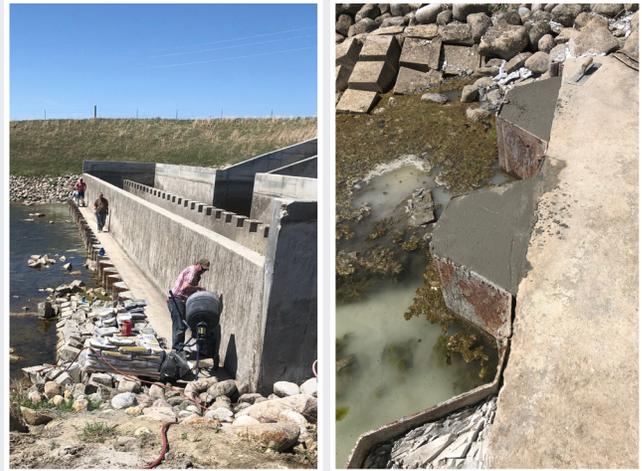
Construction at the Outfall Structure on the Devils Lake East End Outlet features a high-strength, abrasion resistant concrete repair mortar.

The concrete apron at the plunge pool, just prior to outlet water entering Tolna Coulee eroded due to the impact of water coming over the wall of the outfall structure. The SWC construction crew, along with the Devils Lake Outlet staff, removed the deteriorated concrete and replaced it with a high-strength, abrasion resistant concrete repair mortar.
