**PRELIMINARY ENGINEERING REPORT
WELK DAM IMPROVEMENT**

SWC # 400

PRELIMINARY ENGINEERING REPORT

**WELK DAM IMPROVEMENTS
SWC PROJECT #400**

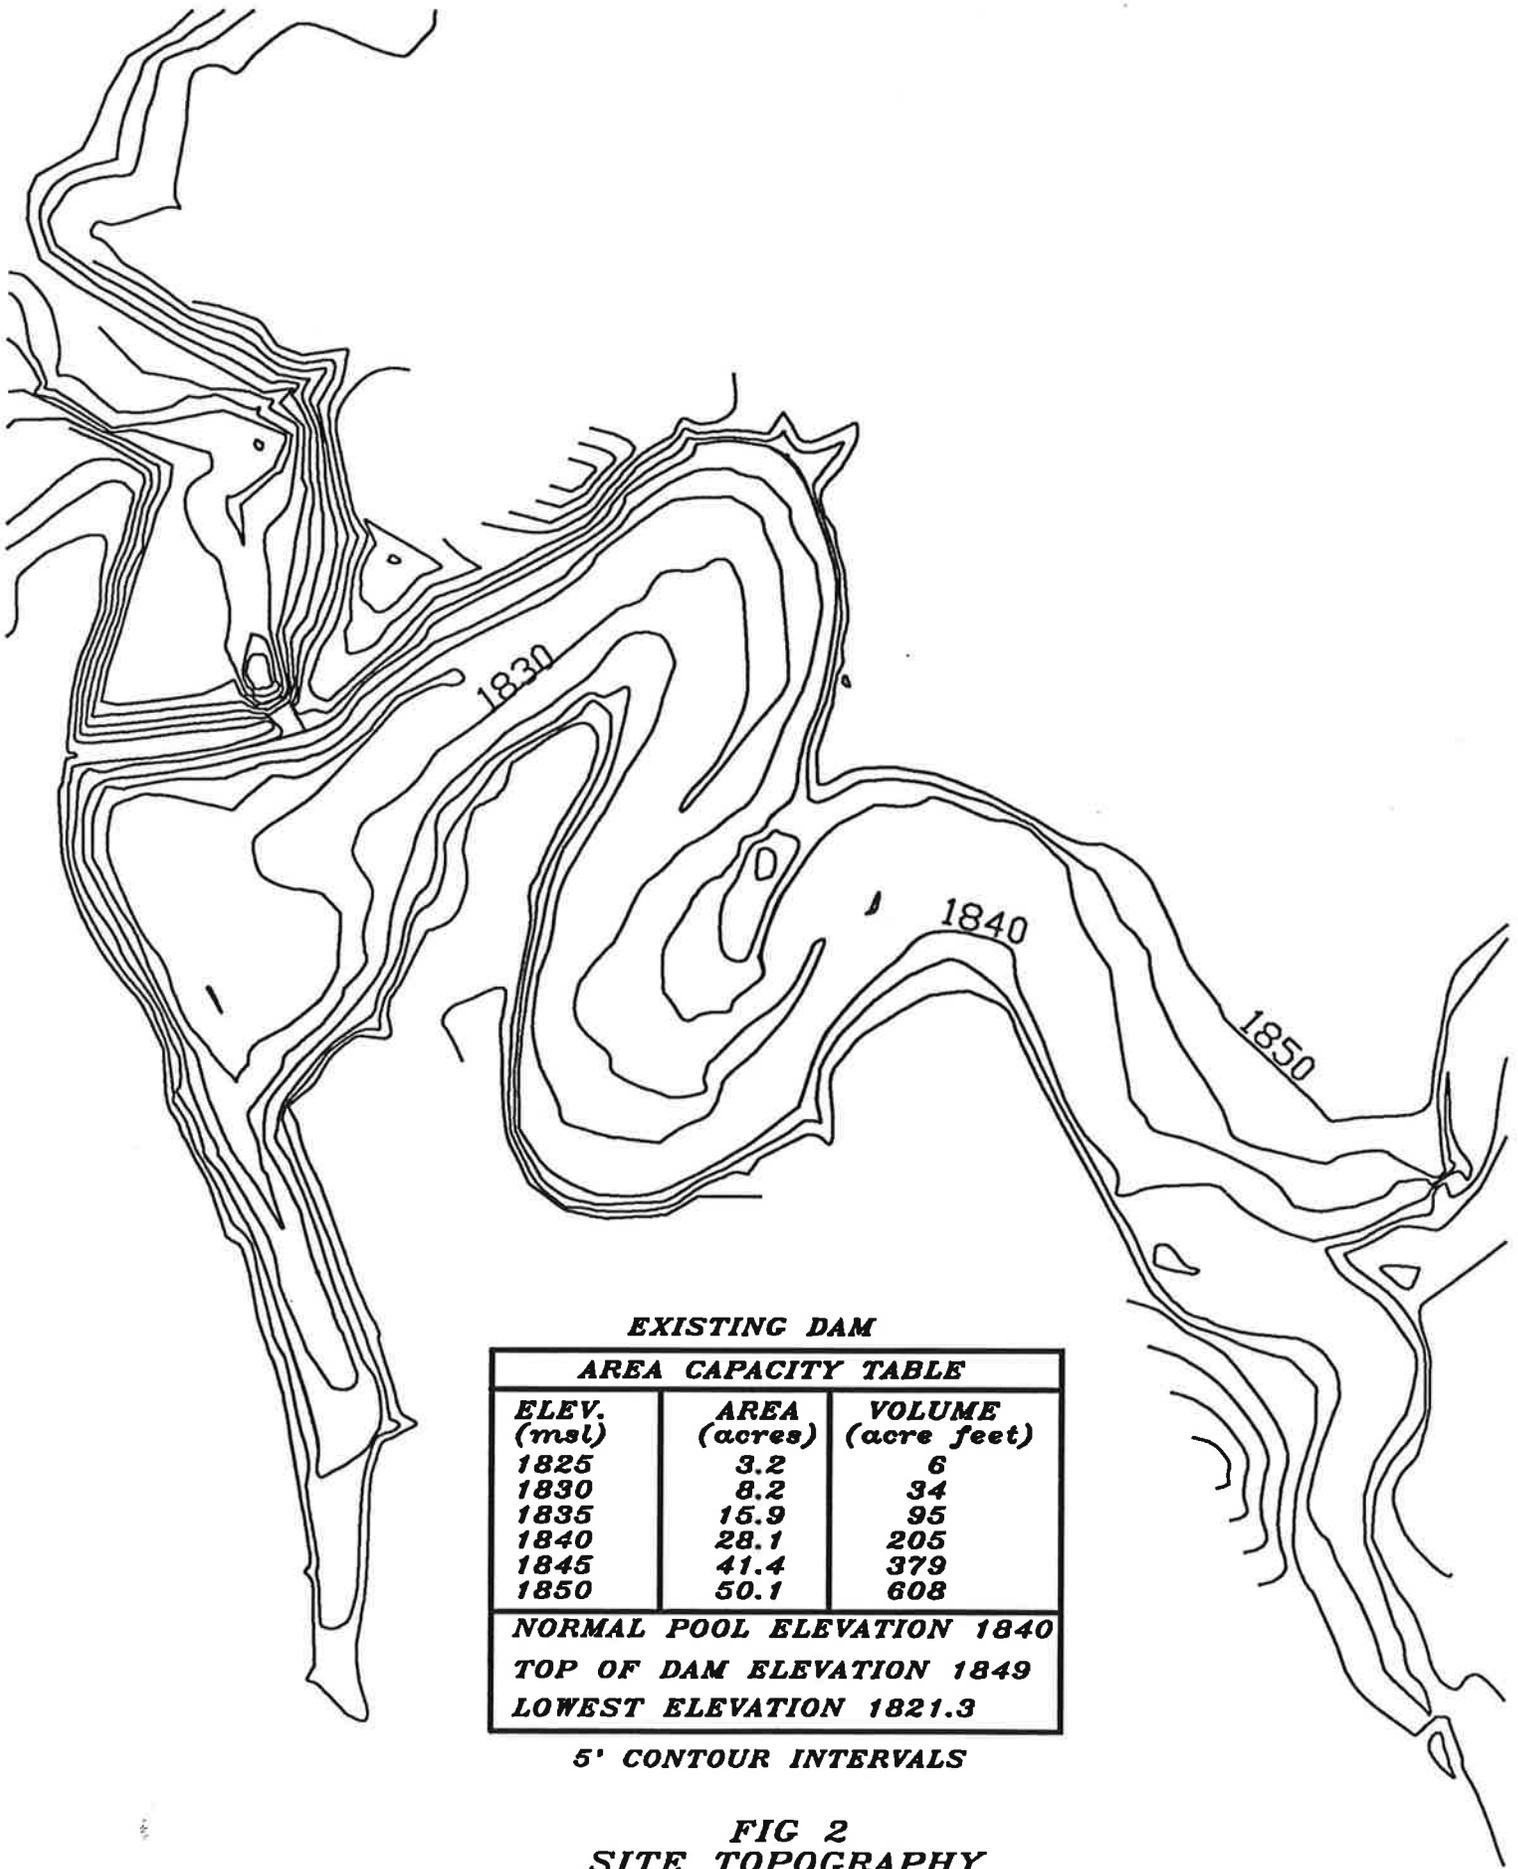
**FIG 2
SITE TOPOGRAPHY**

The principal spillway consists of an approach channel, Ogee concrete spillway, and a plunge pool. The approach channel consists of a flat curved earth channel approximately 50 feet long at the same elevation as the principal spillway (1838 msl). The principal spillway is 42 feet wide with a face slope of 1H:1V. The stilling basin consists of the original 10-foot long, flat rubble masonry apron and a secondary drop 10 feet long and 3 feet deep. The crest elevation of the principal spillway is 1840 msl. The reservoir's water surface is at 1840 msl, covers 28.1 acres, and the capacity is 205 acre-feet. The average depth is 7.3 feet and maximum depth is 18.7 feet (See Figure 2 - Site Topography Map).

NORMAL POOL ELEVATION 1840
TOP OF DAM ELEVATION 1849
LOWEST ELEVATION 1821.3

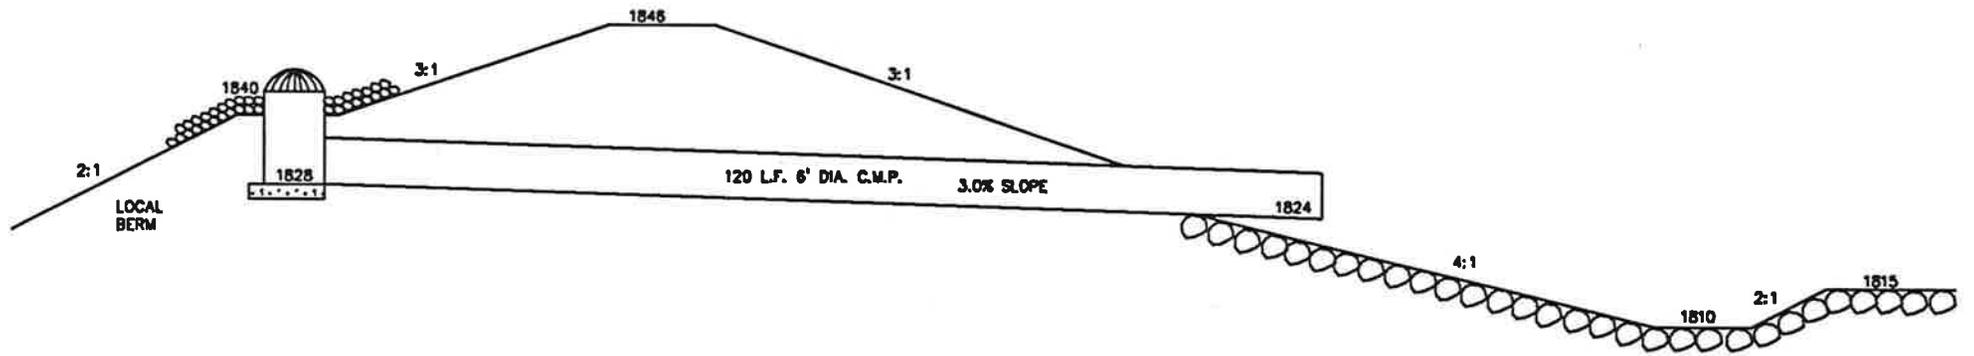
Figure 3

PROFILE — 6' CMP

Two corrugated metal pipes 120 feet in length and 6 feet in diameter will be considered as a replacement for the deteriorated spillway. The inlet would have a 12-foot drop and a 96-inch

intake opening with trash guard. The inlet will have a crest elevation of 1840 msl with the invert of the CMP's at elevation 1828 msl. The CMP's will be laid at a slope of 3.33 percent with the outlet at elevation 1824 msl. The outlet structure consists of a standard cantilevered outlet with stilling basin (See Figure 3). The embankment would have a 14-foot wide top at 1849 msl, with 3:1 side slopes that will tie into the existing embankment (See Figure 4).

The deteriorated spillway would be removed and disposed on-site or hauled away. The old spillway location would be plugged with earth-filled material. A soil investigation may be required to find proper fill material for the embankment. Additional riprap will be needed on the face of the embankment for erosion protection.

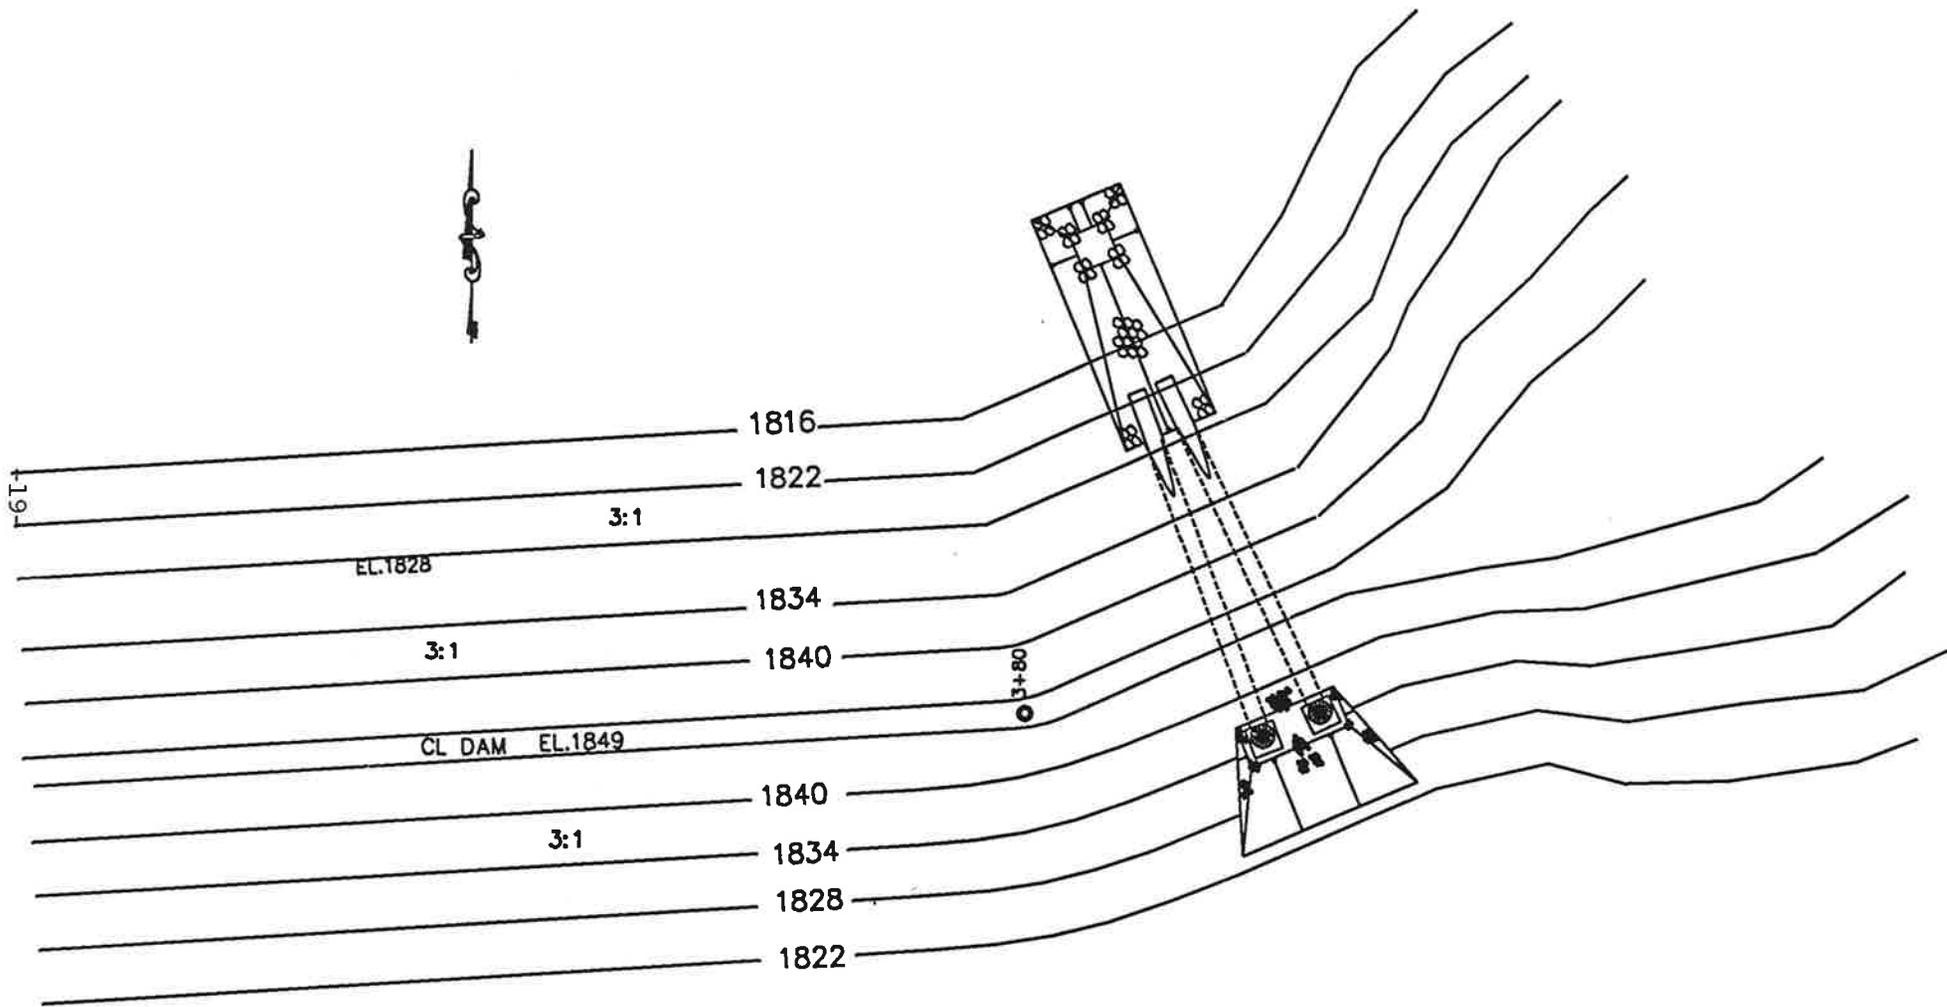
Figure 4

PLAN VIEW — TWO 6' CMP

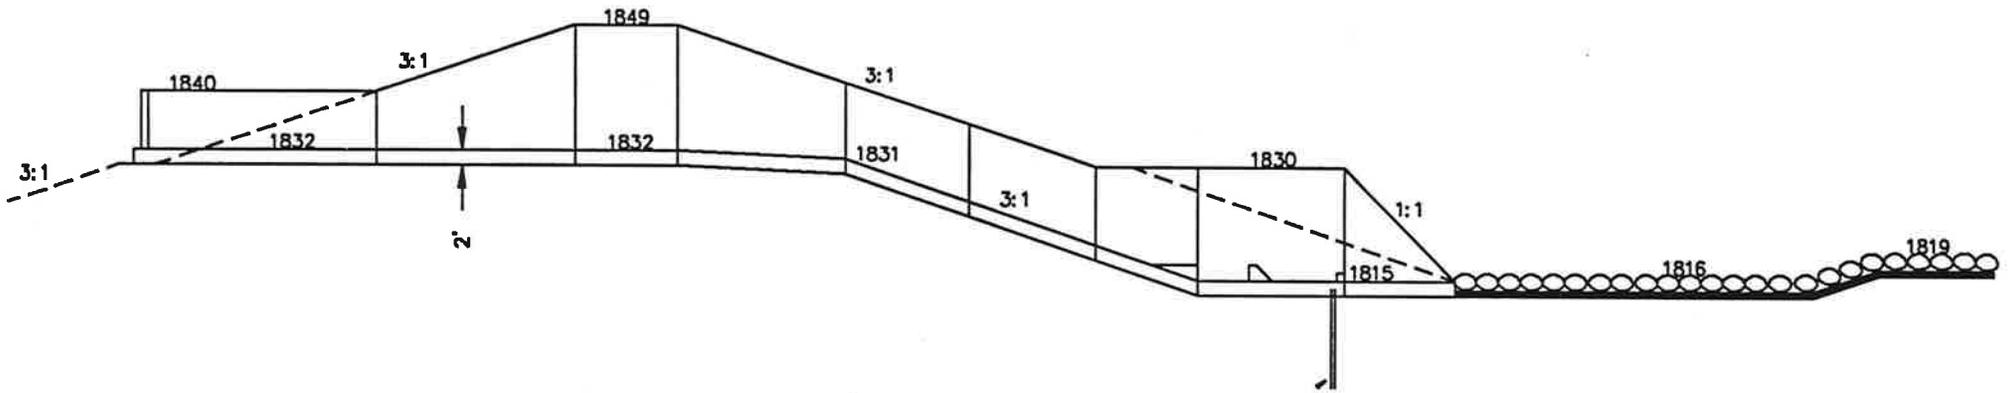
Figure 5

PROFILE — CONCRETE CHUTE
NO SCALE

A concrete chute would be another option for replacement of the deteriorated spillway. The chute would be located in the same area as the original spillway. The concrete chute would be 30 feet wide, 150 feet in length, and have a crest elevation of 1840 msl (See Figure 5). The concrete chute would have a height of 8 feet. The wingwalls on the concrete chute would be at a 3H:1V slope tying into the top of the embankment at 1849 msl (See Figure 6). This alternative also includes a low-level drawdown.

The critical event for design criteria was the 6-hour 50-year rainfall event. The peak outflow over the chute was 1887 cfs. Inflow from the 50-year event will cause the reservoir to rise to an elevation of 1843.2 msl. The top of the embankment (1849 msl) would not be overtopped by the 50-year event. The preliminary estimated cost for a concrete chute is \$315,000.

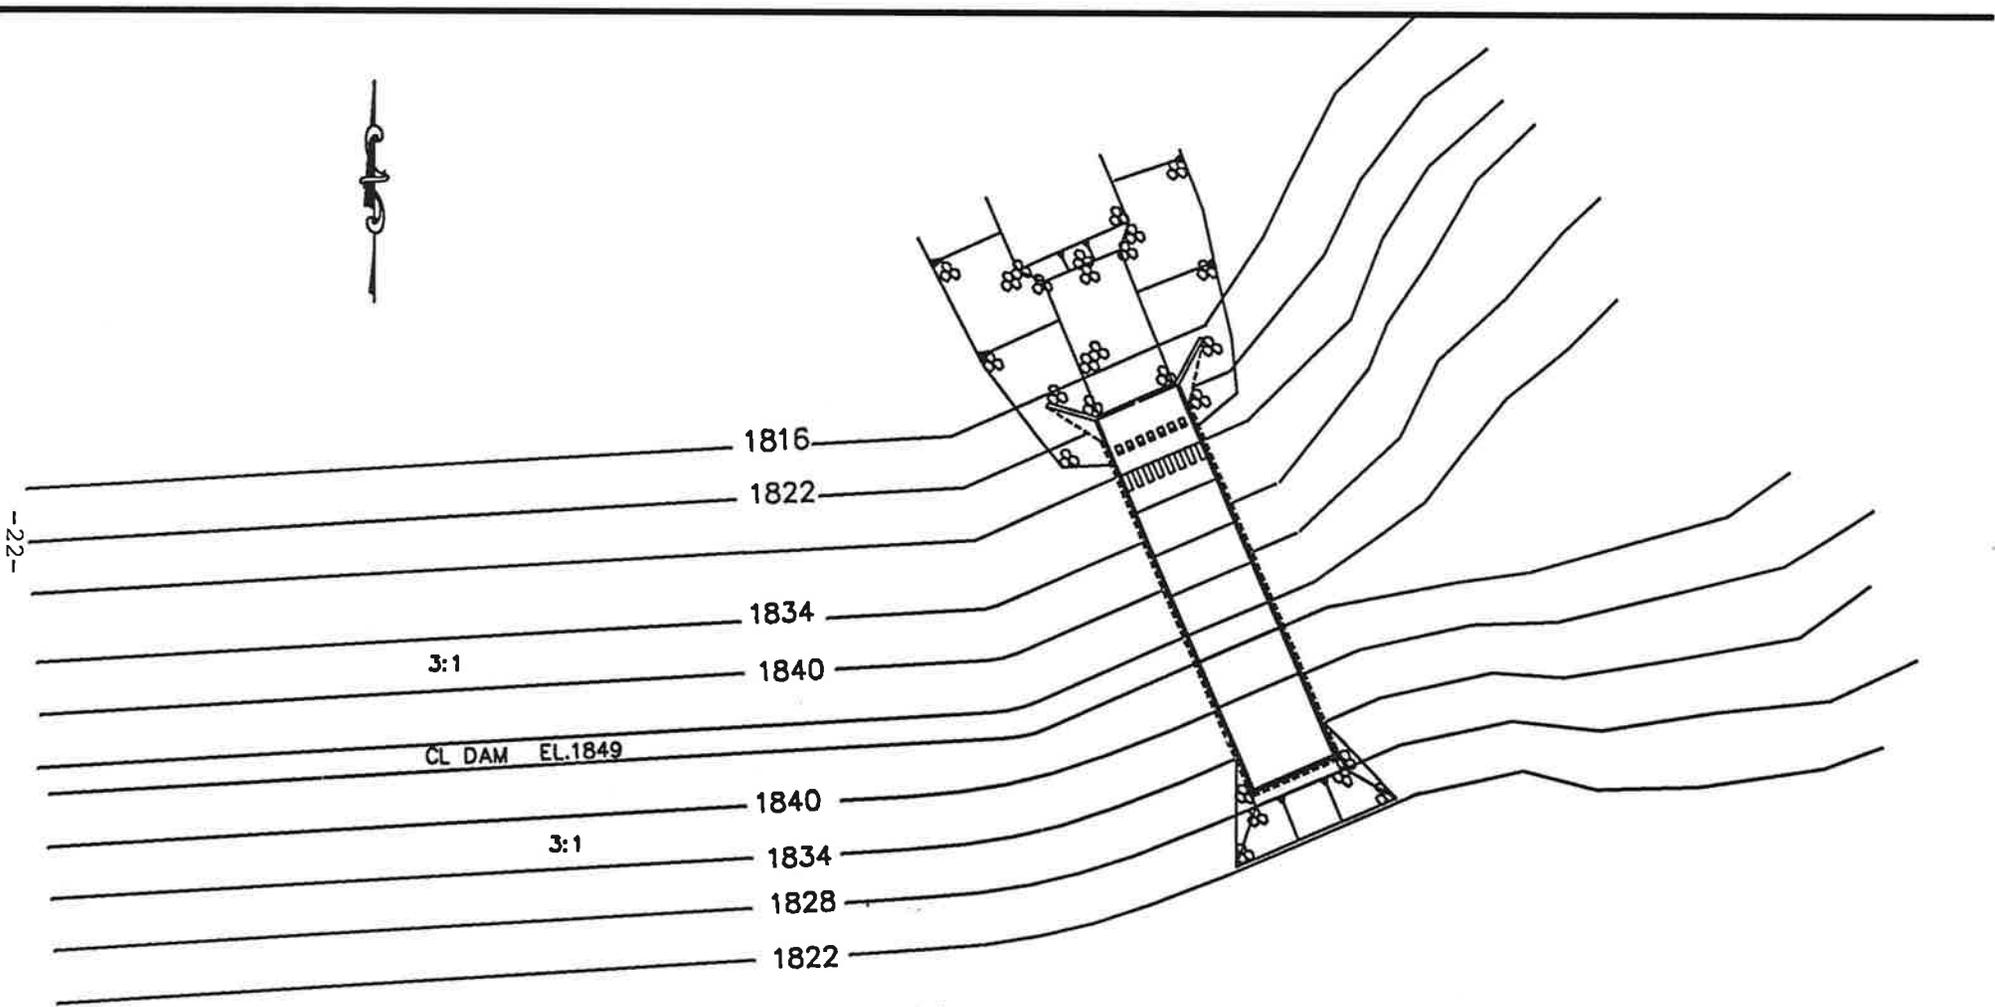
NO SCALE
Figure 6

PLAN VIEW — CONCRETE CHUTE
