SHEEP CREEK DAM

HYDRAULICS STUDY

Project #1358

May 1975

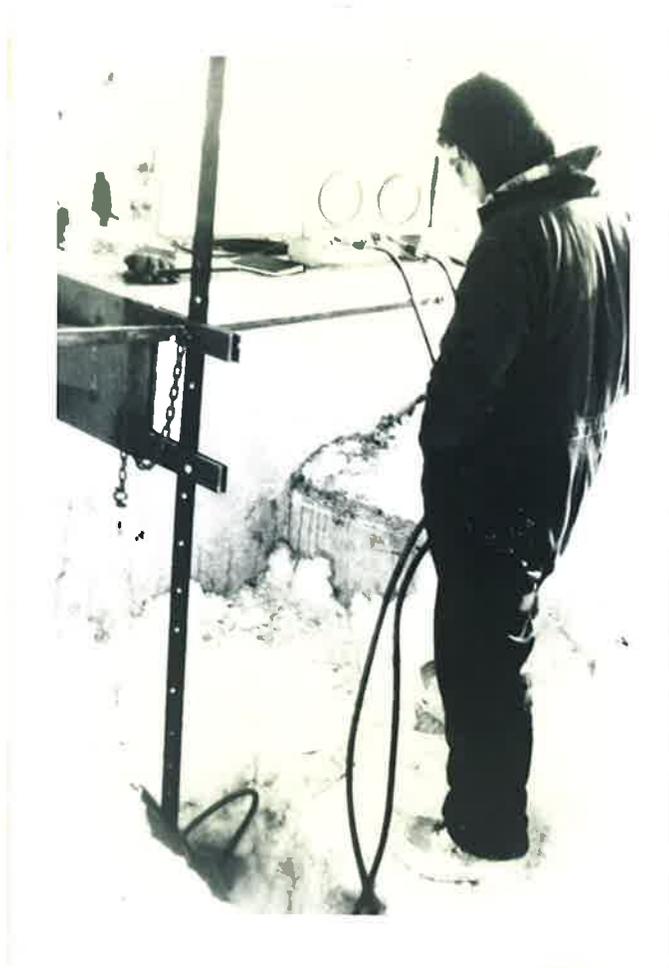
Photo 1. Pitot Tube Operating Through Ice

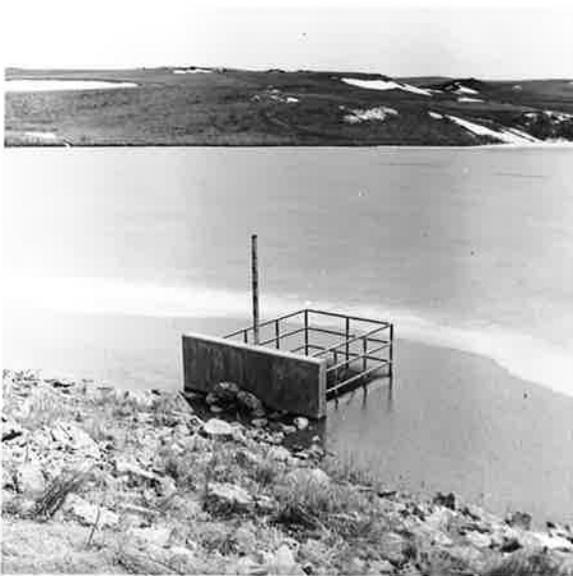
Photo 4. Sheep Creek Inlet

For the next three days there was no change in the level of the reservoir from the reports of Mr. Zacher. On the afternoon of April 15, Mr. Zacher called to report that the water had suddenly begun to rise and the creek two miles upstream had started to flow. Flow at the bridge upstream was estimated to be eight feet wide and three feet deep. At 9:30 that evening the reservoir had risen to two (2) inches over the inlet. By 9:00 the next morning the water level had risen to six inches above the inlet and water was still flowing at the upstream bridge as it had the day before. Photos numbered 4 and 5 show the inlet and outlet at this level. It was at this point that the investigators went to the dam.

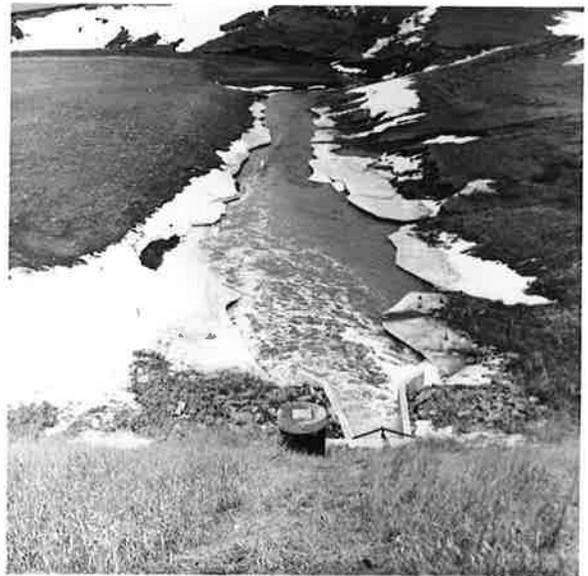
Photo 5. Sheep Creek Outlet and Channel

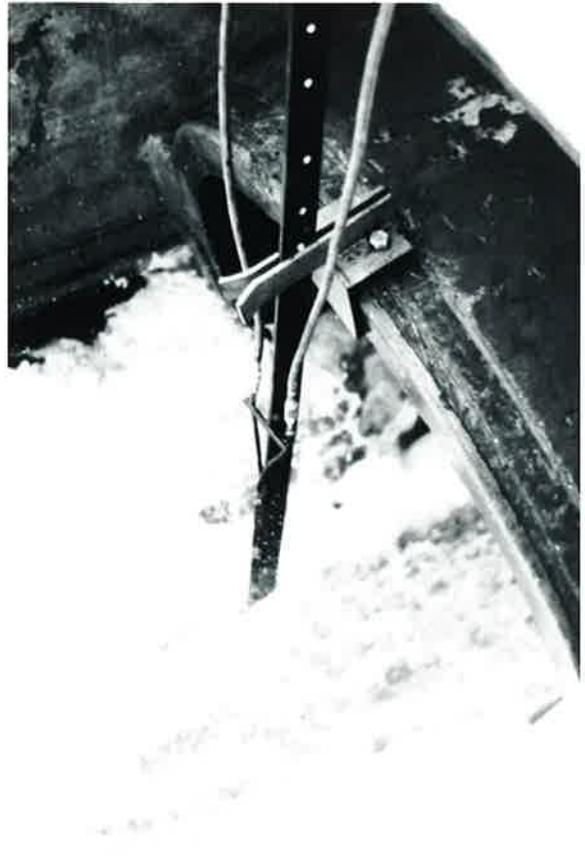
Photo 7. Pitot Tube in Place with Restraining Bracket

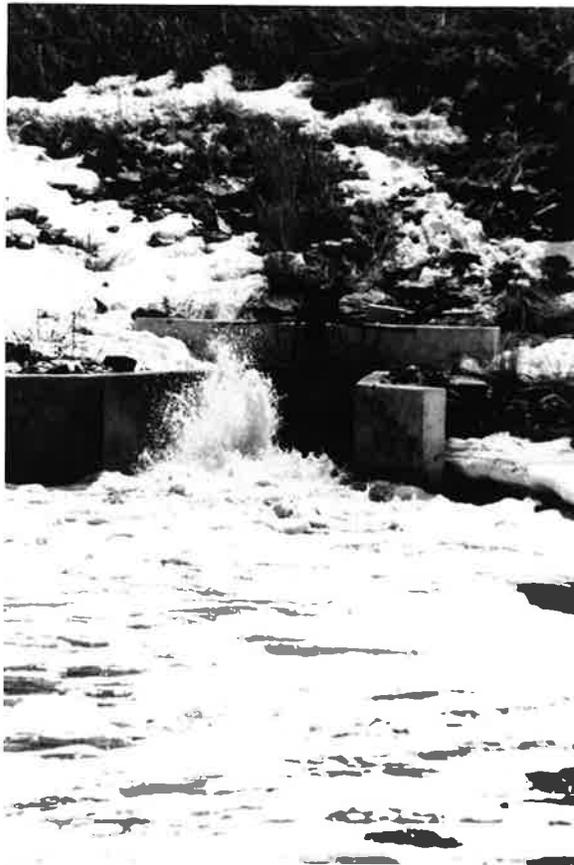
Photo 8. Hydraulic Jump in Outlet

At 1000 hours on April 17 a water surface profile was made at the side-walls of the stilling basin. Figure 3 shows this profile. Although the actual surface of the standing wave was only 4.25 feet, the spray reached heights of 7-9 feet above the water surface. Photo number 8 shows the wave and the spray.

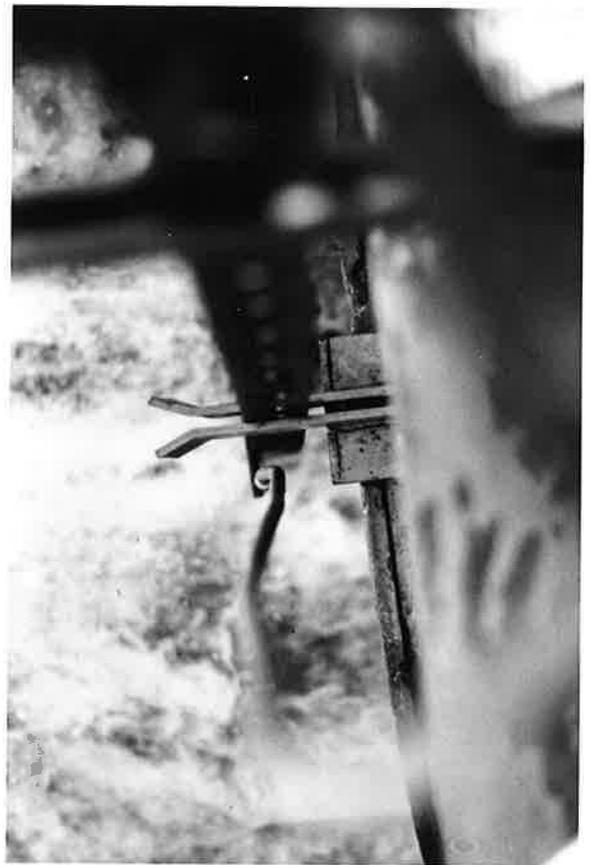
Photo 9. Deflection of Pitot Tube Arm
