Mount Carmel Dam General Information

Emergency at Mount Carmel Dam

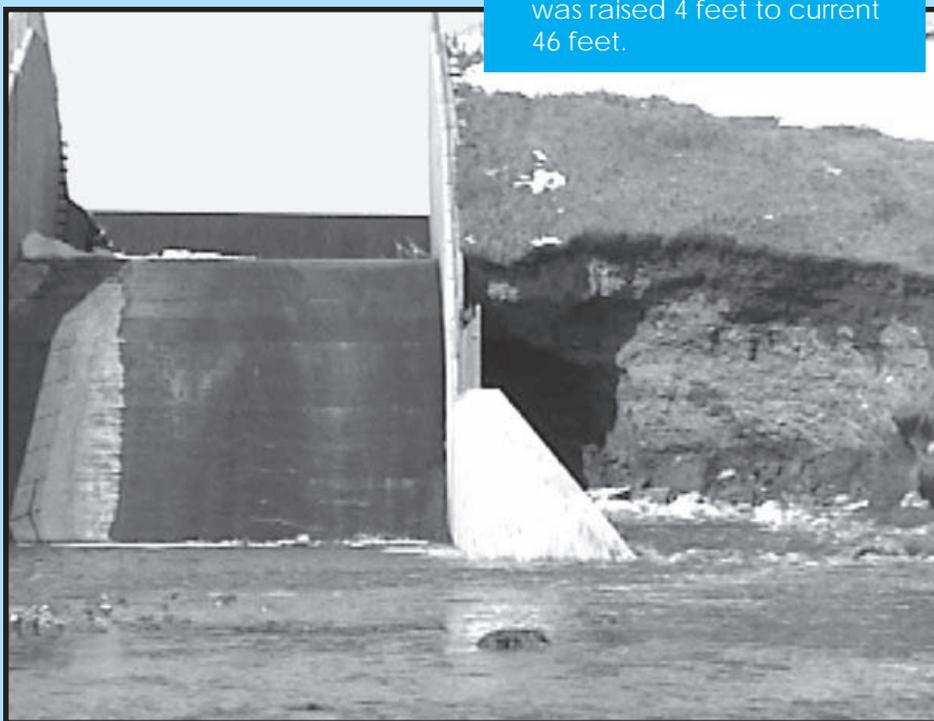
On March 29, 2003, a local high school student taking pictures at Mount Carmel Dam discovered that water was flowing under the chute spillway and was exiting uncontrolled from a large hole at the bottom of the dam. In photo 1, it is possible to see the uncontrolled flow that was occurring under the spillway. Engineers at the State Water Commission estimate that the peak discharge during that event was as high as 500 cubic feet per second, or 323 million gallons per day.

Photo 1: Uncontrolled flow occurring under the spillway of Mount Carmel Dam, March 2003.

dam revealed that the void (or washout) under the spillway was quite extensive, with approximately 45 feet of the downstream section of the spillway unsupported. The remainder of the material under the spillway also appears to be unstable, but the exact condition is yet to be determined.

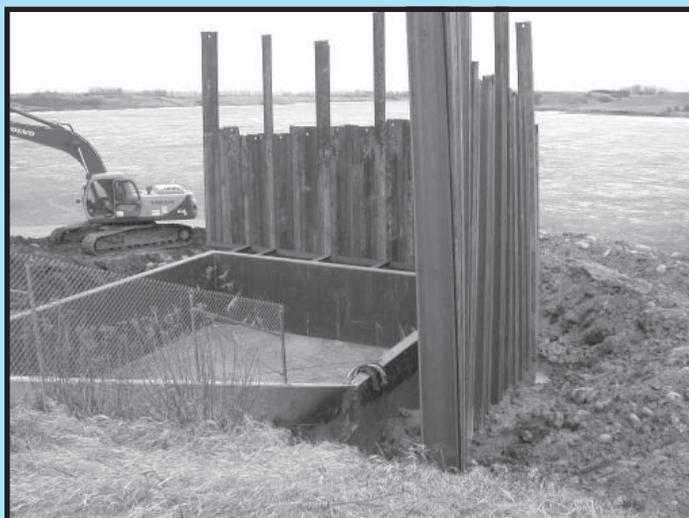
Days after the emergency cofferdam was constructed, a more permanent sheet pile cofferdam was put in place around the inlet of the spillway

(photo 3). This was done to serve as a more reliable temporary solution to stopping the flows until the dam is completely repaired. The sheet pile wall should allow the dam to pass any large flood event through the emergency spillway, without further compromising the integrity of the dam.

Photo 3 (at left): Some days after the emergency cofferdam was constructed, a more permanent sheet pile cofferdam was put in place around the inlet of the spillway.
