The Oxbow

FROM THE NORTH DAKOTA STATE WATER COMMISSION

Lakes Sakakawea and Oahe Are Back!

SWC Approves Cost-Share for Clausen Springs Dam

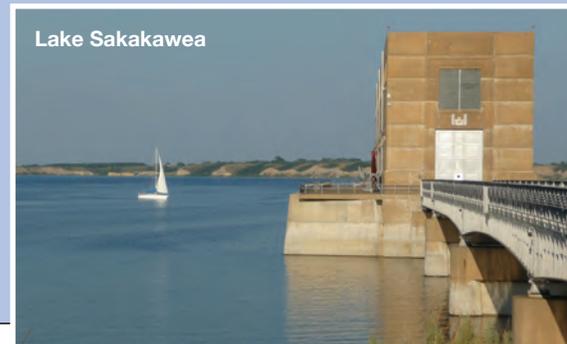
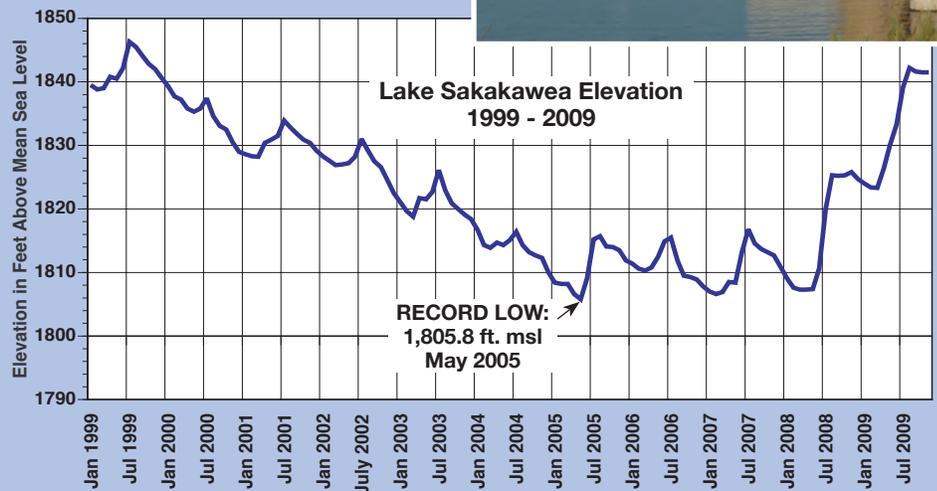
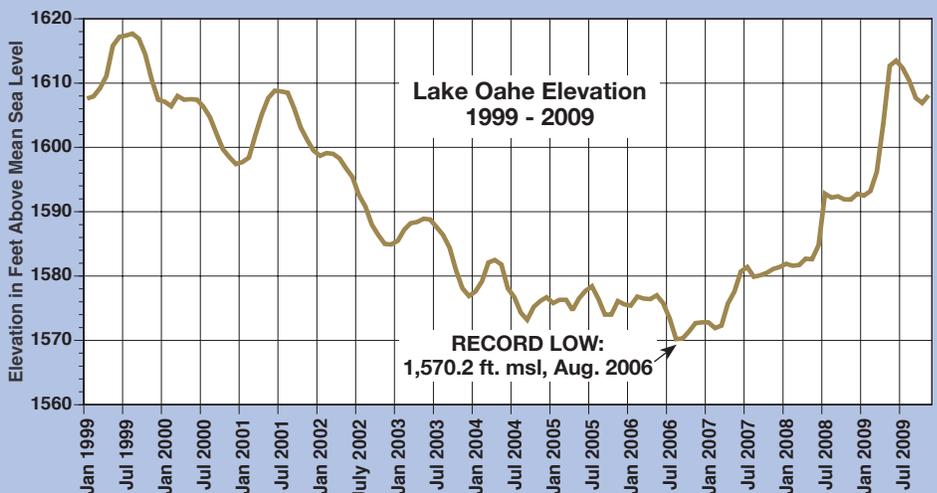
By May 2005, Lake Sakakawea had fallen to an all time low when it hit an elevation of 1,805.8 feet above mean sea level (msl). During that same time, Lake Oahe was also declining, but it didn't reach its record low elevation until August 2006, when it bottomed out at 1,570.2 feet msl.

Fast forward a couple years, and today, both Lakes Sakakawea and Oahe are nearly full - thanks to a wet early summer in 2008, and the spring runoff of 2009.

As of the first part of Dec. 2009, Lake Sakakawea was at an elevation of 1,841.5 feet msl. That's almost 36 feet higher than the record low set in 2005. In comparison, Lake Oahe was at an elevation of 1,608.2 feet msl during the first part of Dec. 2009. That's an increase of 38 feet since its record low was set in the summer of 2006.

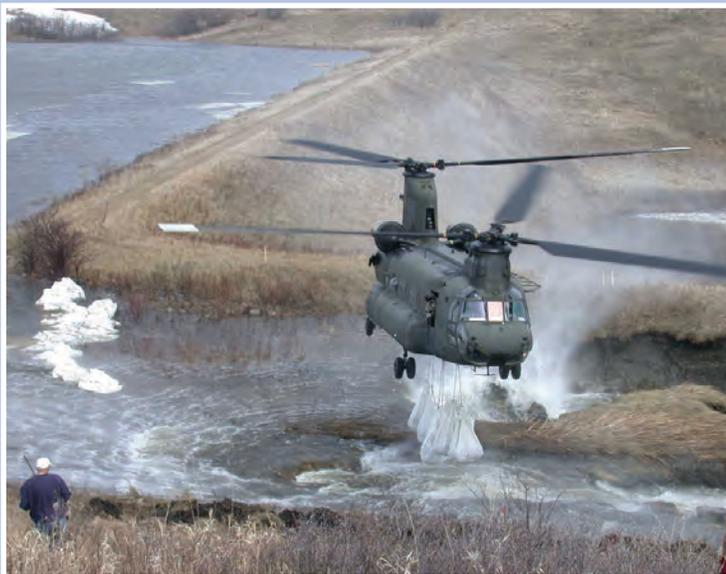
A National Guard helicopter dropped half-ton sandbags to help reinforce the earthen spillway at Clausen Springs Dam (April 2009). ▶

During the spring flooding events of 2009, Clausen Springs Dam was damaged after it filled to capacity and began spilling water out of its earthen emergency spillway. The excessive amount of floodwater flowing out of the spillway started to cause severe

erosion, and emergency measures had to be taken to save the dam from a potential breach (see photos). With the town of Kathryn just downstream, all 55 of its residents had to be evacuated as a precautionary measure.

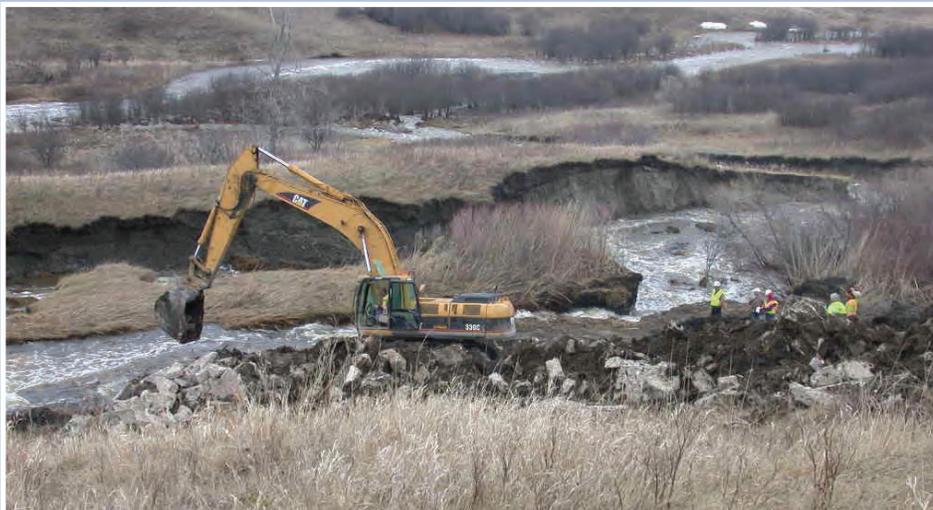
Concrete rip-rap was also placed to slow erosion of the earthen spillway (April 2009). ▼

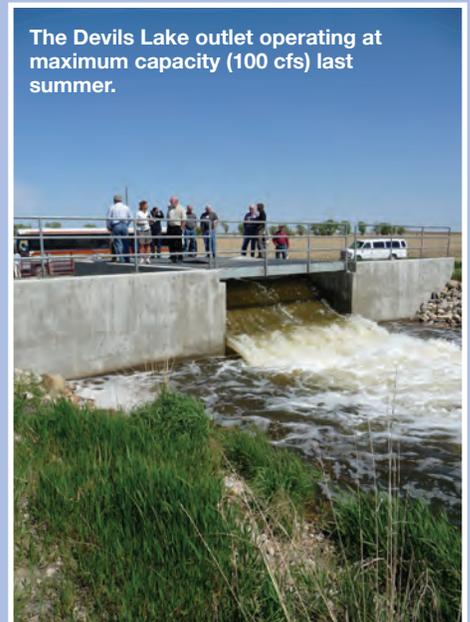
The Devils Lake outlet operating at maximum capacity (100 cfs) last summer.

During the 2009 operating season, the Devils Lake outlet ran for 166 days, from May to November. In total, 27,653 acre-feet of floodwater were removed, which accounted for about 2.04 inches off the lake.

The state is currently working to increase the pumping capacity of the outlet from a maximum of 100 cubic feet per second (cfs), to 250 cfs. To accomplish this increase, two additional 75 cfs pumps will be installed at the Round Lake and Josephine pump sites. It is expected that construction on this effort will begin in early 2010.
