FROM THE DEPARTMENT
OF WATER RESOURCES

2021 WATER COMMISSION CONSTRUCTION SEASON OVERVIEW

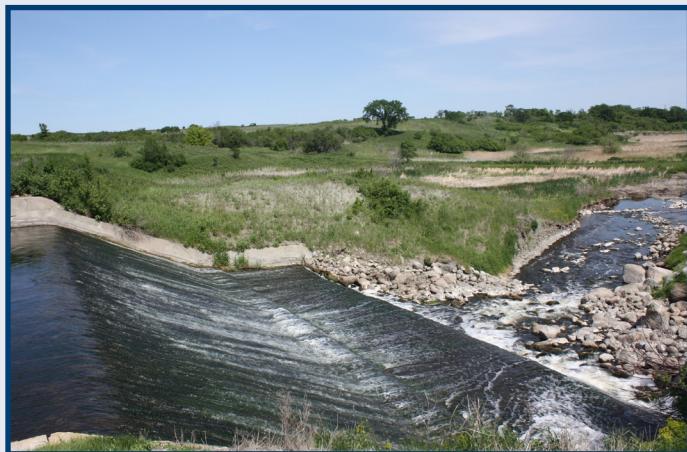
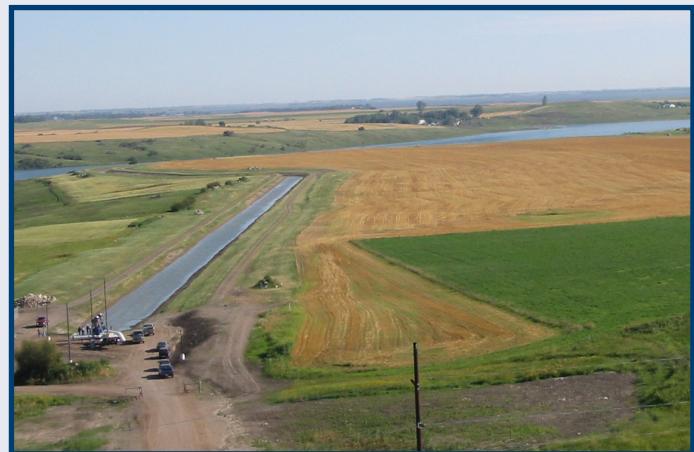
HARVEY DAM, WELLS COUNTY

Harvey Dam is located just south of the city of Harvey and serves as the embankment for ND Highway 3. It is an earth embankment dam with an arched corrugated metal pipe (CMP) principal spillway conduit. The Wells County Water Resource District, along with DWR Dam Safety staff, wanted to perform an inspection of the floor of the conduit pipe, which is normally under water. To further complicate the situation, the low-level outlet valve in the inlet structure could not be fully closed due to debris in the valve and corrosion of the operating stem.

The DWR Construction Crew started by clearing debris from the valve and removing the operating stem so the valve could be closed by hand. They cleared beaver dams from below the downstream end of the pipe to improve the drainage of the plunge pool. Finally, they were on site the day of the inspection to operate pumps to remove the remaining water so the Dam Safety staff and representatives of the water resource district could inspect the floor of the pipe.

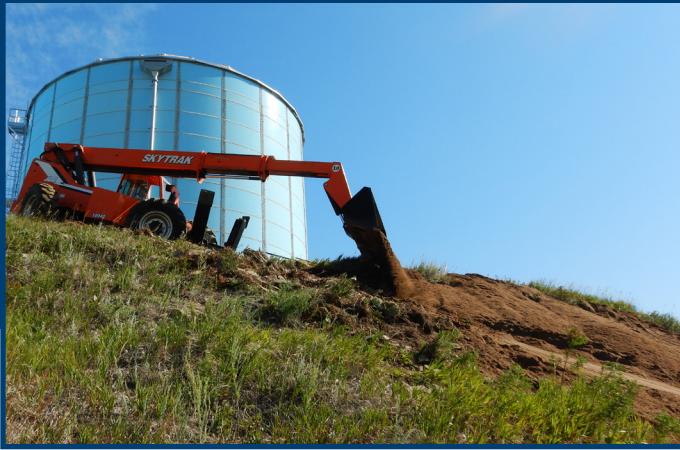
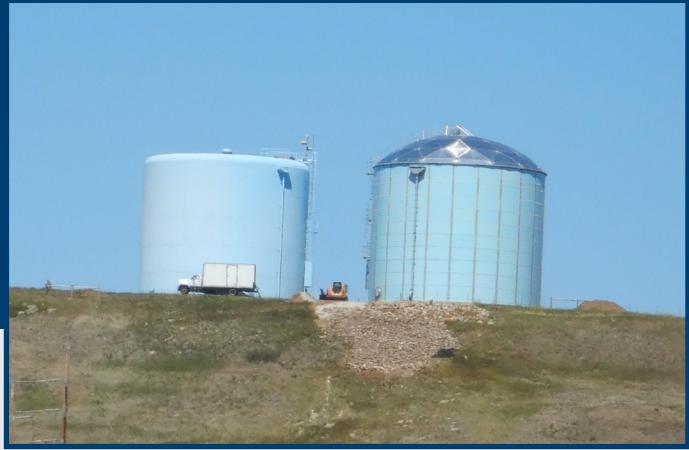
DAVIS BUTTES RESERVOIR, STARK COUNTY

A large erosion scarp formed below the reservoirs on the south side of the butte. Due to concerns that the scarp would continue to grow toward, and possibly undermine the tanks, it was decided to armor the scarp to prevent further erosion.

The project involved several steps. First the DWR Construction & Well Drilling staff pumped seven cubic yards of bentonite grout into voids and cracks in the eroded area. 46 cubic yards of sand was then placed to construct a filter over the eroded area. The sand layer was then covered with a geotextile fabric, 29 tons of drainage rock, and 80 cubic yards of rock rip-rap to armor the area from further erosion.
