STRASBURG SLOUGH INVESTIGATION

Emmons County, North Dakota

SWC Project #558
January 2020

Prepared for:
Emmons County Water Resource District

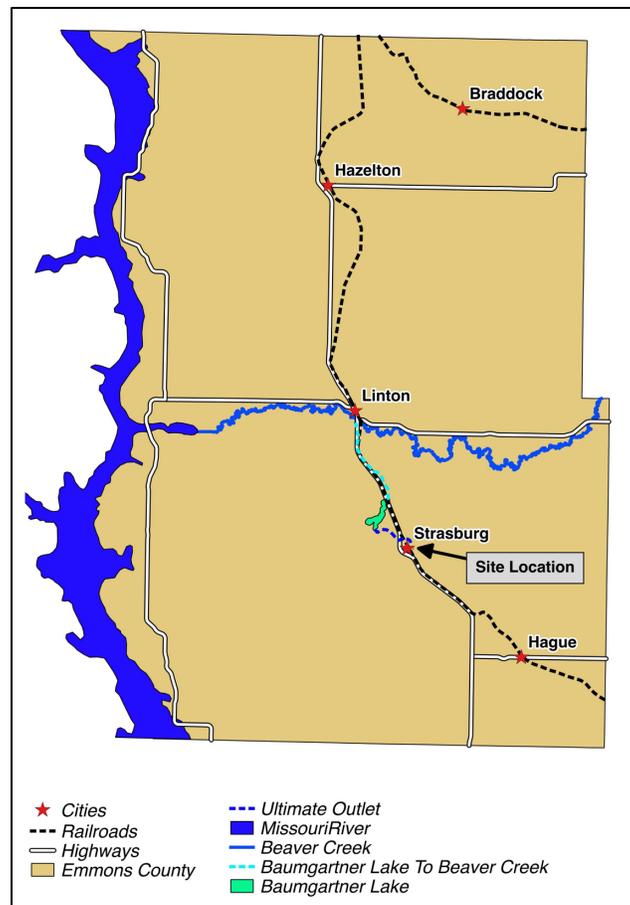
Figure 1. Strasburg Slough, site location

Strasburg Slough is located on the eastern edge of the City of Strasburg in Emmons County, ND (**Figure 1**). Strasburg Slough is a water body in a complex series of non-contributing water bodies surrounding the City of Strasburg. This series of water bodies ultimately outlets to Baumgartner Lake, which eventually flows into Beaver Creek.
