INVESTIGATION AND REPAIR
OF THE
CHANNEL "A" CONTROL STRUCTURE
STARKWEATHER WATERSHED

NORTH DAKOTA
STATE WATER COMMISSION

NOVEMBER 1984

INVESTIGATION REPORT
OF THE
CHANNEL "A" CONTROL STRUCTURE
RAMSEY COUNTY
SWC PROJECT NO. 842

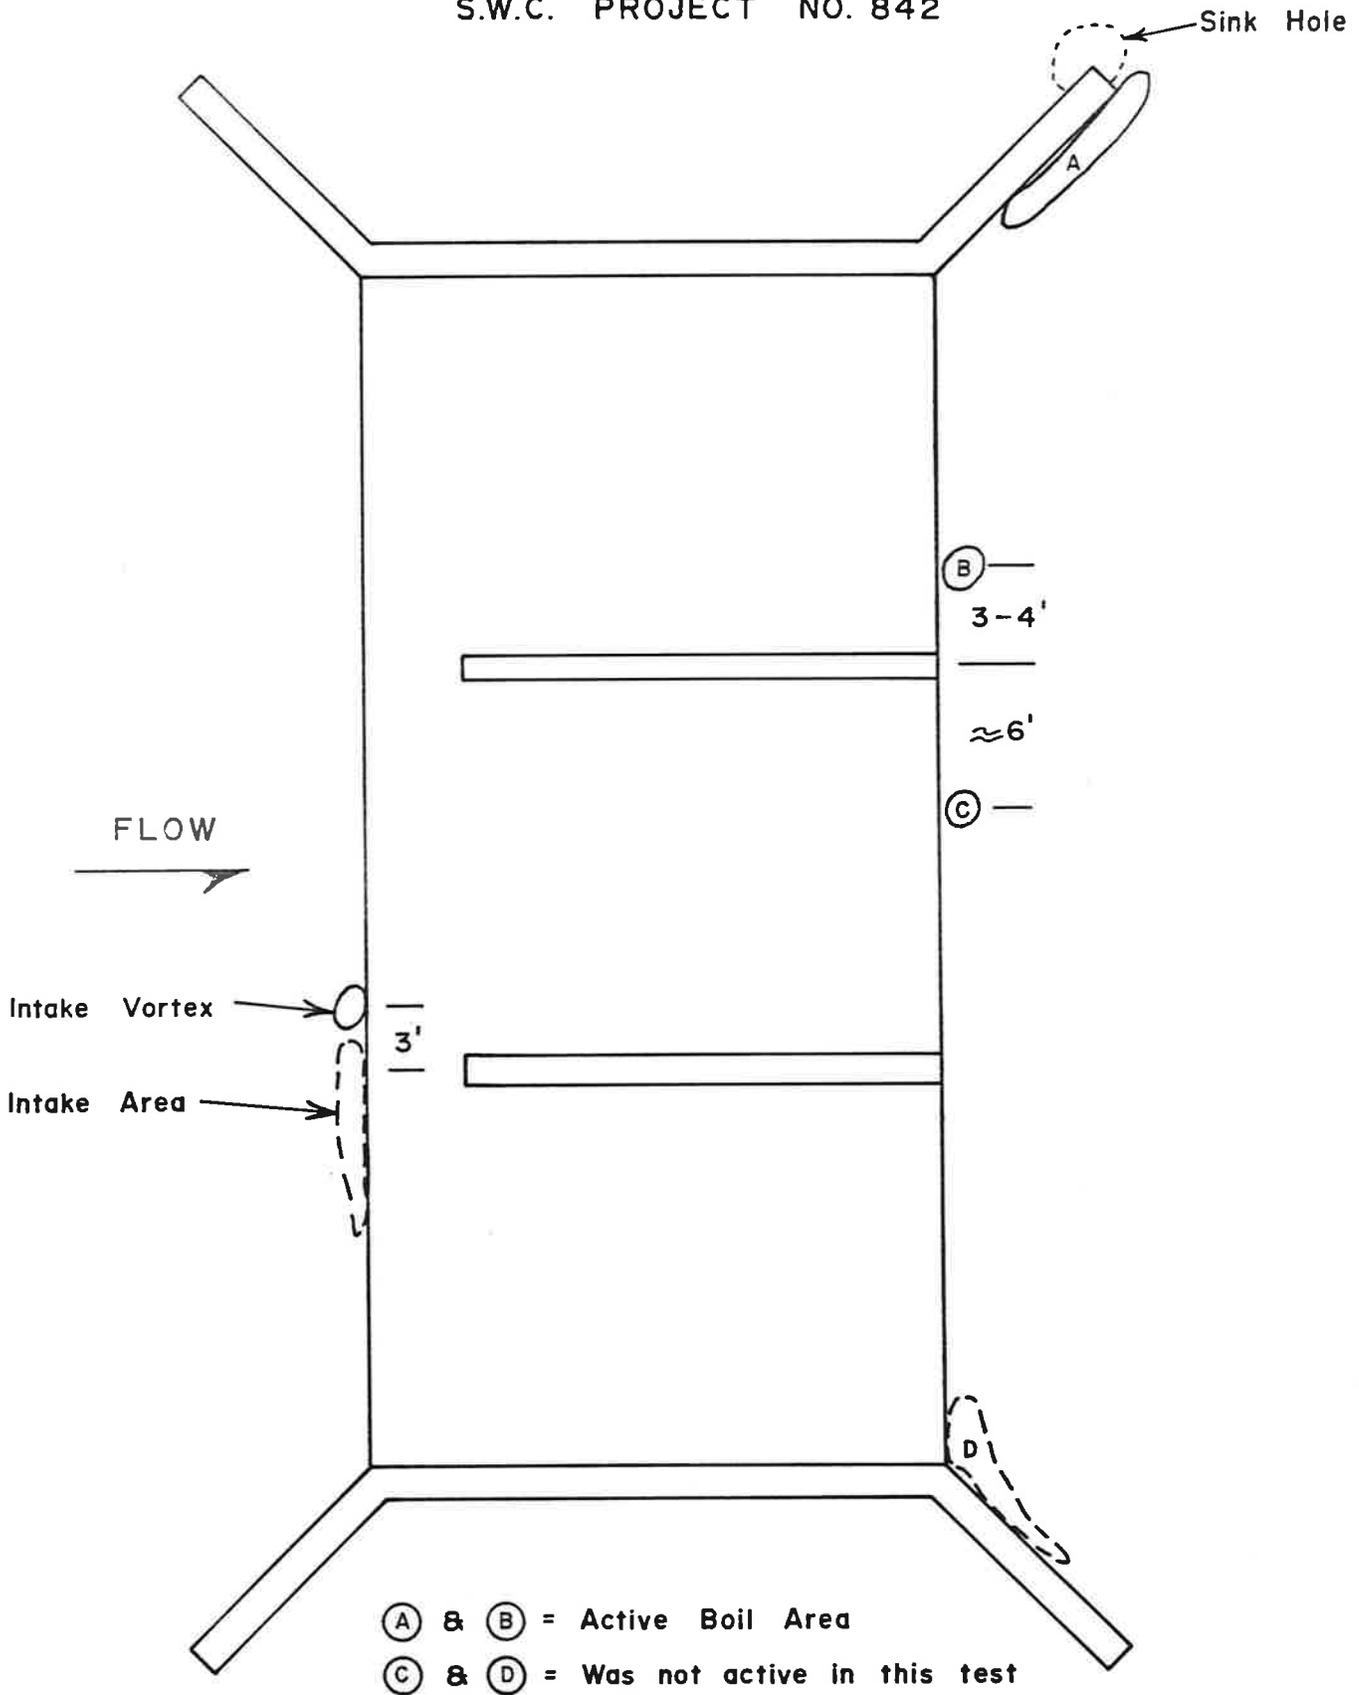
FIGURE 1

Next the gate was closed and the water within the impoundment was allowed to reach the level of Dry Lake once more. A 5-gallon pail of blue dye was prepared and then poured into the water near the west end of the structure. Shortly after this, a small vortex was noted about 3 feet east of the west pier. It took the dye about 4 to 5 minutes to reach the vortex area and another 2 to 3 minutes to emerge from the boils (See Figure 1). Therefore, it appears that one of the major uncontrolled seepage paths extends from west to east beneath the structure. Its flow is evidently along the path of least resistance, emerging in several areas along the face of the downstream wall and east wing-wall.

Dependent upon excavation and inspection of the upstream area, two possible alternatives can be considered to repair the structure. One would be to excavate and pour a concrete cap. The second would be to excavate the front face and place an impervious, compacted clay cutoff wall (clay core) in front of the structure. Both cases would require foundation grouting beneath the floor of the structure. A rough estimate of 25 to 100 cubic yards of grout may be required.

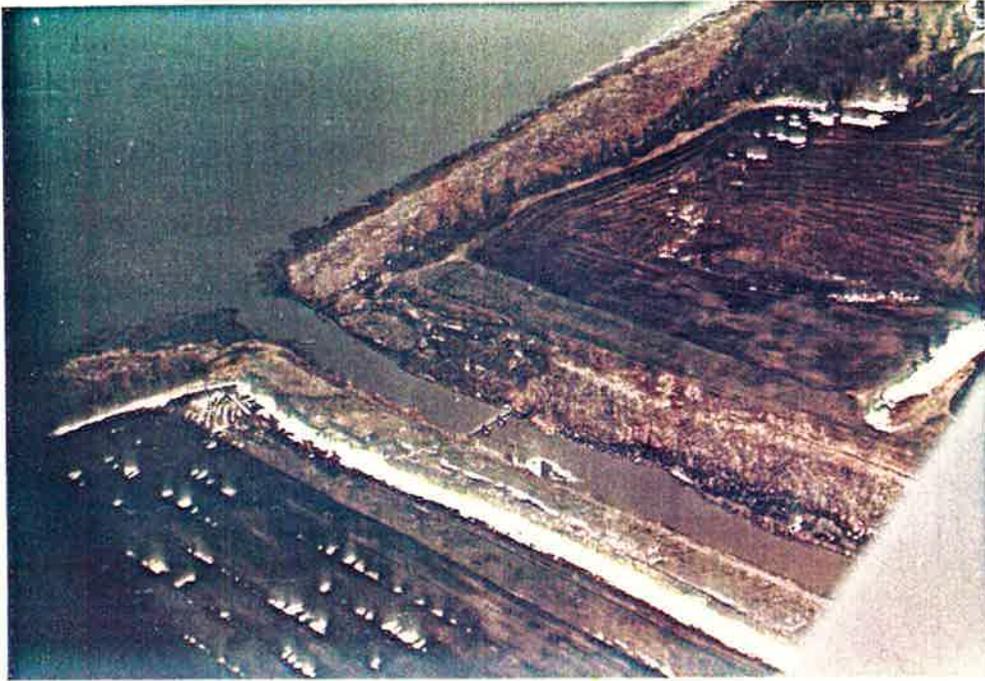
Photo A - Aerial View of the Channel
"A" Control Structure and a Portion of
the Southern Tip of Dry Lake
May 2, 1984

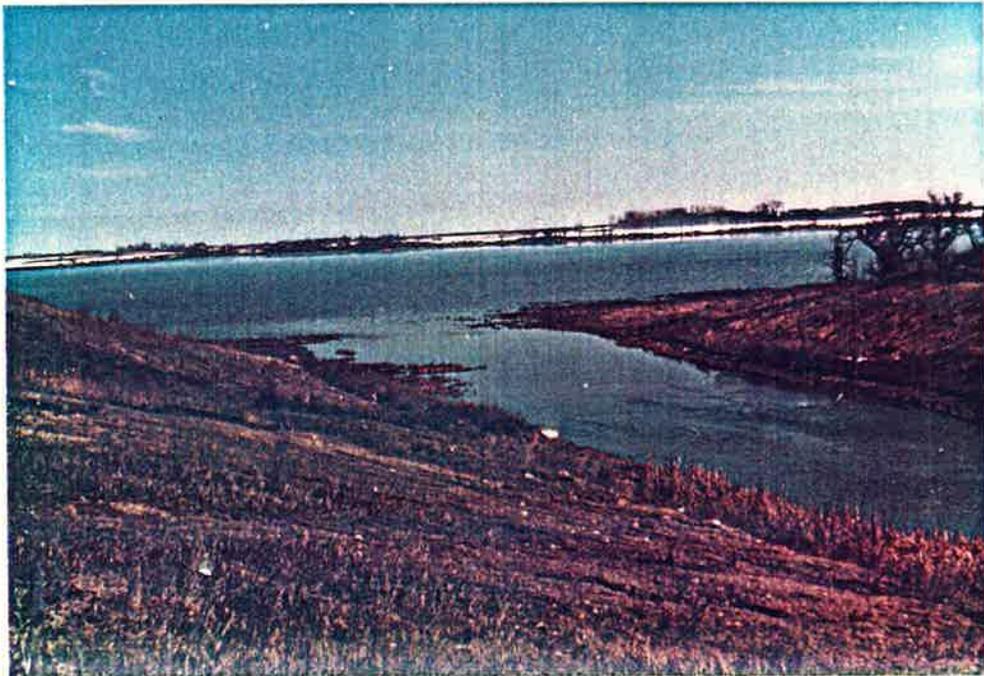
Photo B - View Looking North at Dry Lake
and its Outlet Into Channel "A"
May 2, 1984

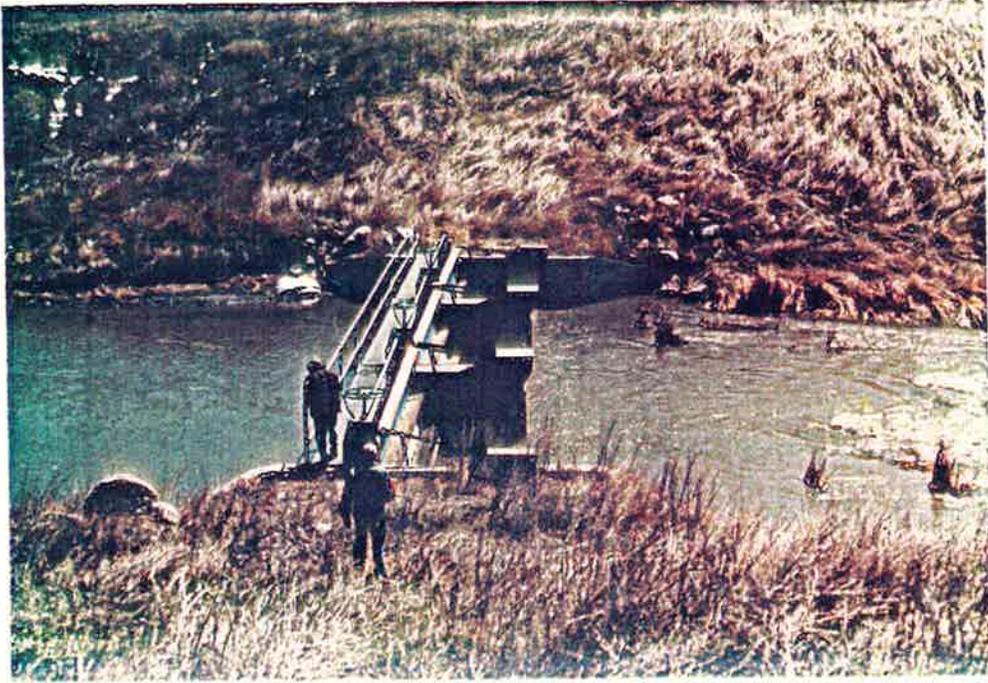
Dave Sprynczynatyk received a phone call from Bob Garske on May 2. Prior to the call, Bob and other Board members had inspected the Channel "A" control structure and found a considerable amount of water bypassing the structure. I was directed by Dave to immediately fly to Devils Lake and make an on-site inspection. John Klingenberg, North Central Engineers, was also contacted and agreed to meet me at Devils Lake. Bob Garske, Dick Regan, John Klingenberg and myself conducted the on-site inspection (See Photos C and D).

Photo C - Channel "A" Control Structure
Viewed From the East Looking West
May 2, 1984

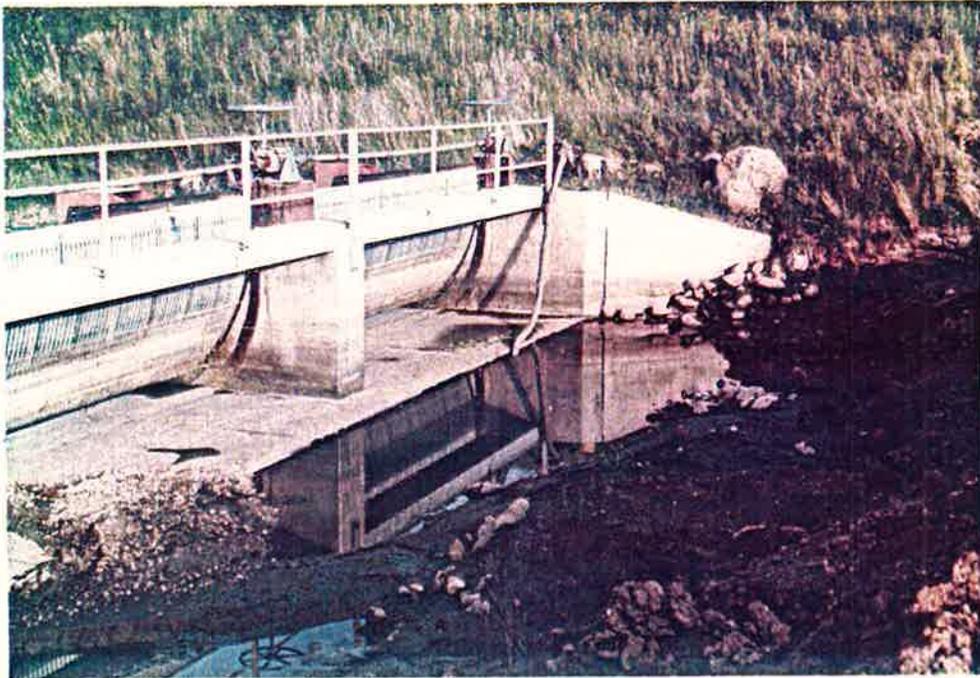
I arrived at the project site at 7:15 a.m. Also present were Gary McDowall and Robert Bucholz. Water had seeped in during the night, requiring the upstream area be pumped again (See Photos 2, 3 and 4). At

Photo No. 2 - Pumping Operations Begin
6-27-84

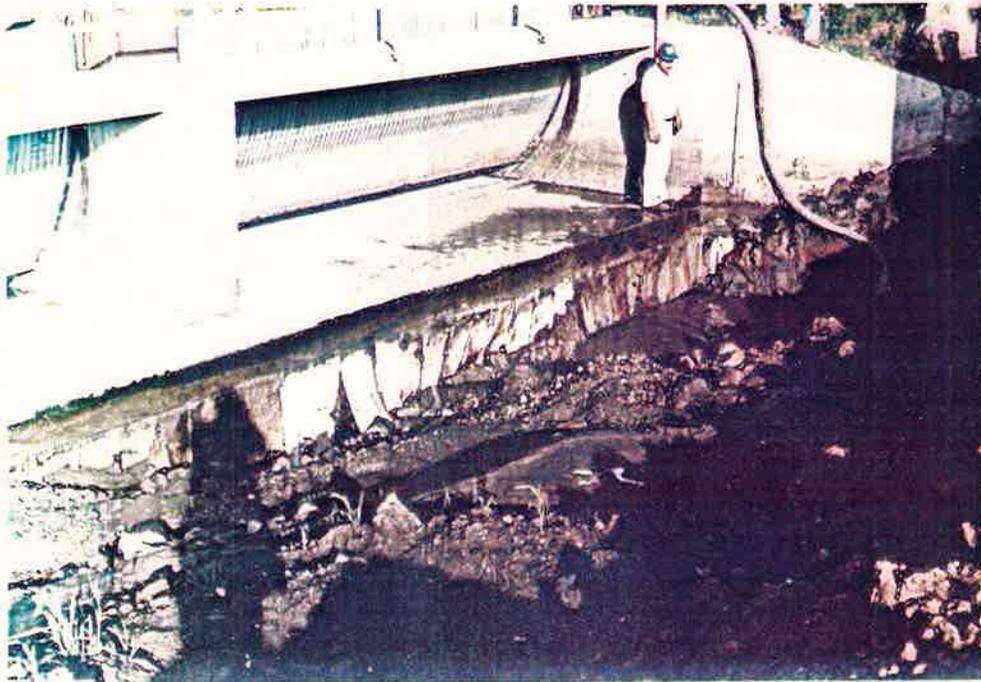
Photo No. 3 - Pumping Operations In Progress
Note Excavated Sump
Some of the Steel Forms Have Been Removed
While Others Are Still Inplace
6-27-84

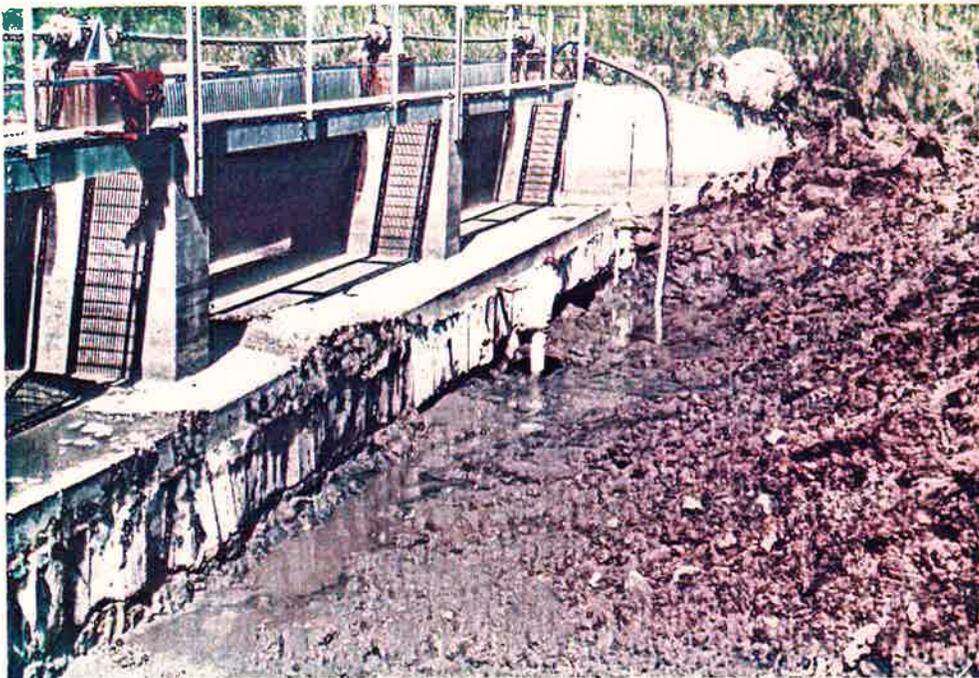
Photo No. 4 - Excavation and Pumping
Operations Nearing Completion
6-27-84

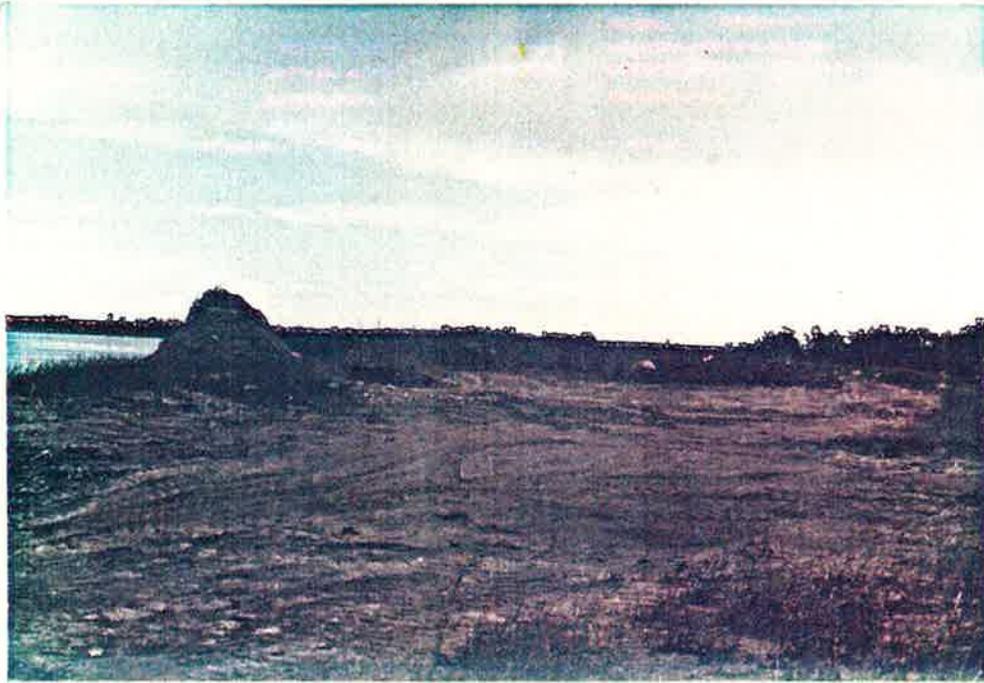
Photo No. 13 - Borrow Area
Located East of Structure
7-2-84

Upon completion of the aforementioned excavation work, we began to backfill the area. The borrow material was acquired from an area just east of the structure. This material had been previously excavated during construction of the channel and had then been placed and shaped to form the upper flat land surface (See Photo 13).

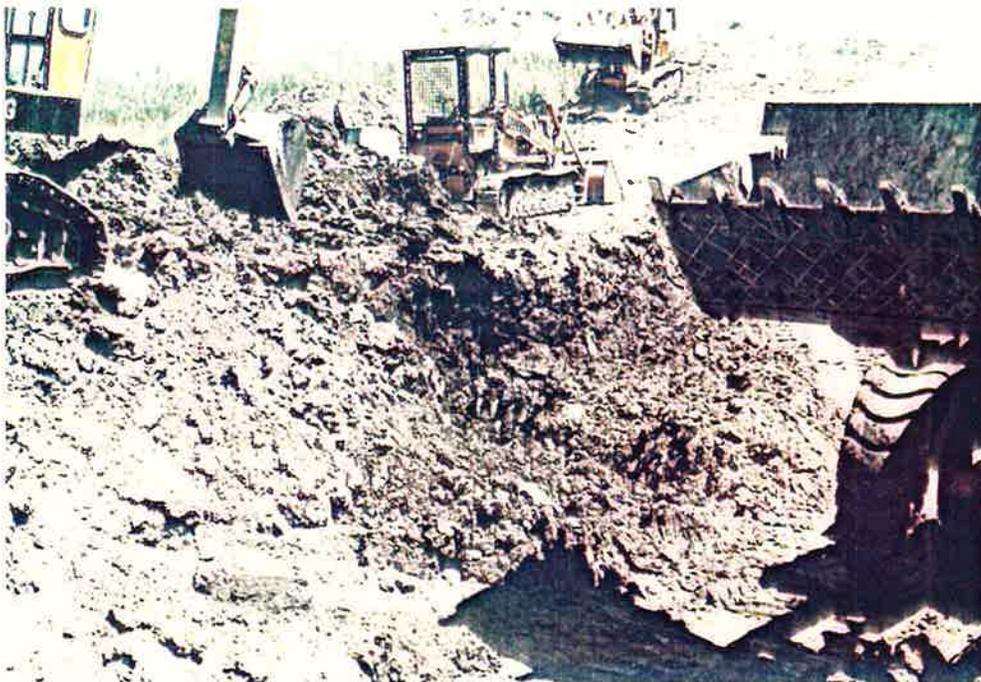
Photo No. 14 - Construction Equipment
Upper Left: Warner Swasey Excavator
Upper Middle: Case 350 Crawler Tractor
Upper Right: JD555 Crawler Tractor
Lower Right: JD644-B Loader
7-2-84

Transporting, spreading and compacting the backfill material was accomplished by a John Deere 694-B rubber tired loader; a John Deere 555 crawler tractor with loader; a Case 350 crawler tractor with loader, pulling a Ray Go compactor (Model No. Rumbler SF-54A); and a hand-held tamper (See Photo 14). The manual tamper was used almost exclusively for tamping along the upstream wingwalls, where, it was virtually impossible to get any other compaction equipment in position (See Photo 15).

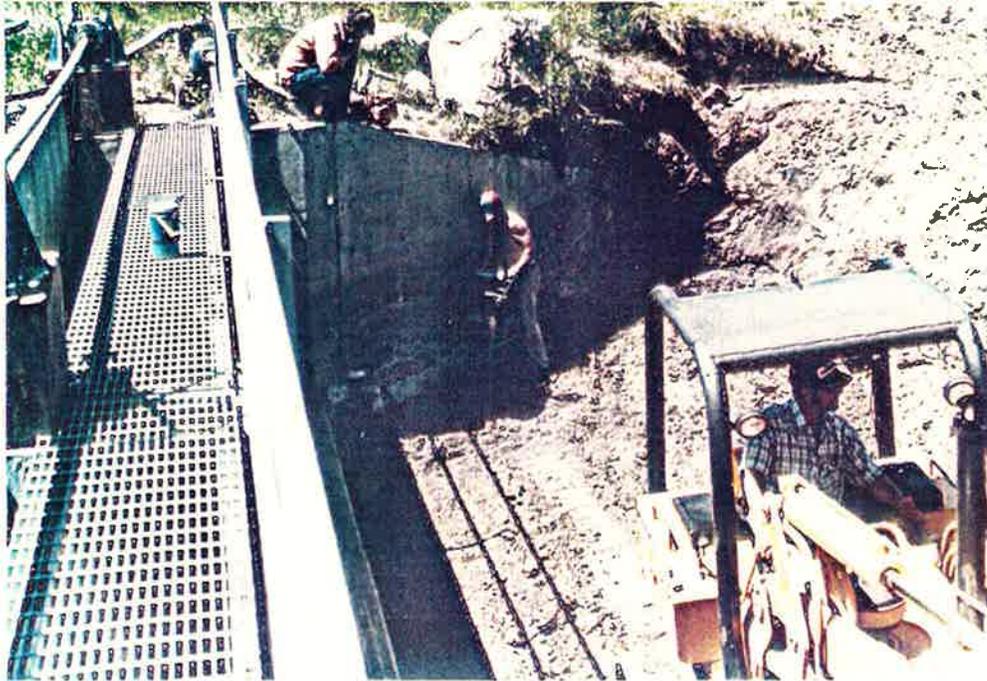
Photo No. 15 7-2-84
Bob Bucholz, SWC Employee Operating
Manual Compactor Along West Upstream Wingwall

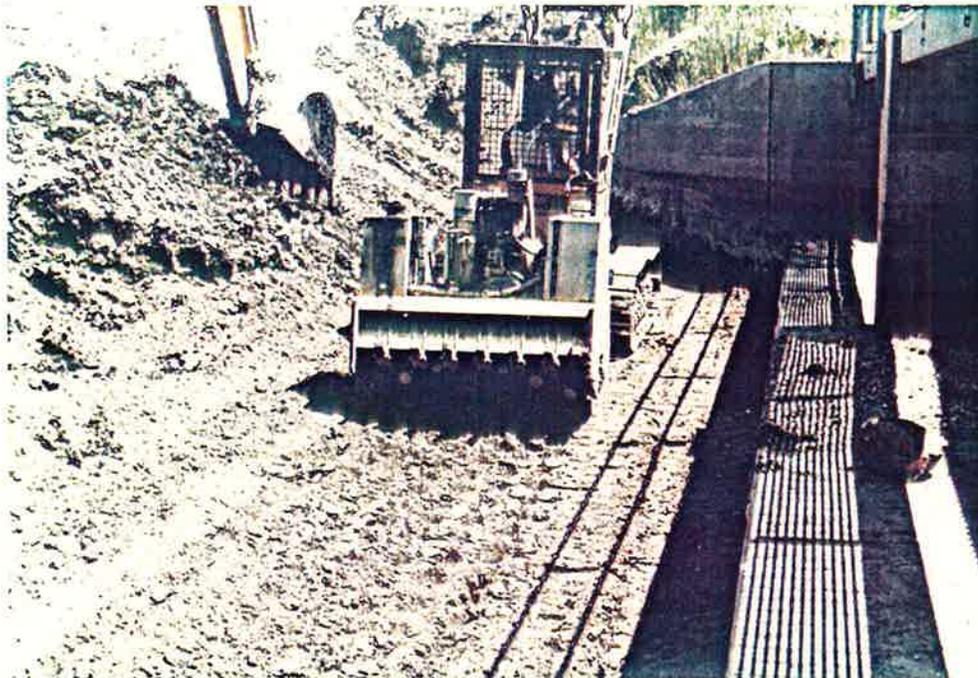
Photo No. 16 - Compaction & Excavation Operations
Case 350 Crawler Tractor Pulling Ray Go Compactor
Note the Bucket of the Excavator - At this Point, We Had
Began to Excavate Into the Existing Cofferdam to Enlarge
Our Impervious Cutoff Area.

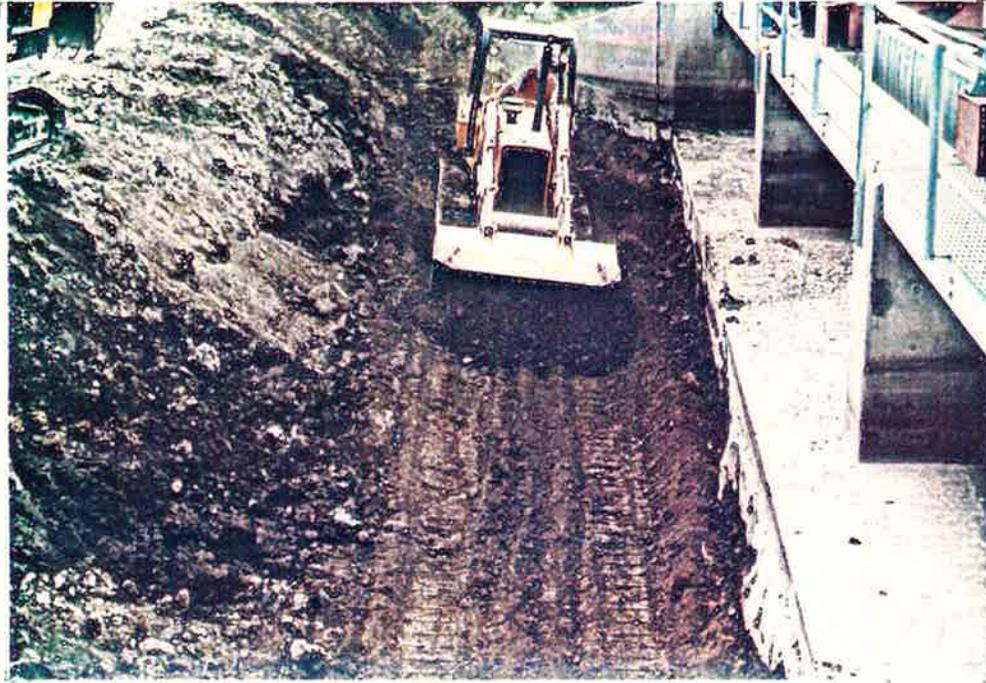
Photo No. 17 7-2-84
Gary McDowall, SWC Employee, Spreading
Backfill Material With Our JD-555

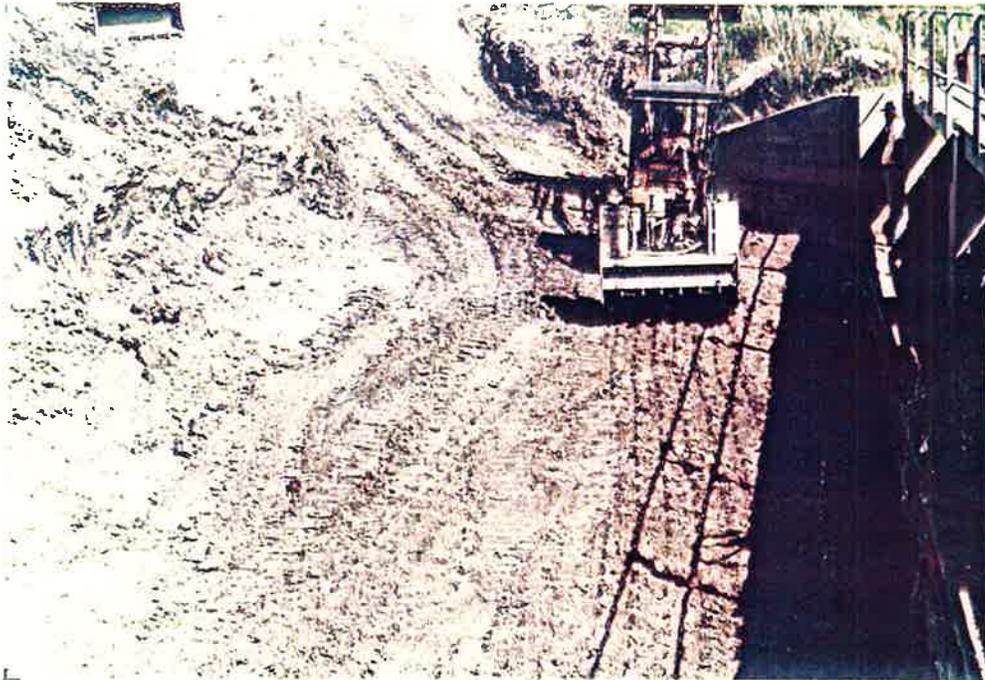
Photo No. 18 - View of Compaction Operations
Note the Entry and Exit Ramp
to the Left of Equipment
7-2-84

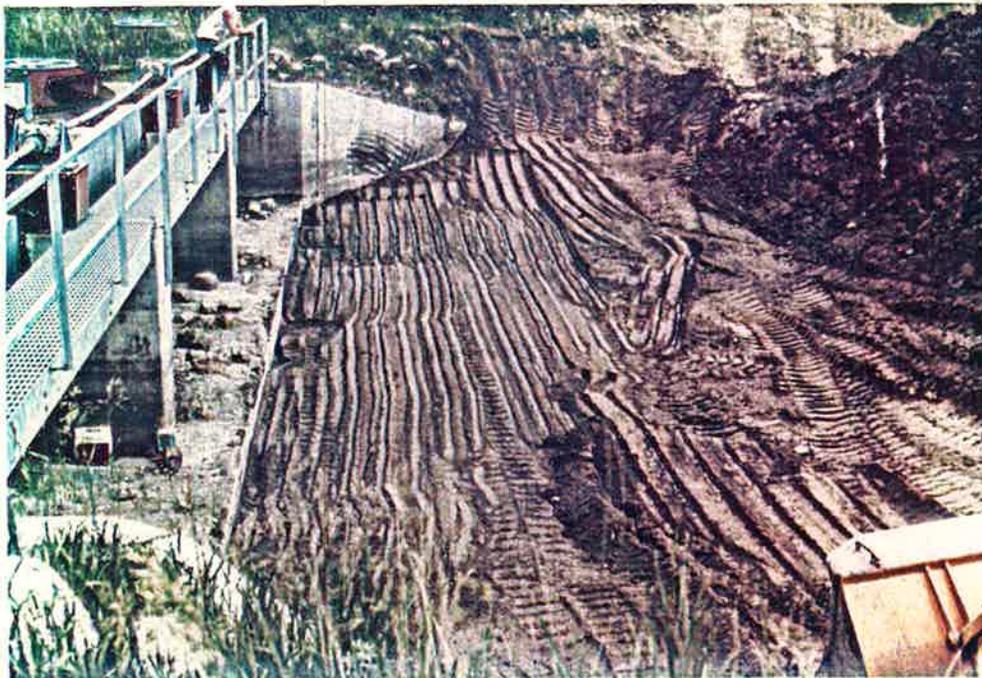
Photo No. 20 7-3-84
Placing the Sand-Gravel Filter Blanket

After waiting for sometime, Durbin's trucks delivered one load of pitrun sand-gravel and two loads of rock. Several inches of the sand-gravel mixture were placed over the fill material, and then covered with several inches of gravel rock (See Photos 20 and 21). The filter-rock riprap protection served a dual purpose: (1) to provide drainage and yet prevent the movement of the base material due to flowing water, and (2) to further prevent erosion of the underlying sand and fines.

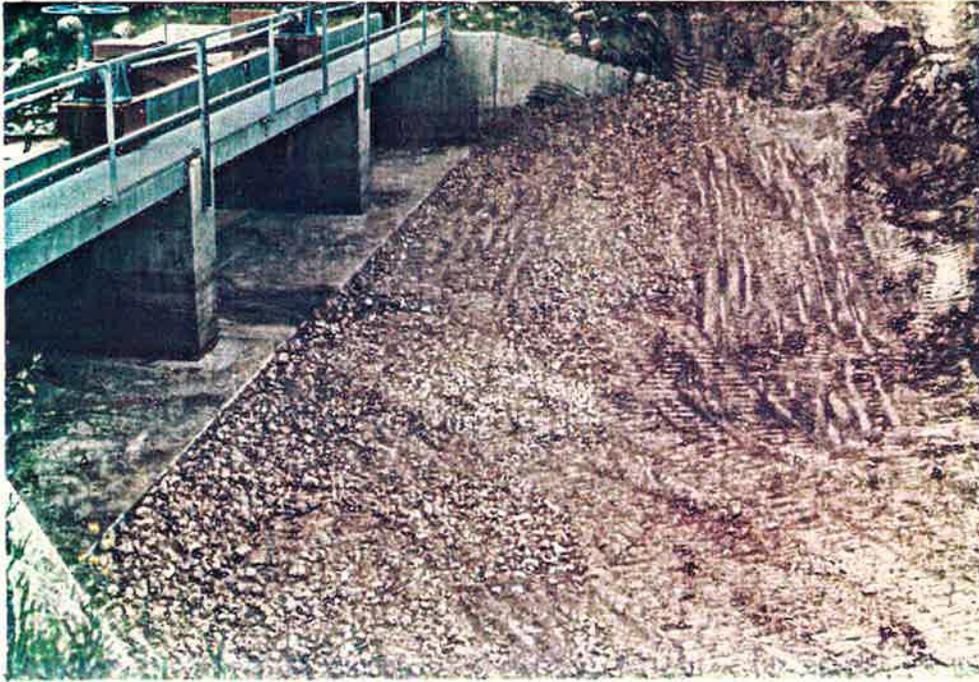
Photo No. 21 7-3-84
Close-up View of the Gravel-Rock Inplace

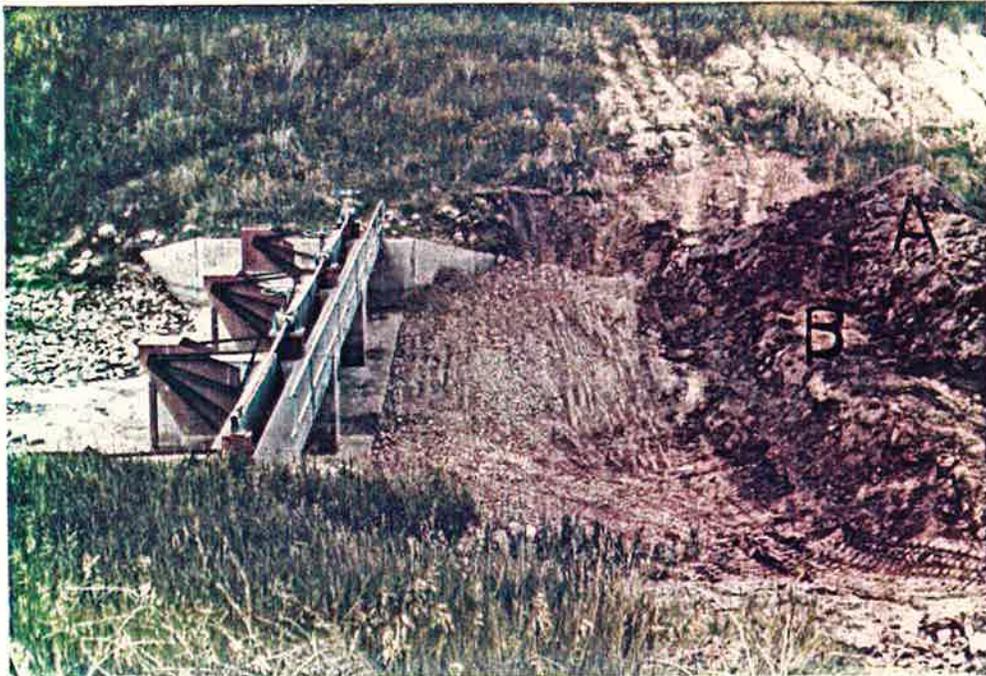
Photo No. 22 7-3-84
View of Structure, Clay Core and Cofferdam
The Upper Portion (A) of the Cofferdam Represents
the Material that was Excavated on July 2, 1984, to
Enlarge the Claycore. The Lower Portion (B) Represents
The Original Height of the Cofferdam as First Built

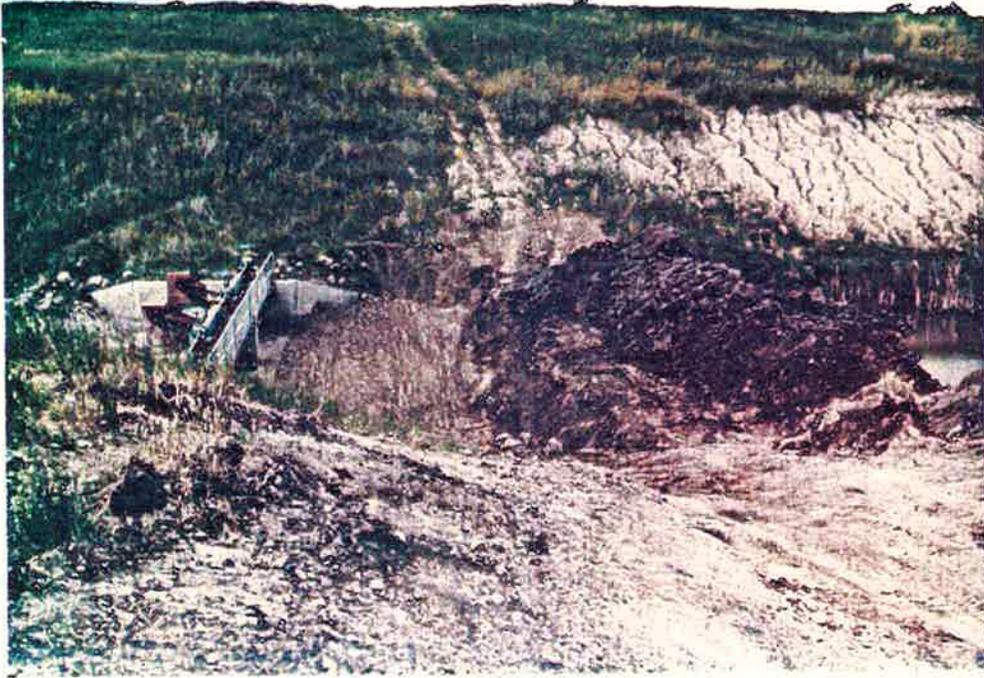
Photo No. 23 7-3-84
The Upper and Lower Photos, Looking West,
Show the Project Upon Completion of the
1st Phase of Repair

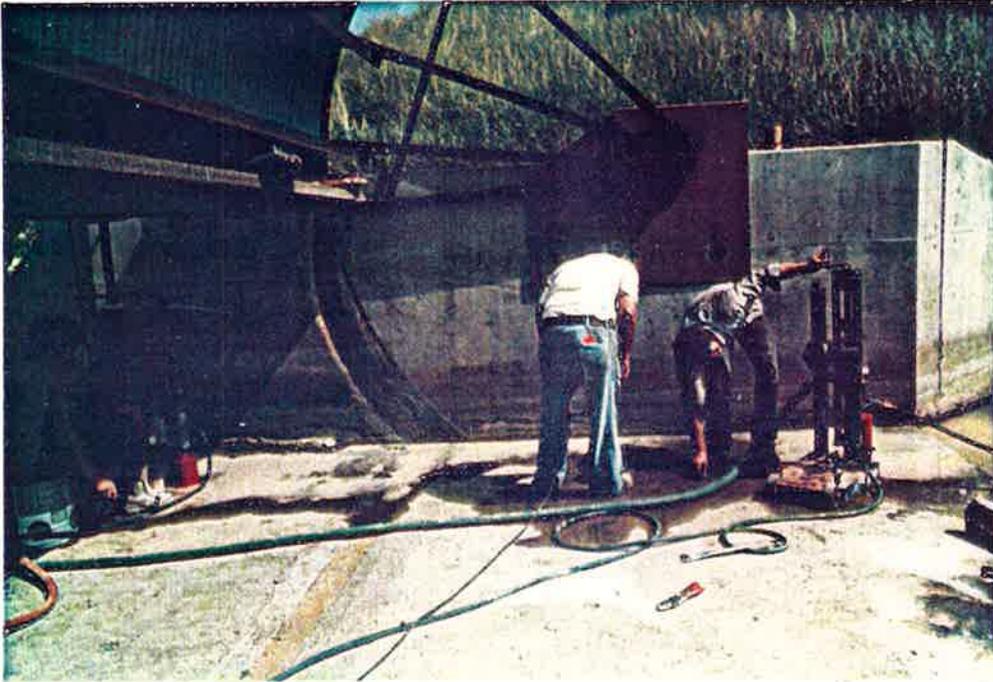
samples were removed and examined (See Photos 25 and 26). The log of the results are shown on Figure 2, which gives the location of the drill holes and the depths of the void measured.

Photo No. 25 7-30-84
Drilling Operations In Progress

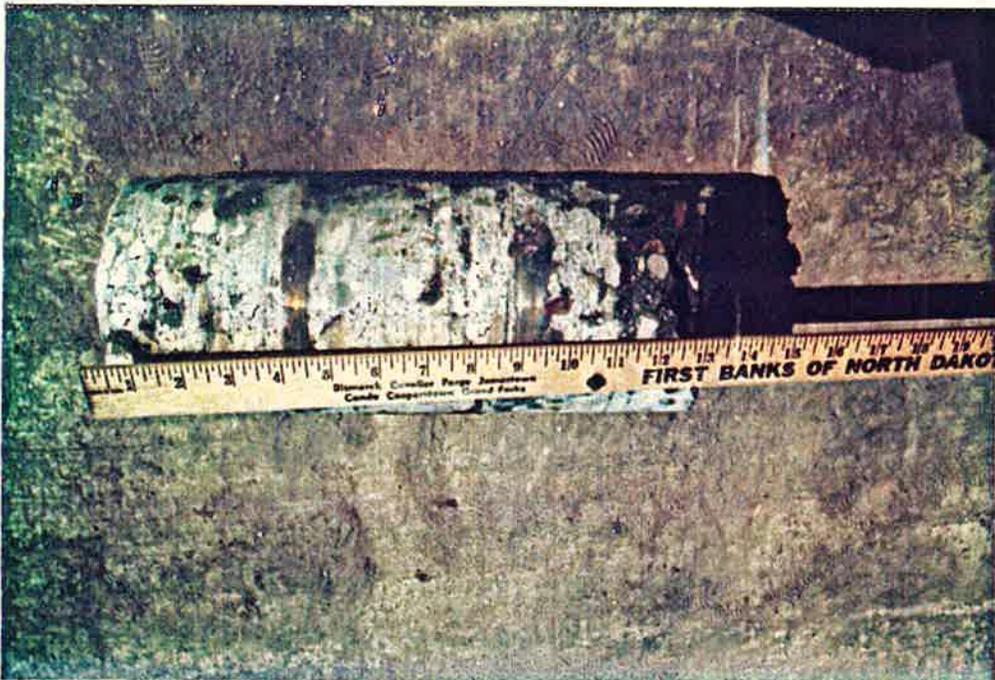
Photo No. 26 7-30-84
Close-Up View of 6-Inch Diameter Core Sample
Removed From Structural Floor

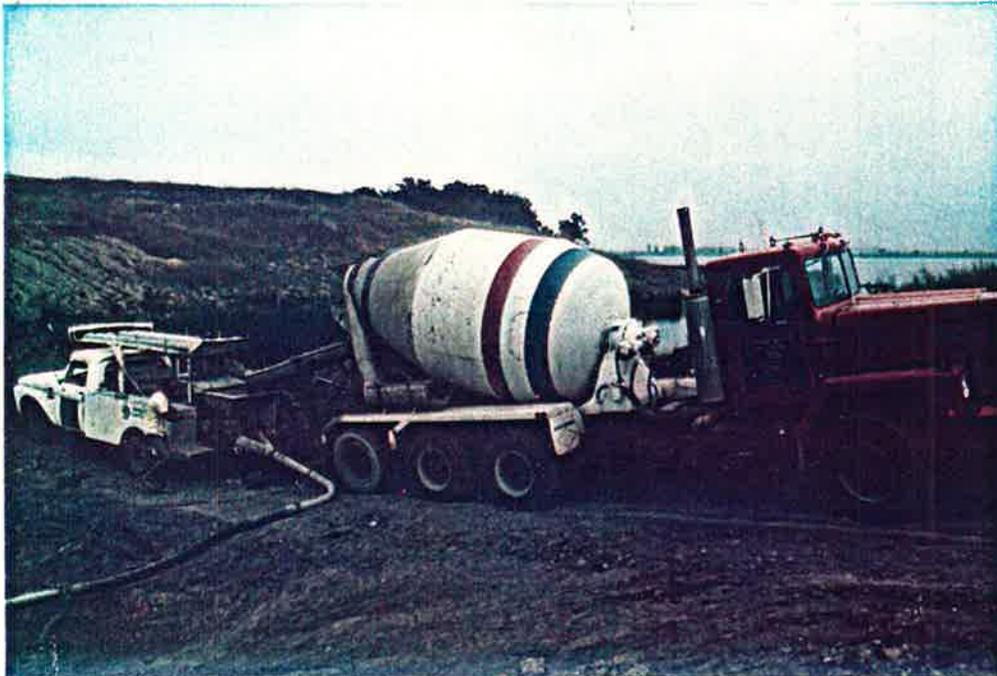
Photo No. 28 8-3-84
Concrete Pumping Operations
The Concrete is Delivered to the Site by a
Truck Mixer, Discharged by Chute into a
Pumper, and Then Pumped by Hose into
Holes Previously Drilled on the Structural Floor

The concrete was pumped into the voids until the holes were filled (See Photos 28 and 29). Then a trough was placed over the hole and more concrete placed into it and vibrated down until no more would be accepted

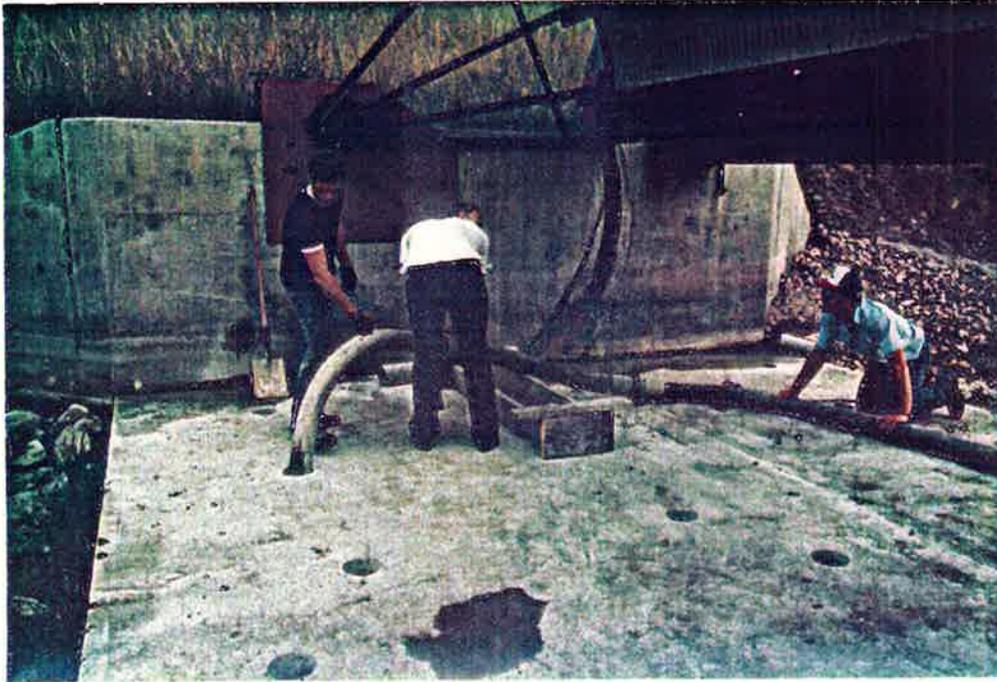
Photo No. 29 8-3-84
Concrete Pumping Operations
Close-Up View of Concrete Being
Pumped into the Structural Foundation
Note the Drilled Holes on the Floor
An Attempt Was Made to Pump Concrete into Each Hole

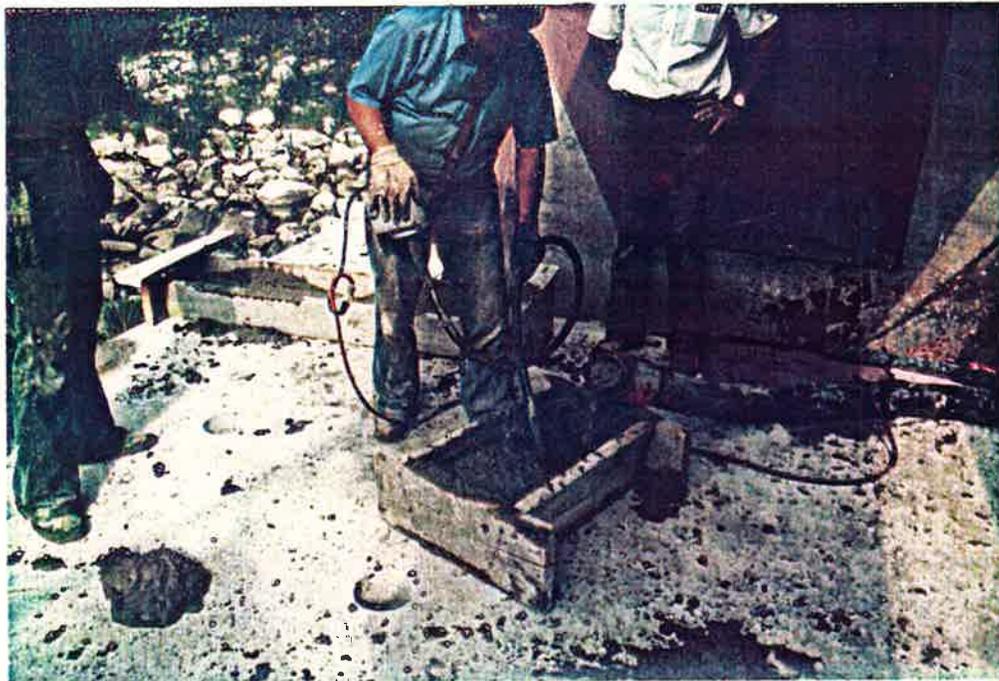
Photo No. 30 8-3-84
View Showing Concrete Being Vibrated
Down into the Structural Foundation

(See Photos 30 and 31). This process was started at the west end and proceeded systematically until the east end was filled. It appeared that the vibration process was insuring that all voids were being filled. Two cylinders were taken from the second truck and two more from the third (See Photo 32). I told them to break two at 7 days and two at 28 days. The compressive strength test results are shown on Table 2. It required slightly less than 30 cubic yards to fill the voids. The left over concrete was used to fill the hole eroded near the east downstream wingwall (See Photo 27).

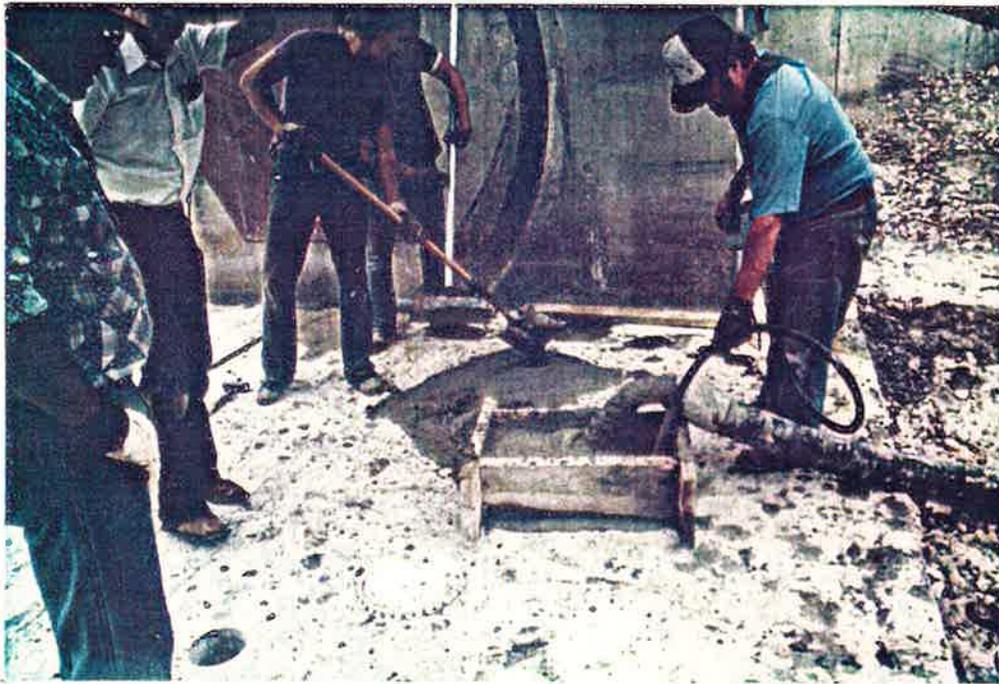
Photo No. 31 8-3-84
Another View of Concrete Simultaneously
Being Pumped and Vibrated into the
Structural Foundation. The Man Wearing
the Blue Shirt is Don Dahl, Owner
and Manager of Dahl's Industrial Tool
Company, West Fargo, North Dakota

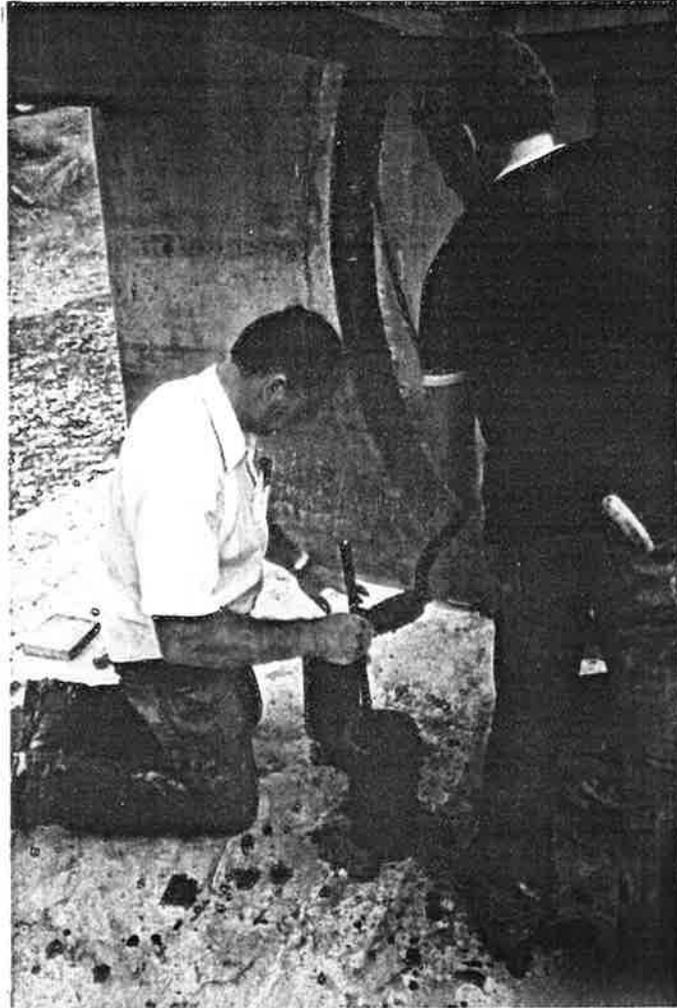
Photo No. 32 8-3-84
Making Concrete Specimens
in the Field, in Accordance
With ASTM Designation C31.
The Compressive Strength of
the Molded Concrete Cylinders
Were Later Determined by Twin
City Testing and Engineering
Laboratory, Inc., Grand Forks,
North Dakota
