INVESTIGATION REPORT  
**FORT CLARK IRRIGATION**  
SWC PROJECT NO. 287

NORTH DAKOTA  
STATE WATER COMMISSION  
NOVEMBER 1998

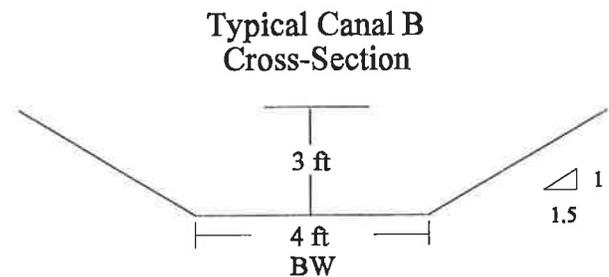
The existing canal system is made up of canal B and its laterals (See appendix - Map 2). Canal B was designed to irrigate up to 1400 acres, and is approximately 12.7 miles long with

its laterals. It has a range in bottom width from 2-6 ft, and 1.5:1 side slopes, and has a designed

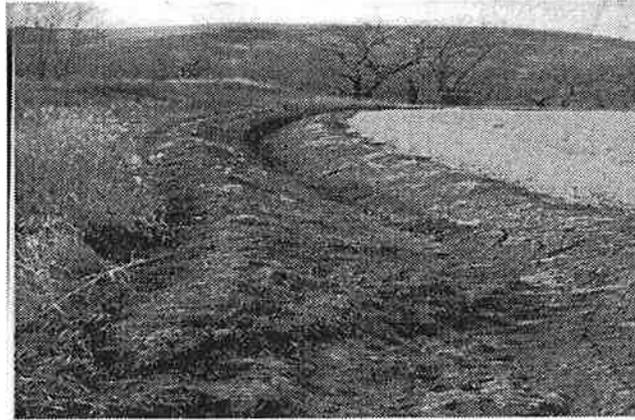
After several years of neglect canal B has become silted in and damaged by cattle. In order for the system to operate at optimum efficiency the canals should be restored to their original size and shape. This is even more important if an increased flow is introduced to the system by the addition of another pump at the inlet. This alternative would entail cleaning out the open channel in order to improve the flow characteristics. Over the years deposits have accumulated along the bottom of the canal, decreasing the overall size. These deposits may be a result of the sandbar located in front of the inlet. The upper third of the irrigation district needs the most attention, because most of the deposits drop out through this stretch. Also, a large number of deposits have accumulated behind structures used to alter the flow of the water, and before entering a culvert.

The actual cleaning could be done with the use of a channel dredge or some other form of digging machinery. This process could be done by the irrigators or be contracted to a local company. By doing it themselves the irrigators could save a considerable amount of money. The

soil that is removed from these areas could be used to fill in others that have been destroyed by cattle or erosion. By doing this the overall efficiency of the system would be increased. Once these areas are repaired, a fence could be built around the areas that are frequented by cattle, to assist in preserving the channel.
