# PRELIMINARY ENGINEERING REPORT

## EAST BRANCH OF SHELL CREEK FLOOD CONTROL THROUGH PARSHALL

S.W.C. PROJECT NO. 1656

NORTH DAKOTA  
STATE WATER COMMISSION  
SEPTEMBER 1980

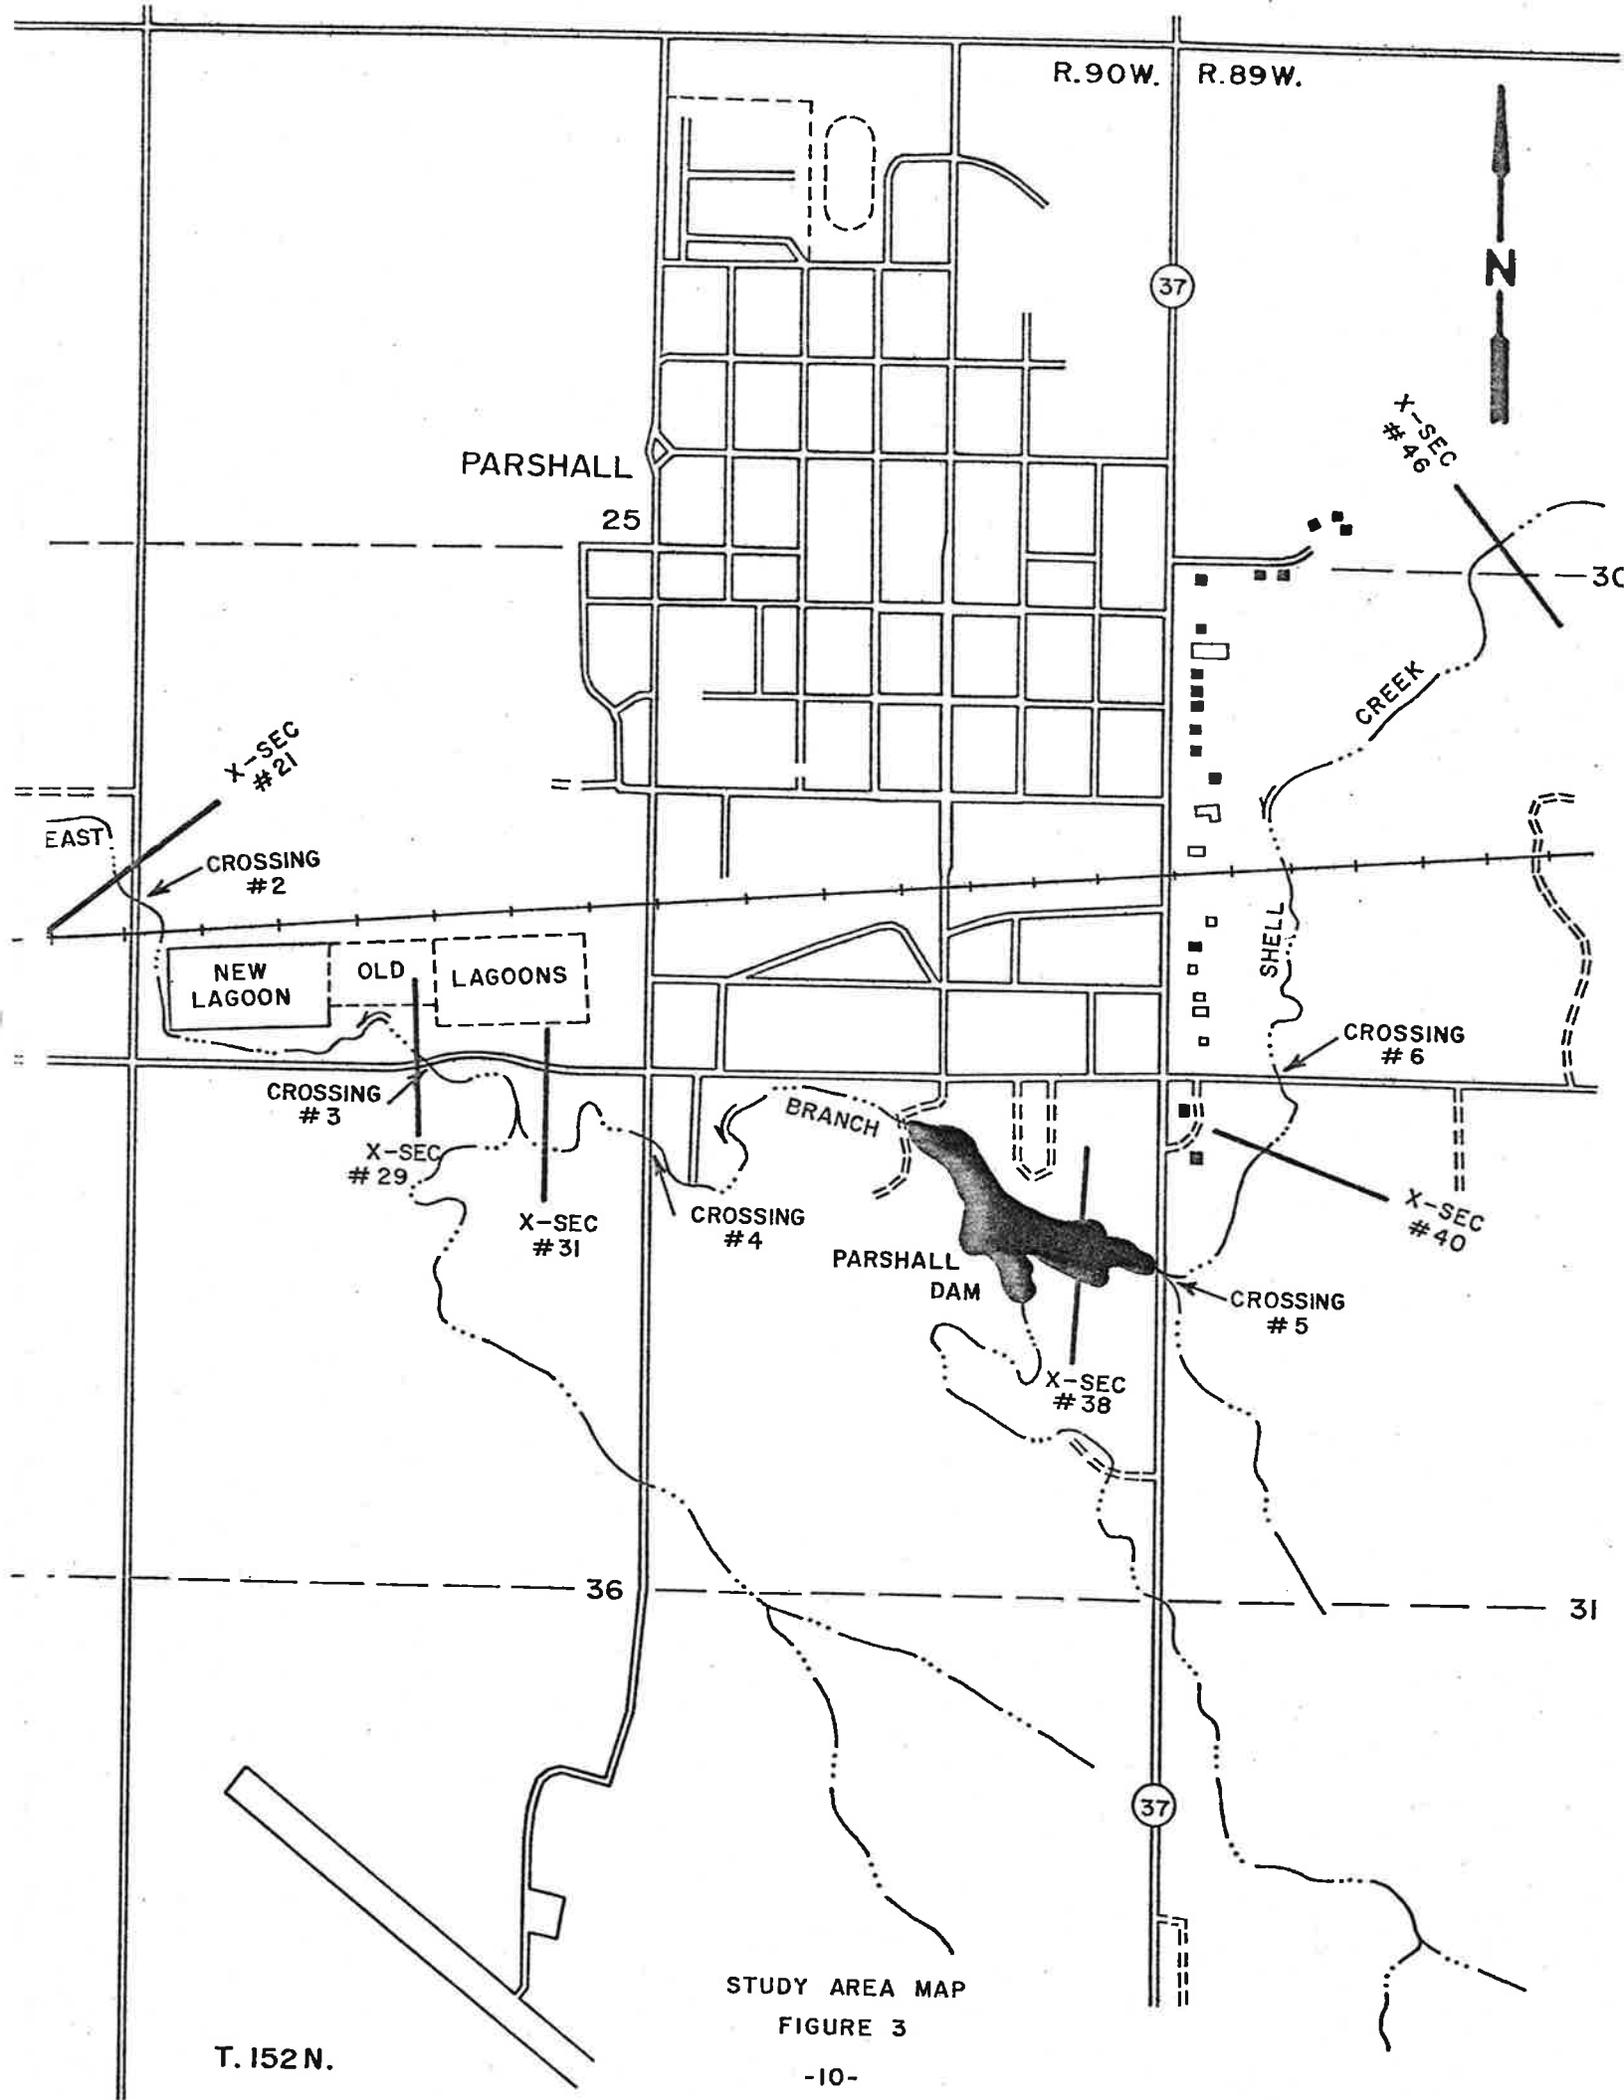
STUDY AREA MAP  
FIGURE 3

Figure 3 shows the limits of the study area. On this map the roadway crossings and locations of various cross sections used in the analysis are identified. Seven crossings are in the 2.5 mile study area. Two of these are railroad crossings. Roadway crossing number one is downstream from the study area and is not shown on the map. The railroad crossings along the entire length of the creek are all timber trestles, except for some in the upper reaches of the creek. These are generally

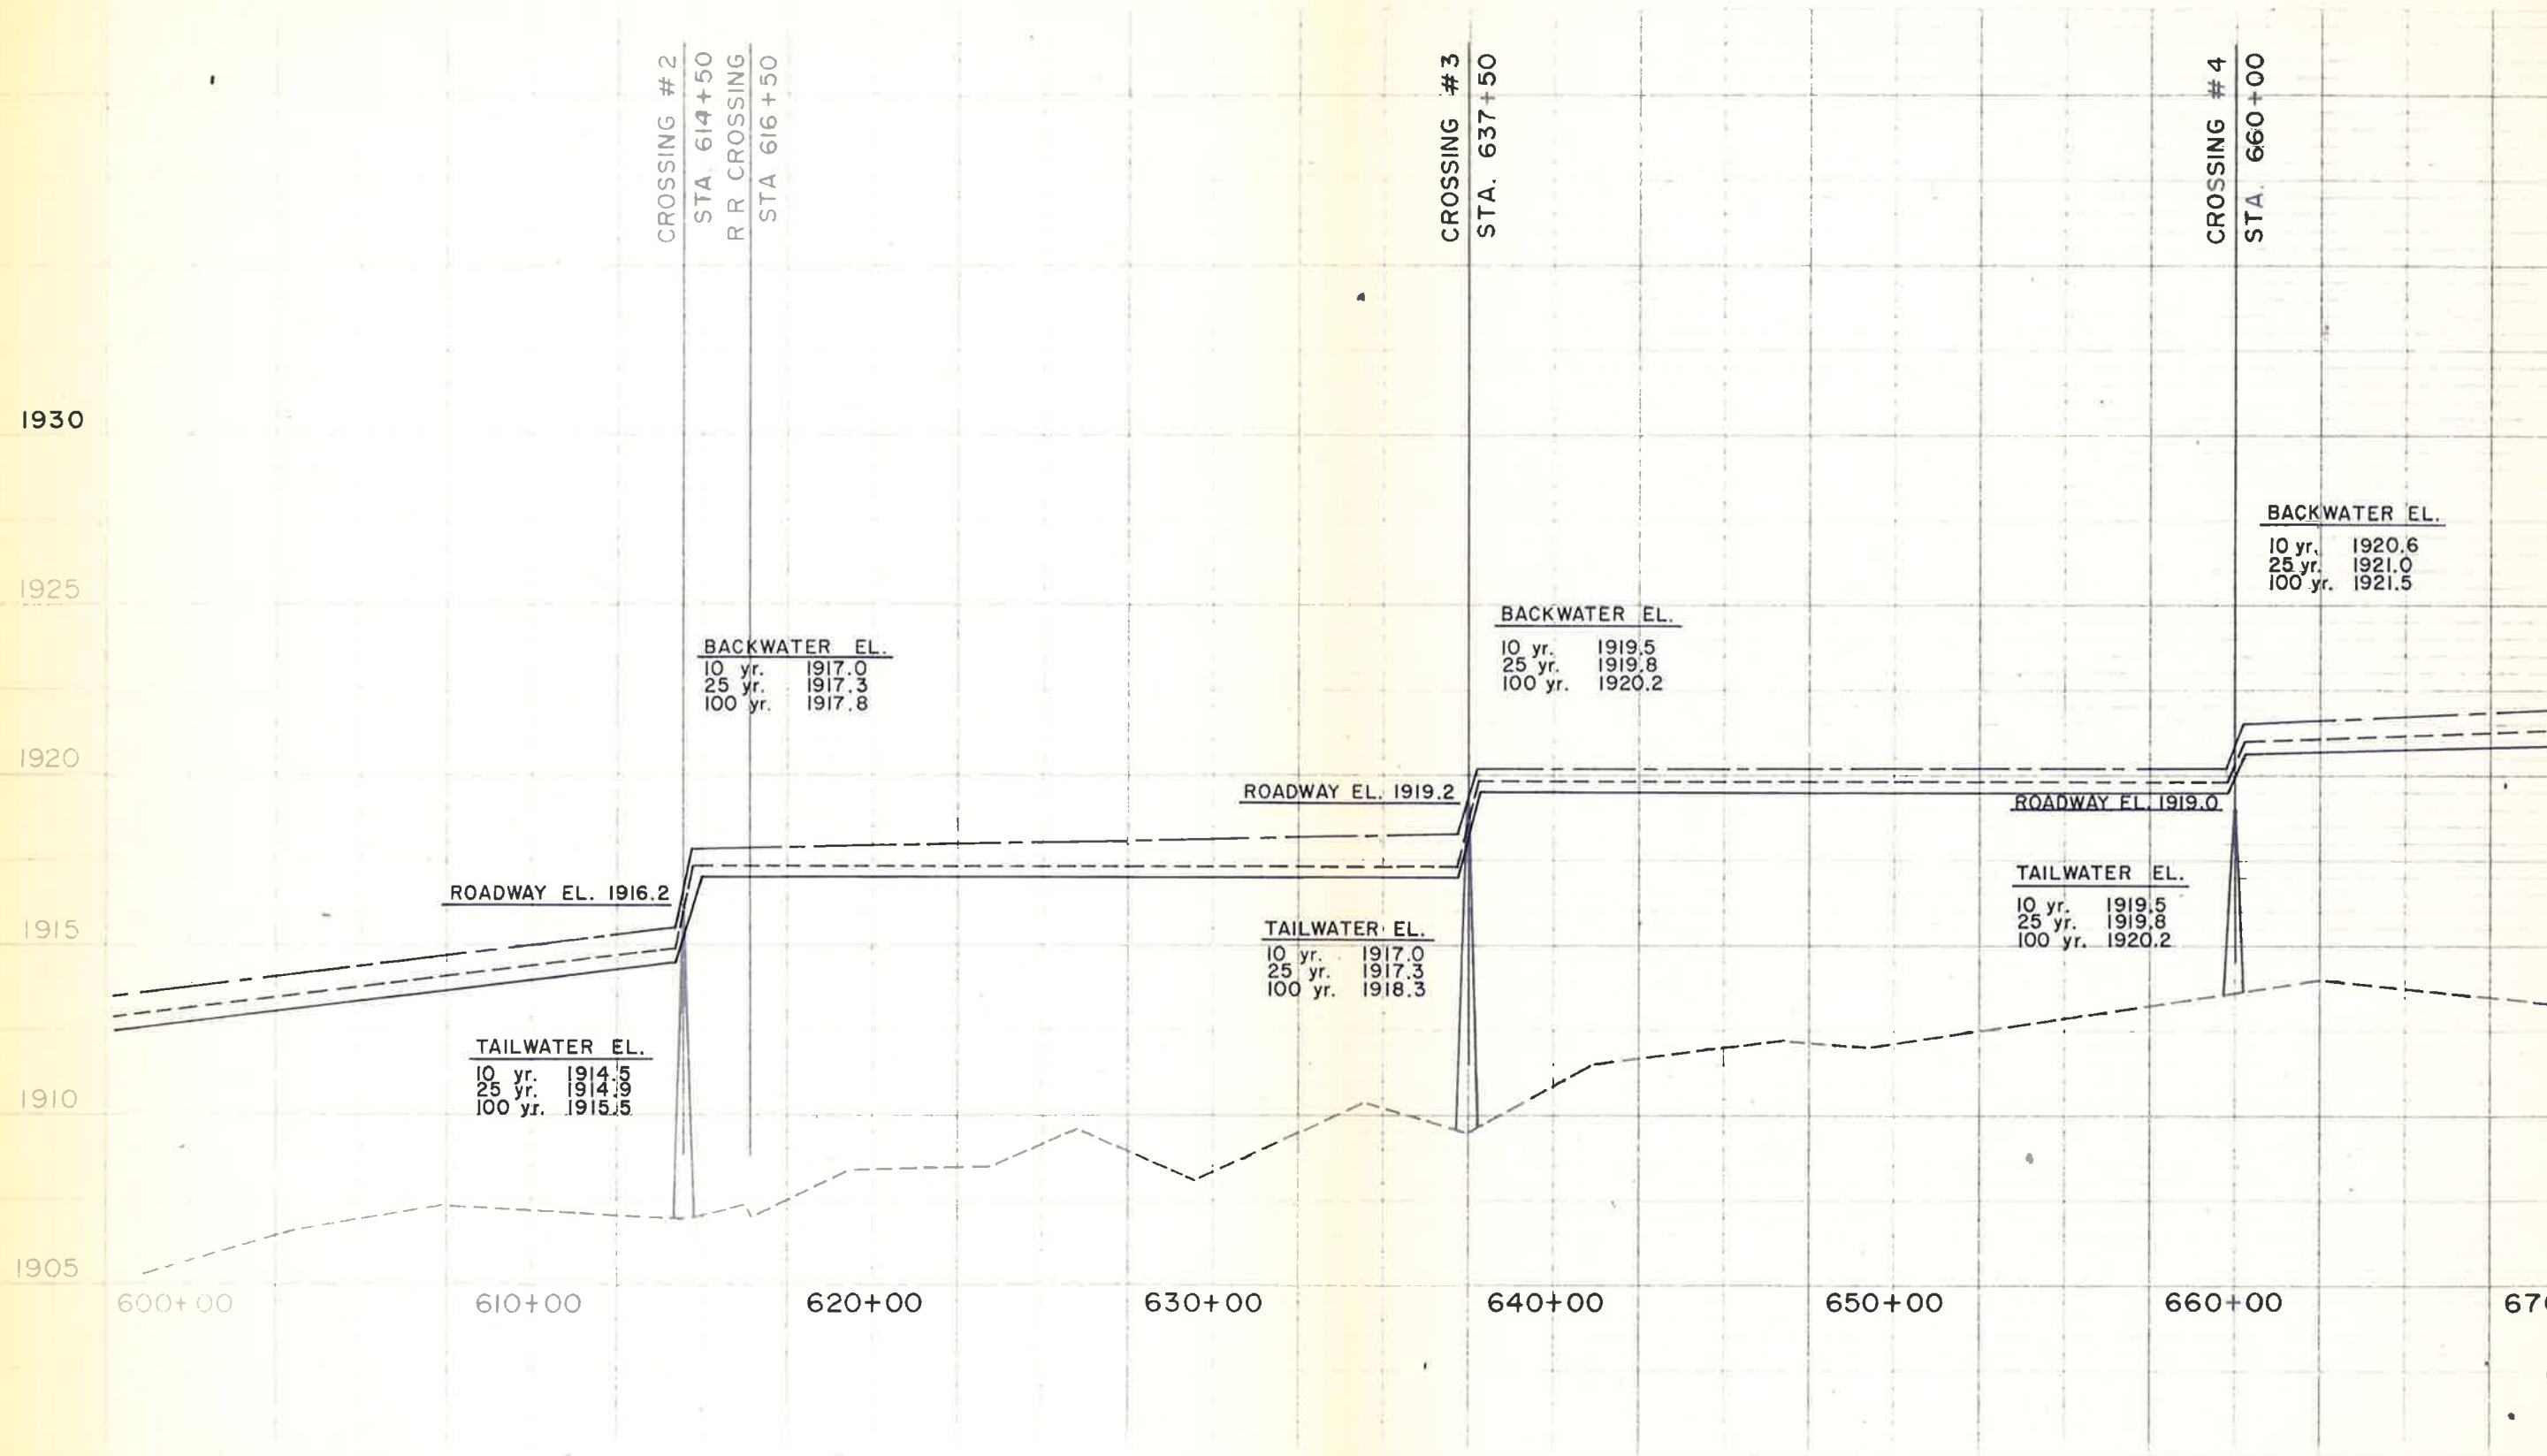
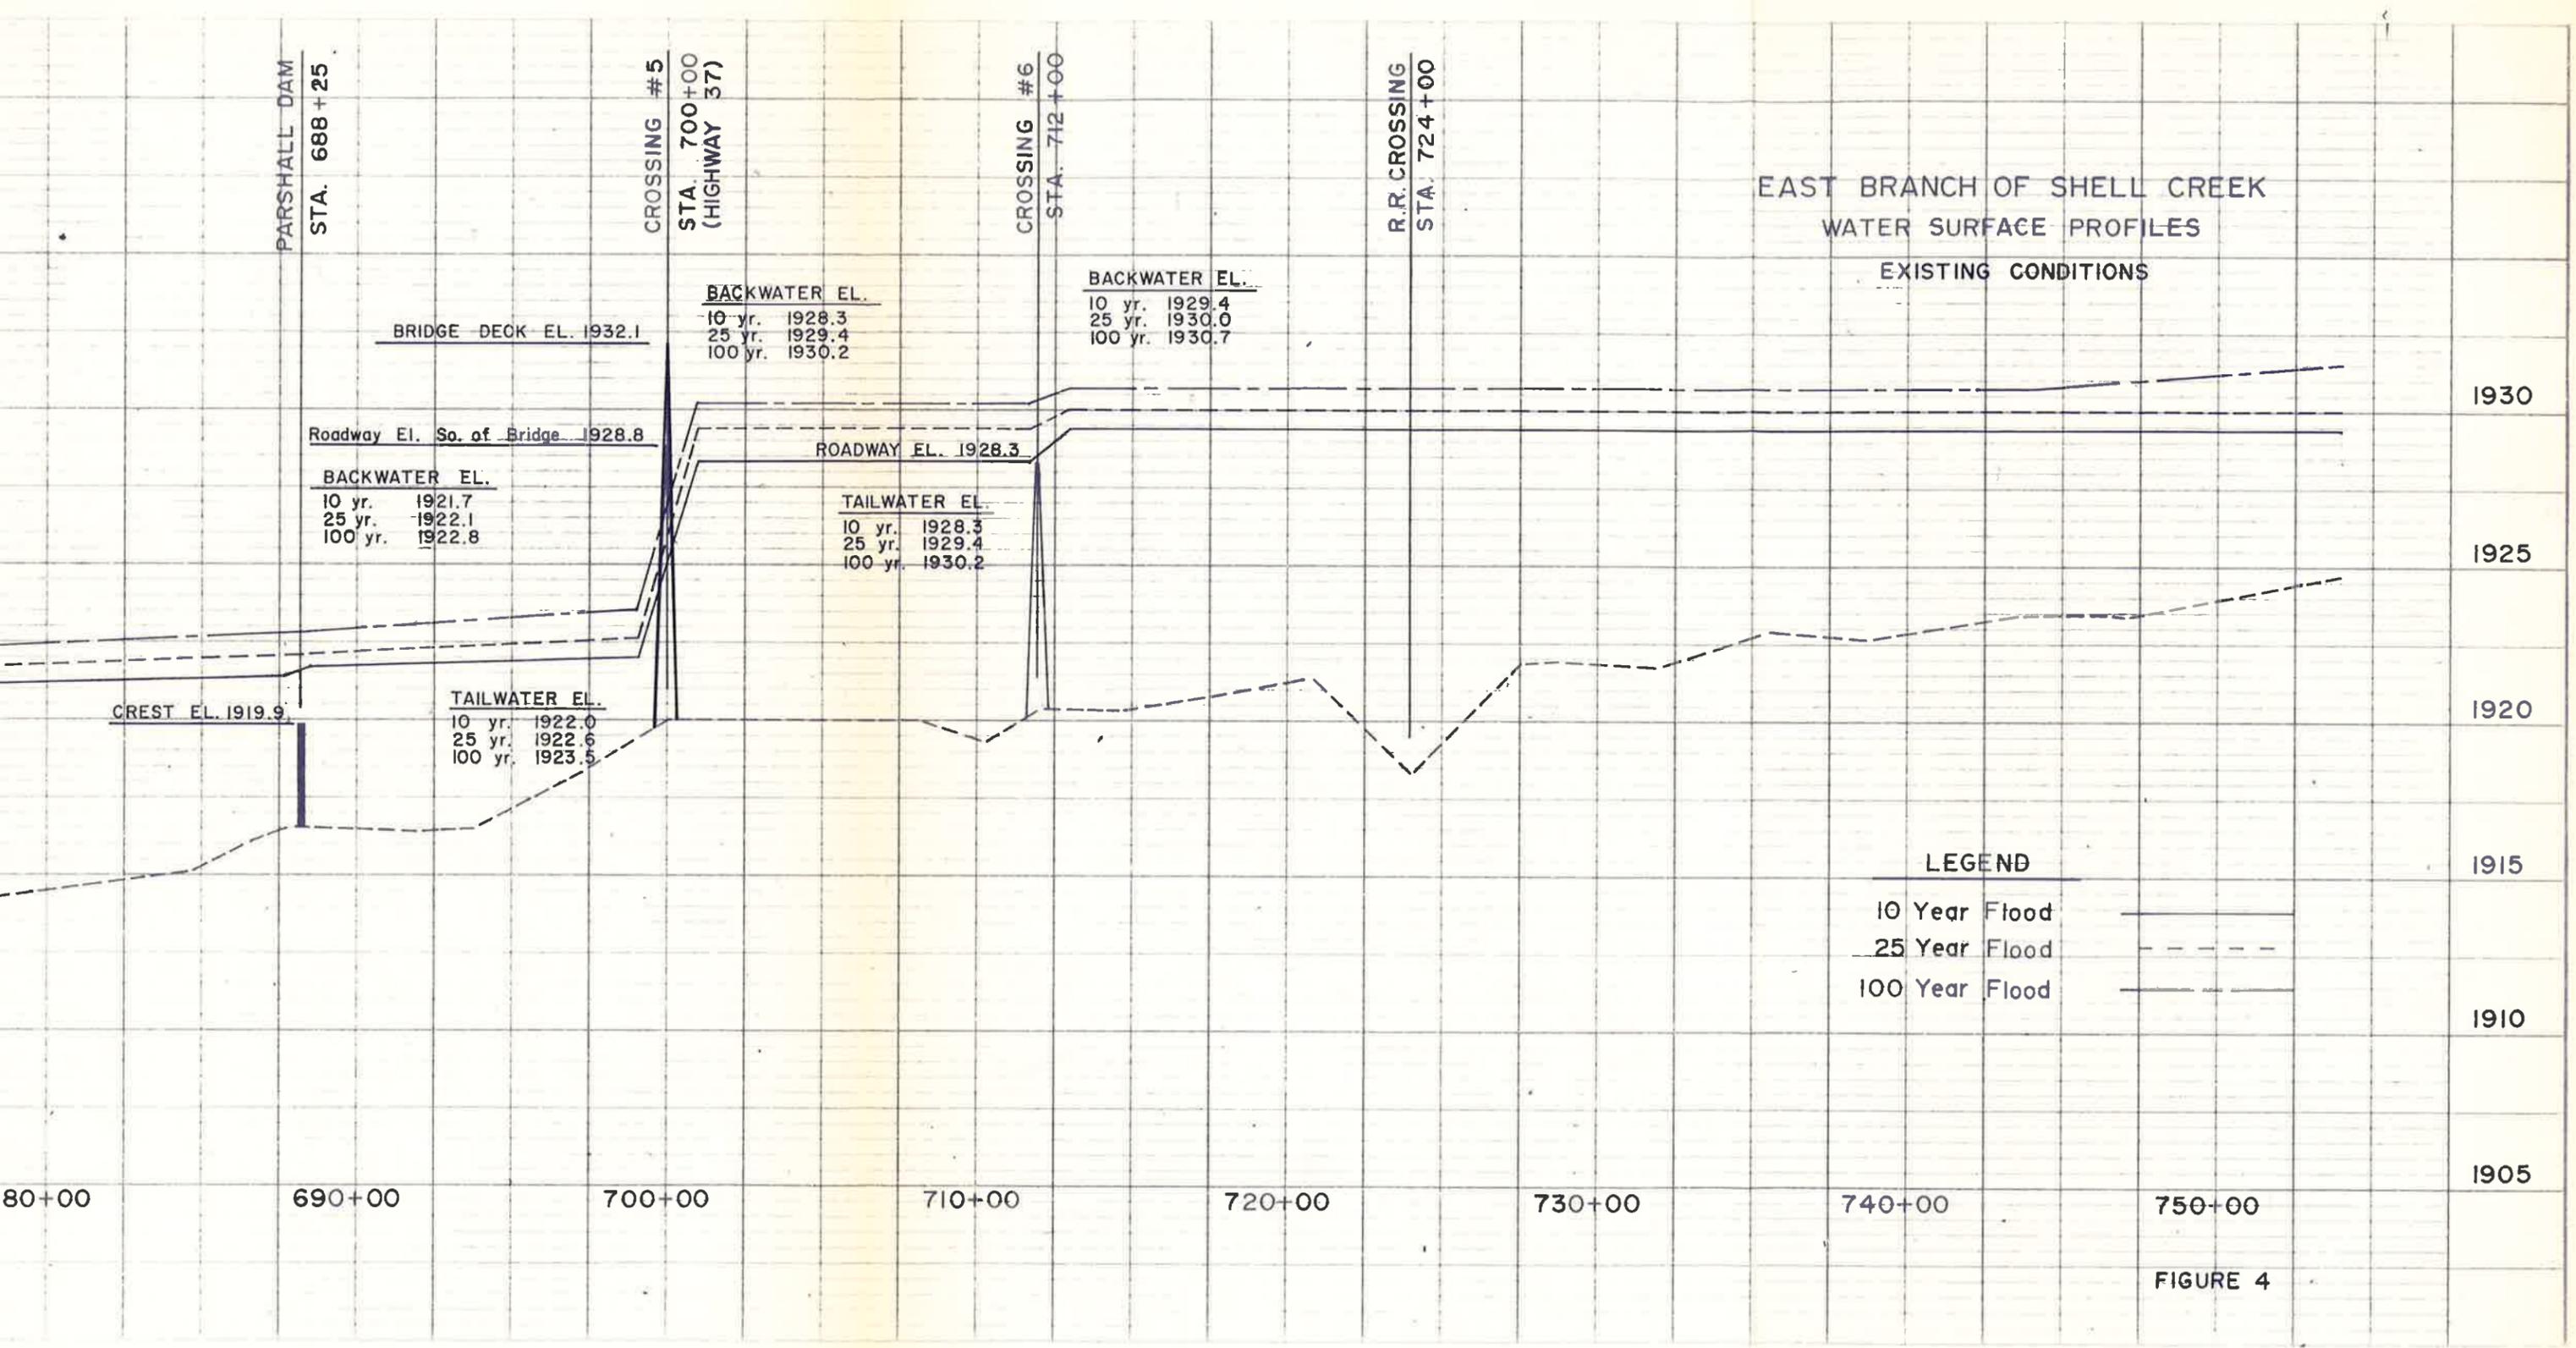
FIGURE 4

In order to evaluate the existing conditions of the East Branch of Shell Creek, as well as the conditions after making certain improvements, water surface elevations at various cross sections and crossings were calculated. These are shown on Figure 4. This process started by choosing a cross section just downstream from crossing number two, the first one on the downstream end of the study area. Since there are no crossings a short distance downstream from here to back up flows, calculating the water level needed to pass various flows through the cross section resulted in a tailwater elevation for crossing number two. Using pipe flow equations, the amount of flow through the culverts was calculated.

From this series of calculations the tailwater and backwater elevations were found for all the roadway crossings in the study area. These were plotted on a drawing of the streambed profile (see Figure 4). This drawing shows how high the water will back up behind the various crossings and how much water, if any, will flow over the road.

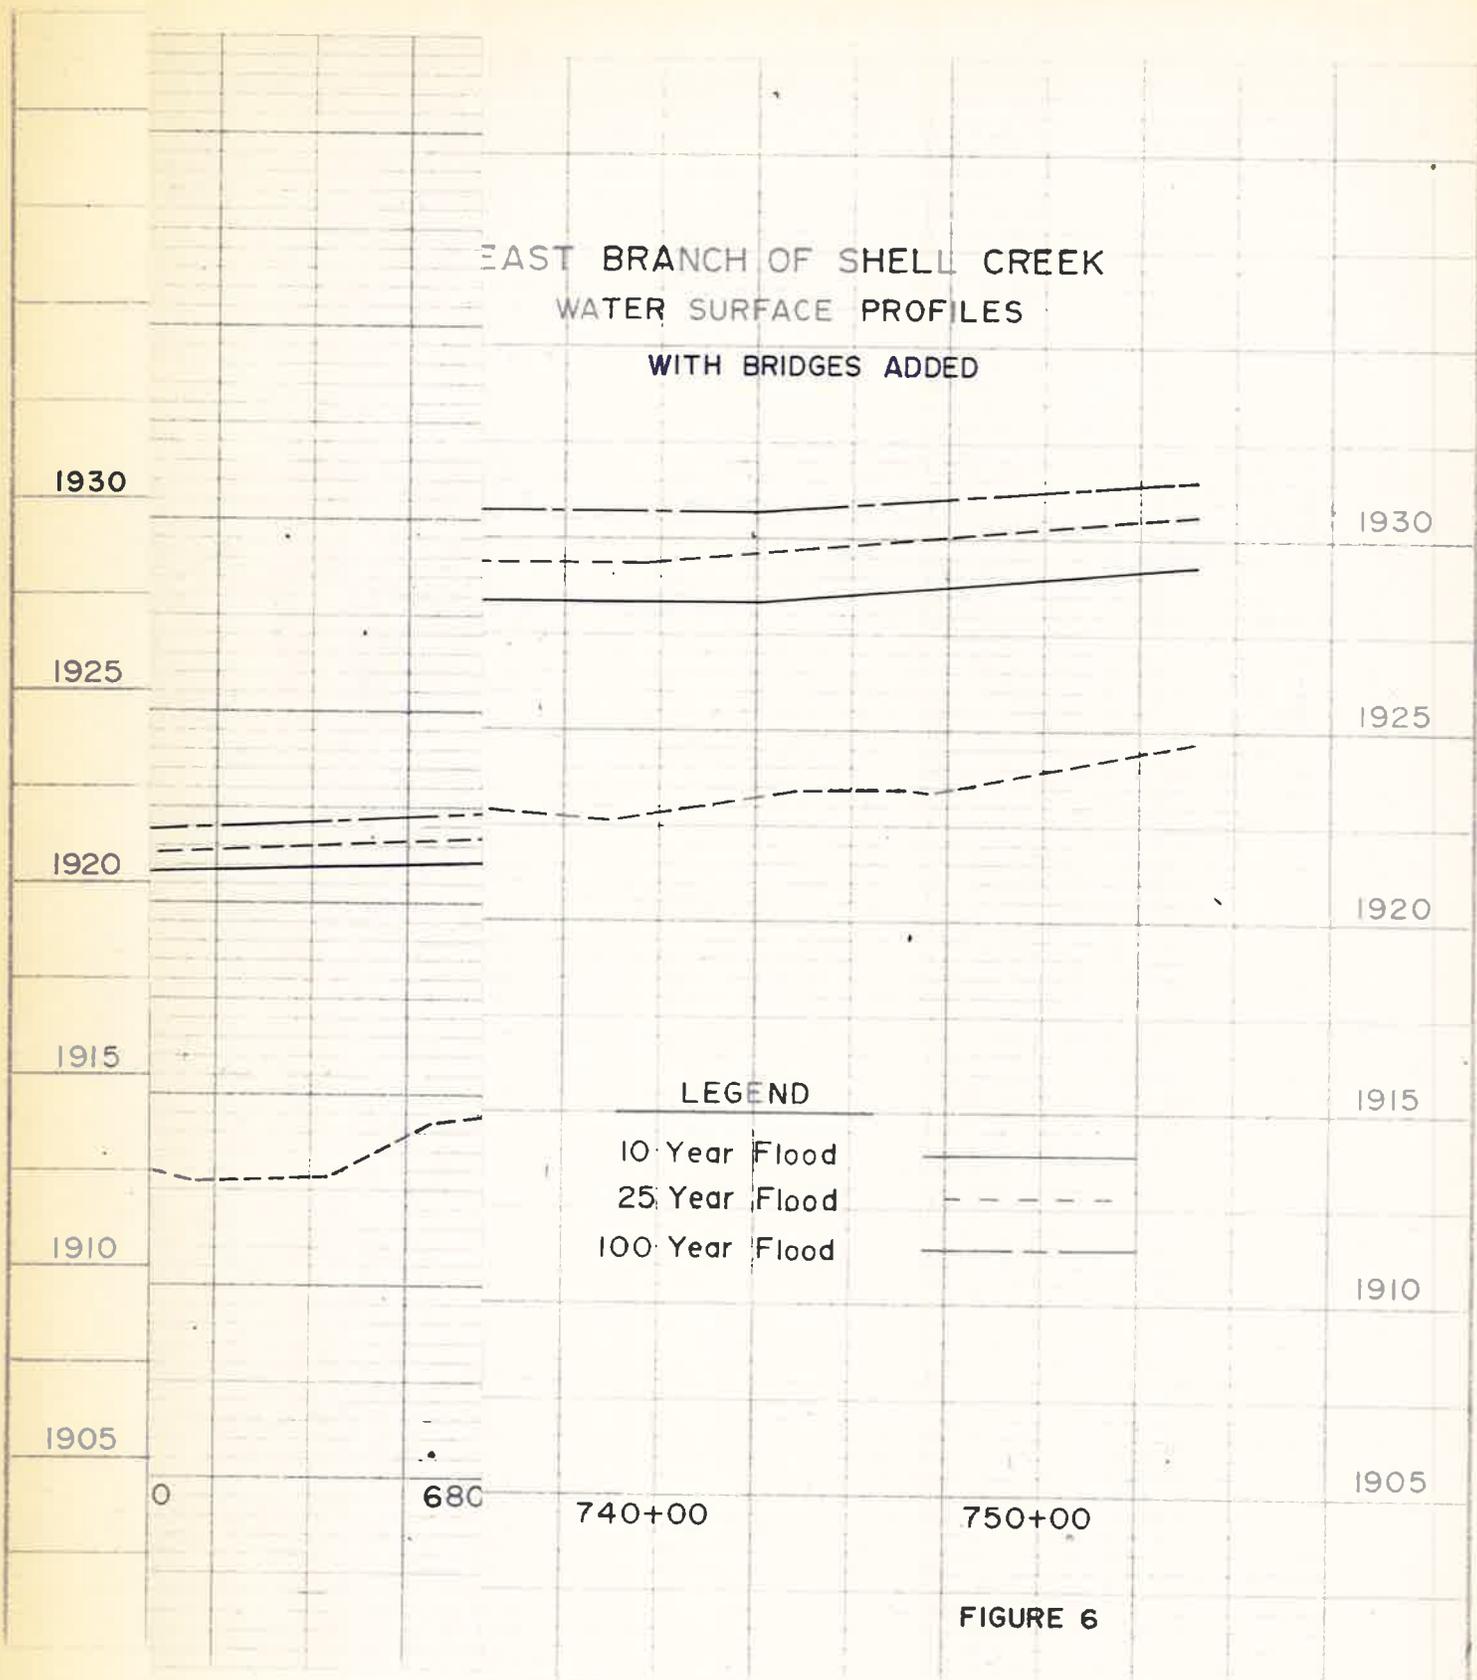
FIGURE 6

The drainage area above the study area is about 140 square miles. This is large enough to require bridges on all the crossings. The alternate proposes that bridges be built on crossings two, three, and six. They are designed to handle a twenty-five year flood. Figure 6 shows the water surface profiles that can be expected with the added bridges. These bridges will reduce the water levels needed to pass the twenty-five year flood. A comparison of the tailwater and backwater elevations for the existing and improved conditions is shown in Table 7.

EAST BRANCH OF SHELL CREEK  
 WATER SURFACE PROFILES  
 WITH BRIDGES ADDED

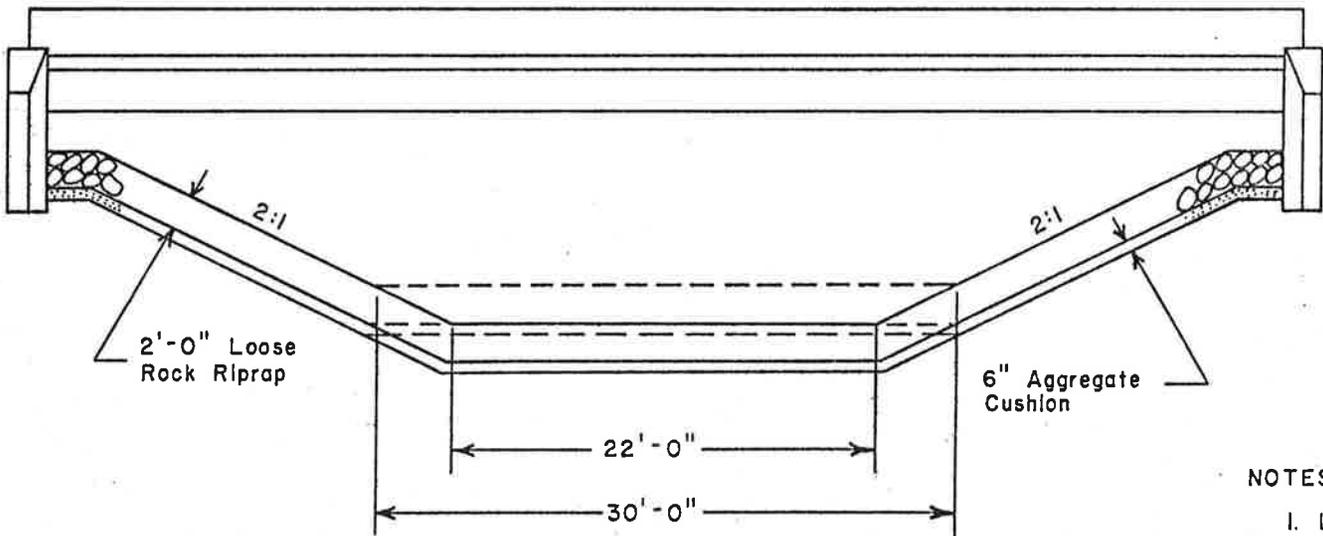
FIGURE 7

develop. The existing bridge was designed for open channel flow which depends on stream gradient to provide energy for flow. This bridge is 65 feet long and has a trapezoidal flow area with a bottom width of 30 feet (see Figure 7).

If the bottom of the channel below the bridge is lowered by two feet (see Figure 7), the backwater elevations can be reduced as shown in Table 9.

EAST BRANCH OF SHELL CREEK  
CHANNEL LOWERING AT CROSSING #5

- NOTES:
- 1. LOWER CHANNEL FROM EL. 1920.0 TO EL. 1918.0.
  - 2. REMOVE & REPLACE ROCK RIPRAP.
  - 3. EXISTING CHANNEL - - -
  - 4. LOWERED CHANNEL - - -

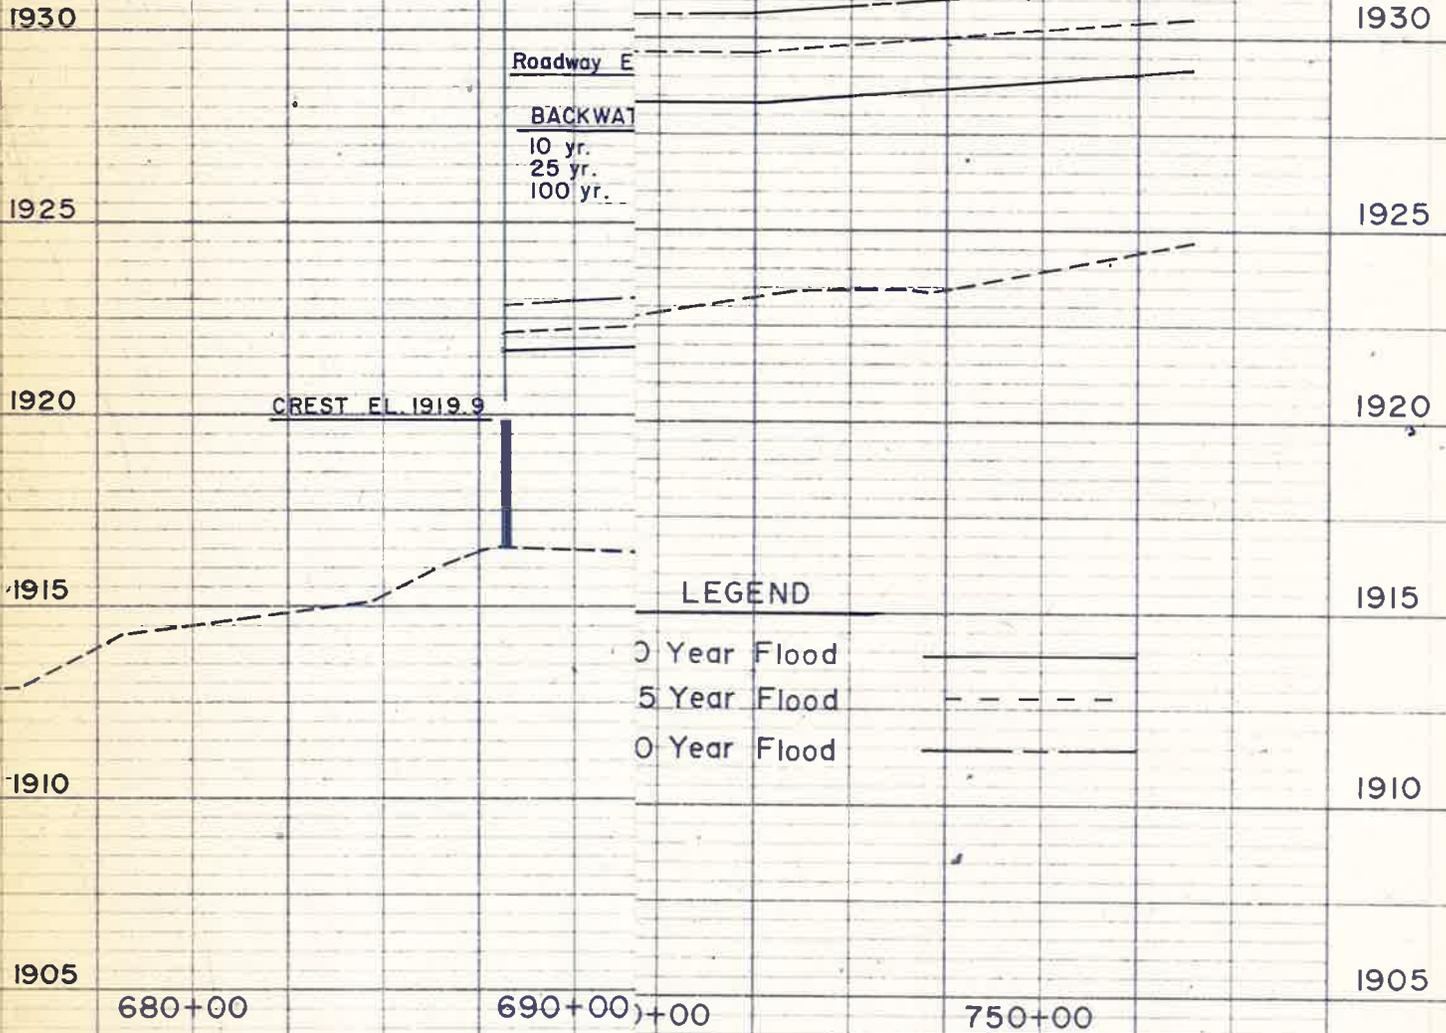
FIGURE 8

CROSSING #5 LOWERED  
WITH CULVERTS ADDED  
AT CROSSING #6

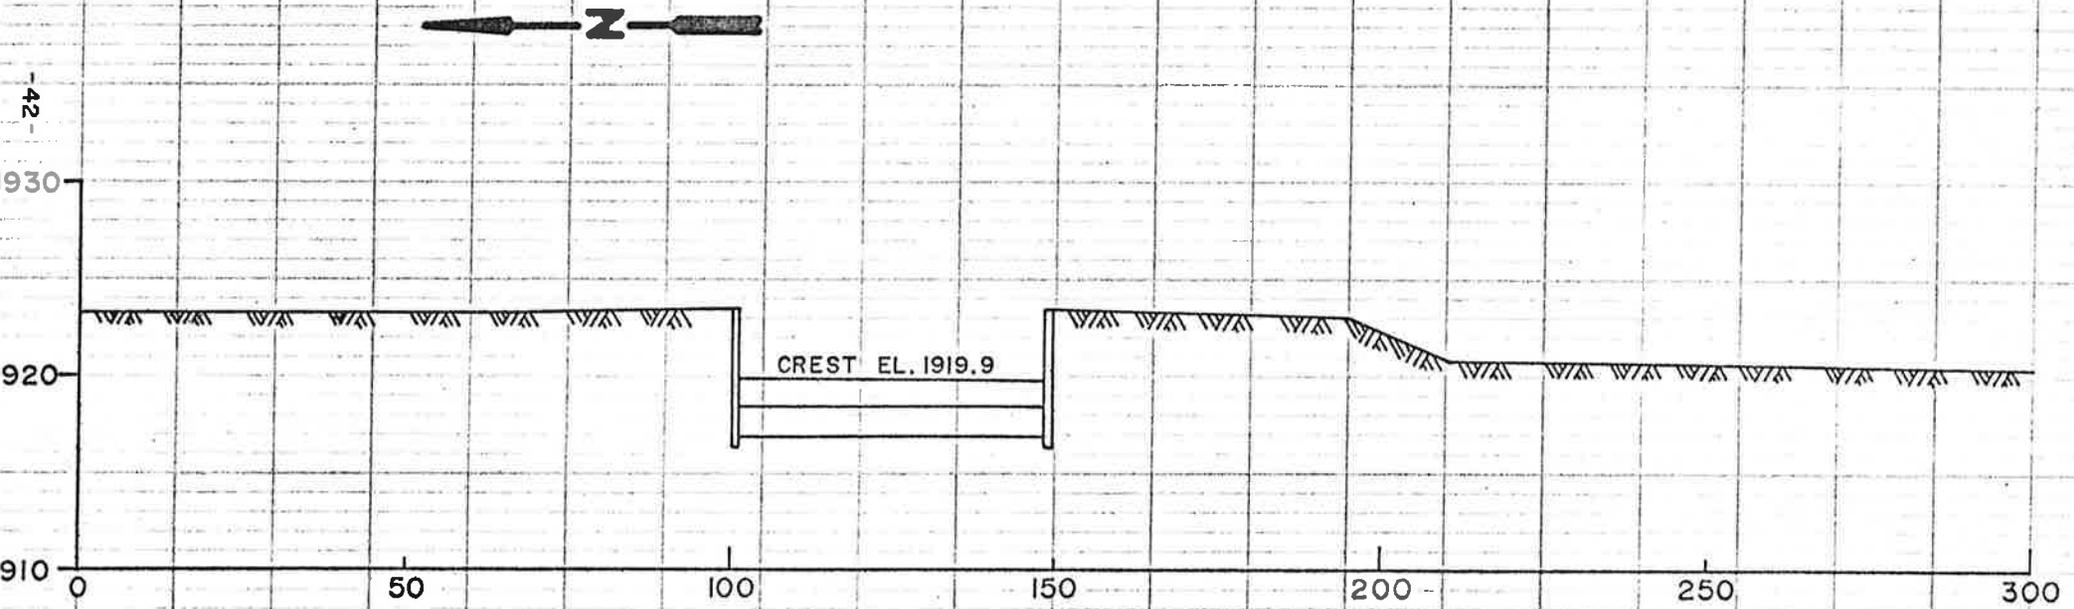
FIGURE 10

EAST BRANCH OF SHELL CREEK  
PARSHALL DAM PROFILE

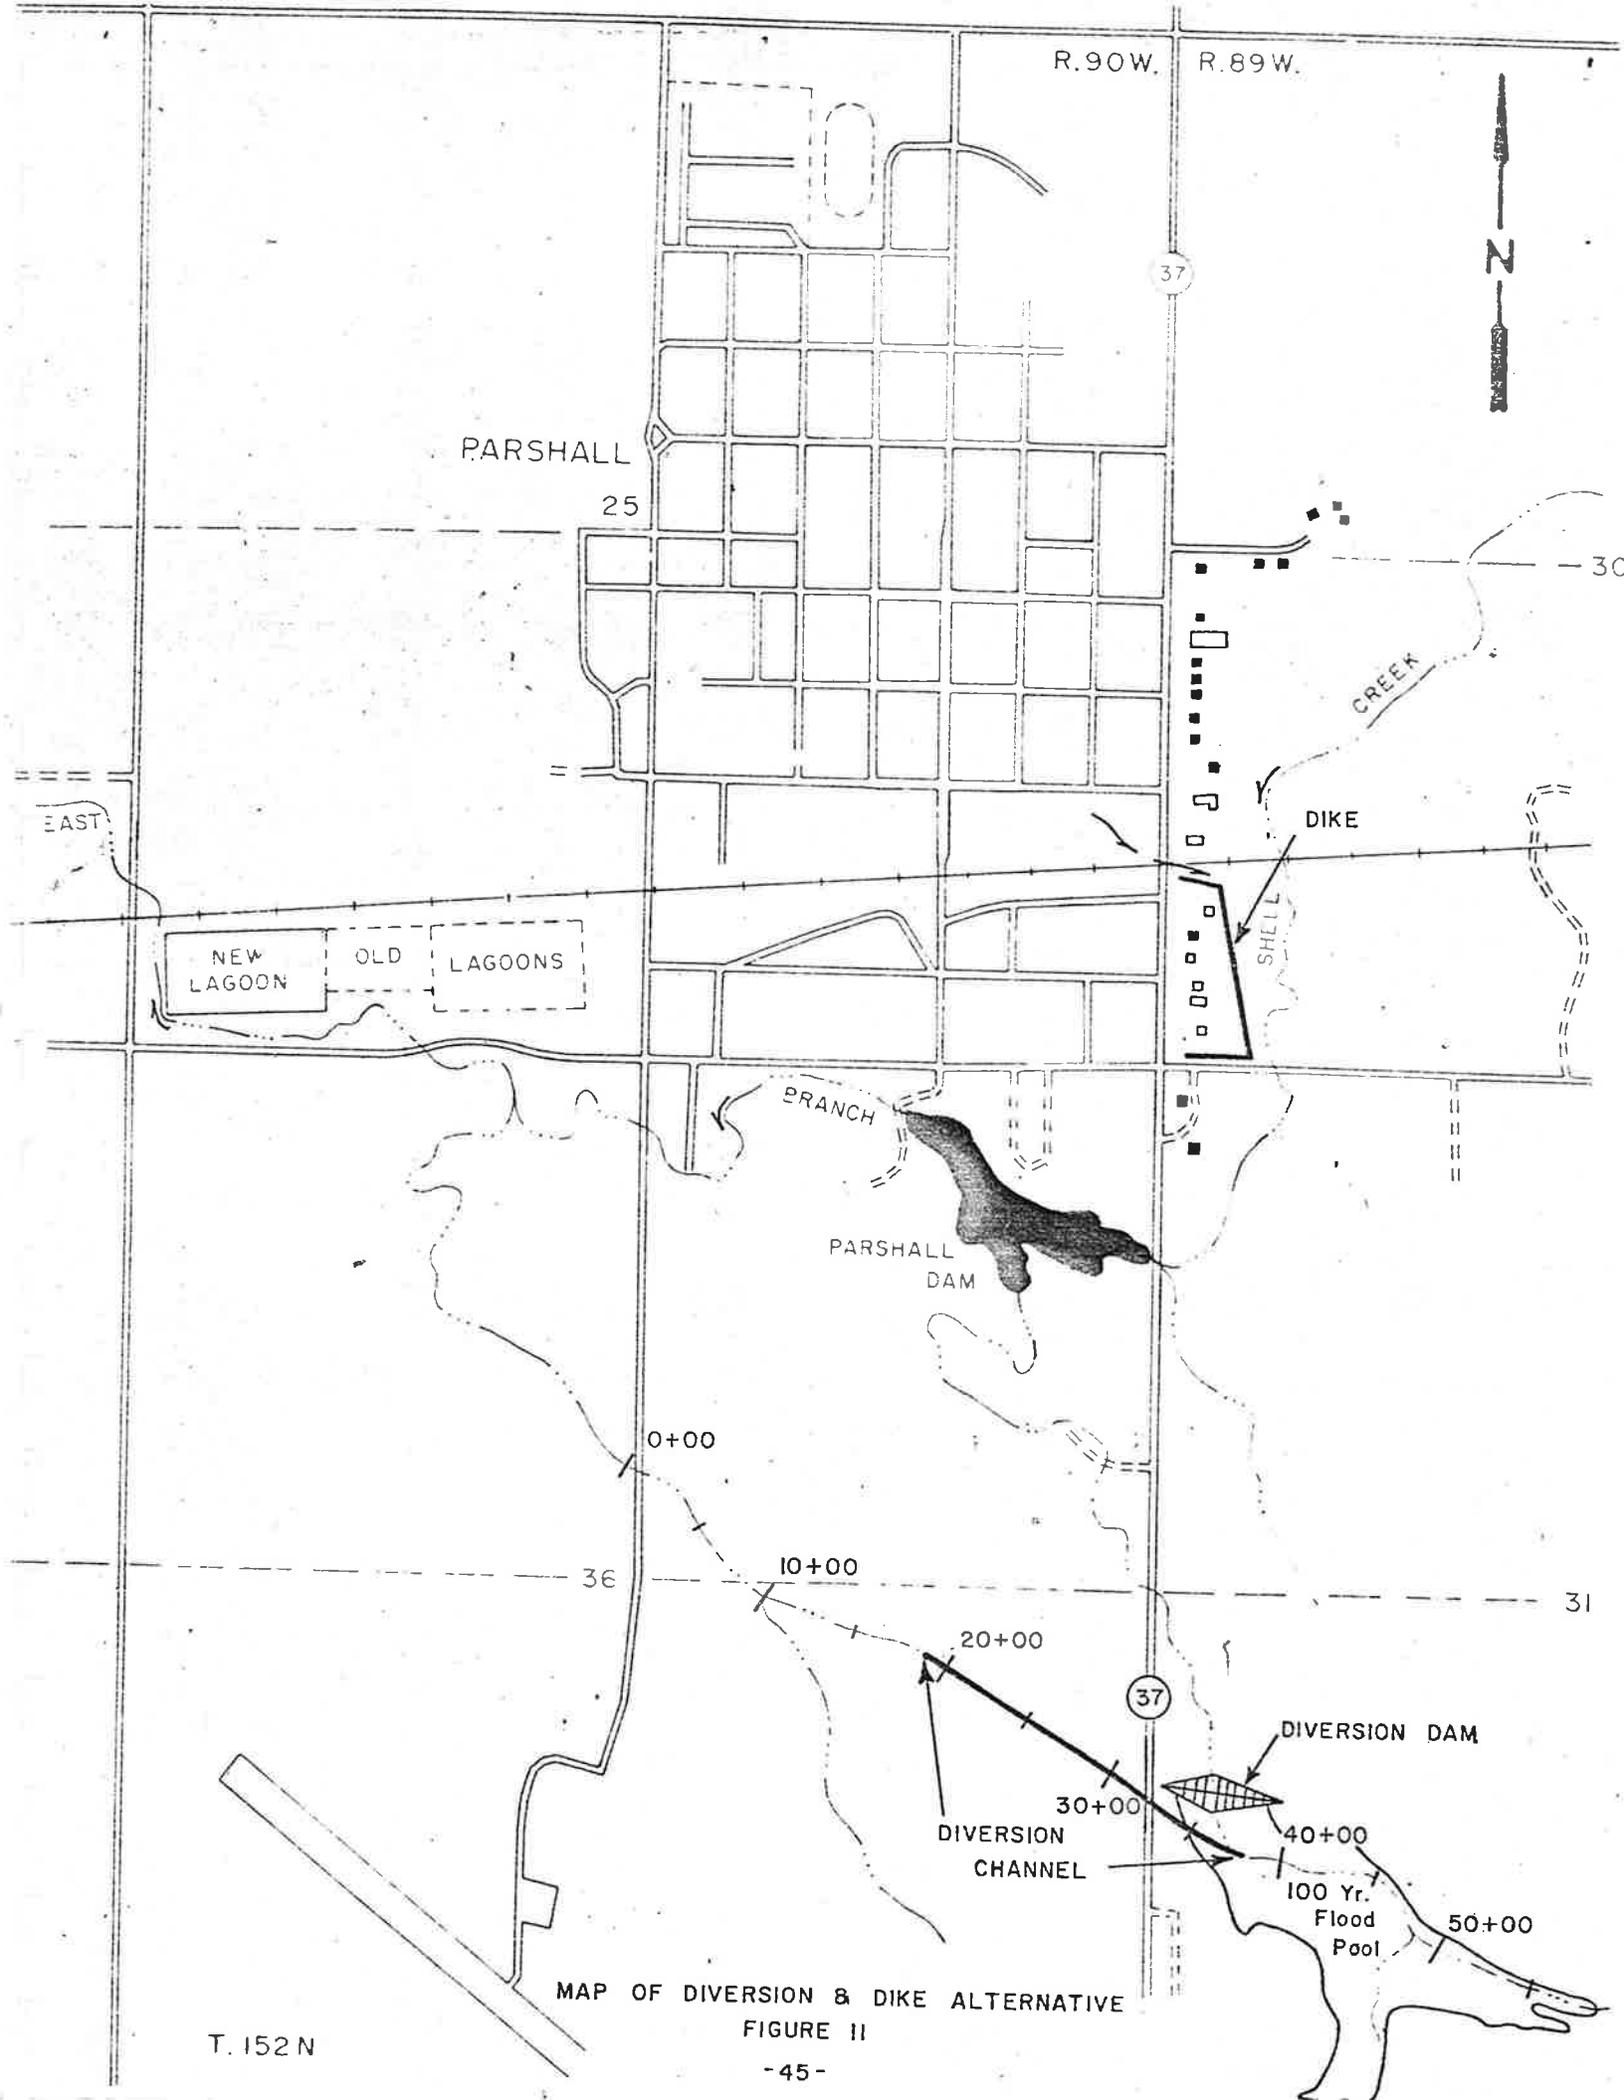
MAP OF DIVERSION & DIKE ALTERNATIVE  
FIGURE II

length of the tributary covering 35 acres. Figure 11 shows the area flooded by the 100 year event. Easements will have to be attained for the 35 acres below elevation 1950.0 that will be flooded. The cost of this alternate is about \$180,000 not including the cost of any easements or land acquisition for the dam and the channel.

Figure 11 is a map of the study area. North of the railroad tracks are two barns and a house that had water get close to them in 1979. On the north side of the road over crossing six, at its intersection with highway 37, is a complex of grain bins including a few larger buildings and quansets. This area was flooded in 1979. South of this road are two houses surrounded by some smaller buildings. The houses were above

Figure 11 shows the location of the proposed dikes. They will have a ten foot top width and 2 to 1 (horizontal to vertical) side slopes. There will be 1400 feet of dike south of the tracks. Since the top of the ridge above the floodplain is near elevation 1930, the dike will be about two feet above the existing high ground. At the grain bin location, the dike height will be about four feet. There is little room for the dike on top of the ridge. Therefore the landside edge of the dike top will be located at the edge of the ridge. From here the dike will extend out into the low area below the ridge. The two grain bins on the side of the ditch just south of the tracks will have to be moved.

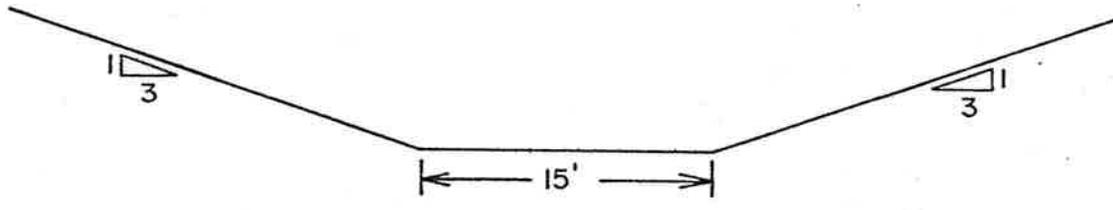
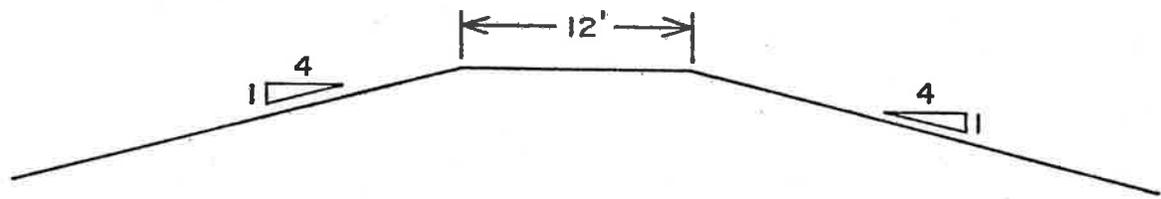
EAST BRANCH OF SHELL CREEK  
SOUTH TRIBUTARY DIVERSION

CHANNEL X-SEC.

DAM X-SEC.
