# PRELIMINARY ENGINEERING REPORT

## EAST BRANCH OF SHELL CREEK FLOOD CONTROL THROUGH PARSHALL

S.W.C. PROJECT NO. 1656

NORTH DAKOTA  
STATE WATER COMMISSION  
SEPTEMBER 1980

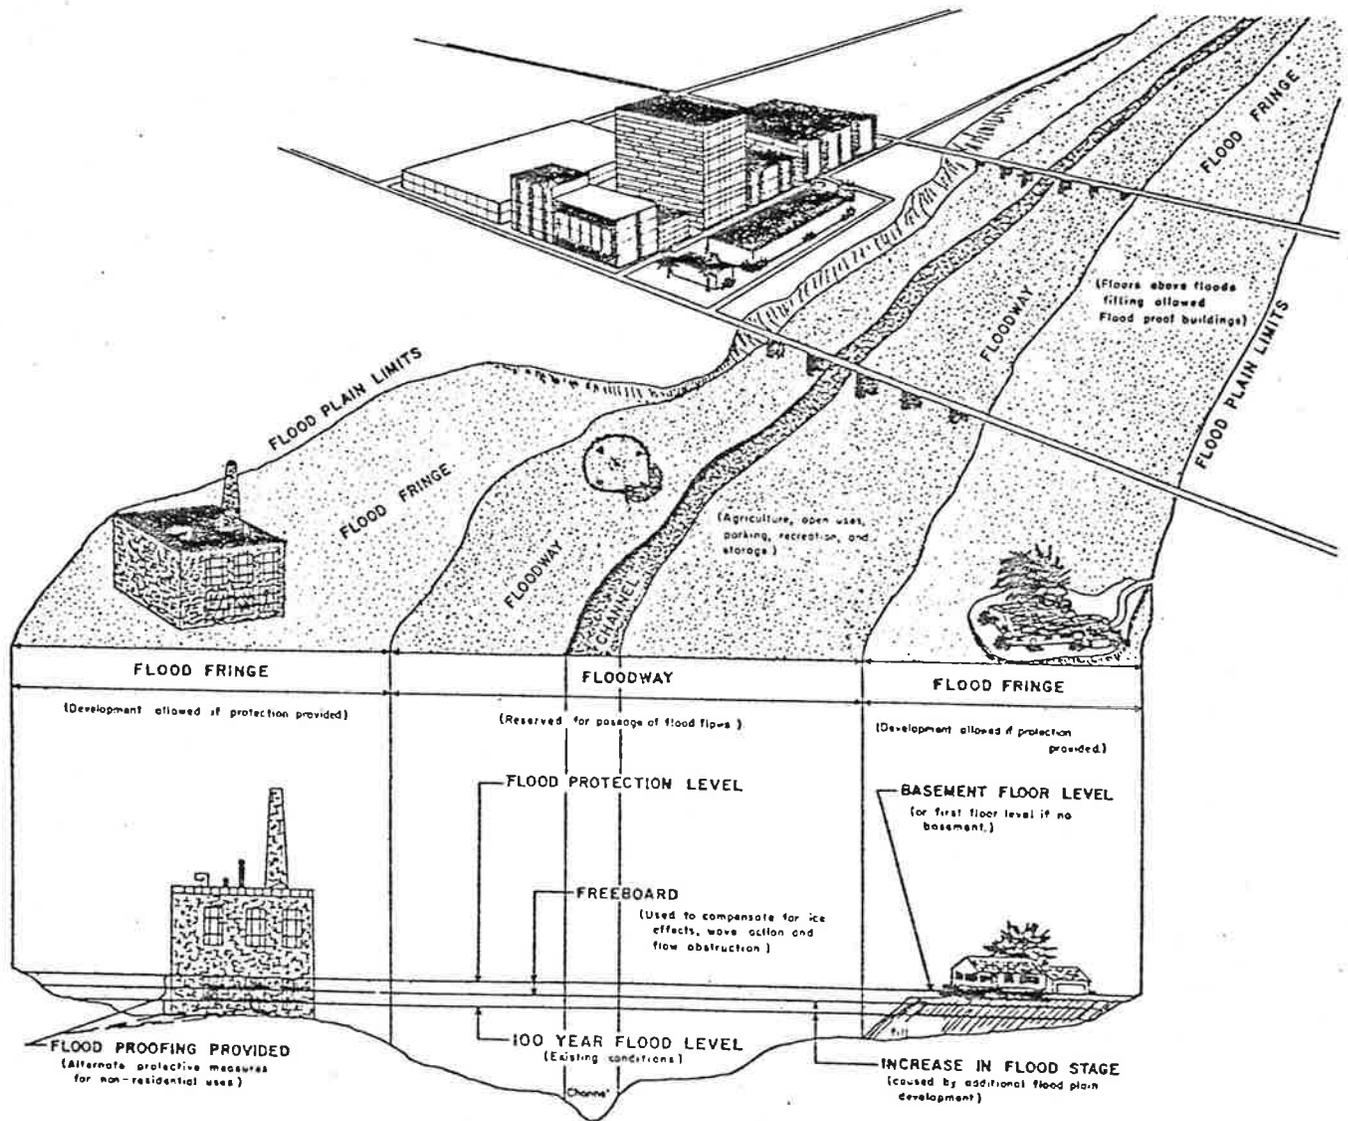
into a floodway and a floodway fringe (see Figure 14). The floodway is the channel of the stream, plus adjacent flood plain areas, that must be kept free of encroachment in order that the 100 year flood be carried without substantial increases in flood heights. Criteria adopted by the Division of Federal Insurance and Mitigation limit such increases in flood heights to 1.0 foot, provided that hazardous velocities are not produced.

The area between the floodway and the boundary of the 100 year flood is termed the floodway fringe. The floodway fringe thus encompasses the portion of the flood plain that could be completely obstructed without increasing the water-surface elevation of the 100 year flood more than 1.0 foot at any point. Typical relationships between the floodway and floodway fringe and their significance to flood plain development are shown in Figure 14.

FIGURE 14 Perspective and cross sectional view of the structure of a typical regulatory flood plain.
