PRELIMINARY ENGINEERING REPORT

SUNDOWN ACRES

S.W.C. PROJECT NO. 576-27

BURLEIGH COUNTY

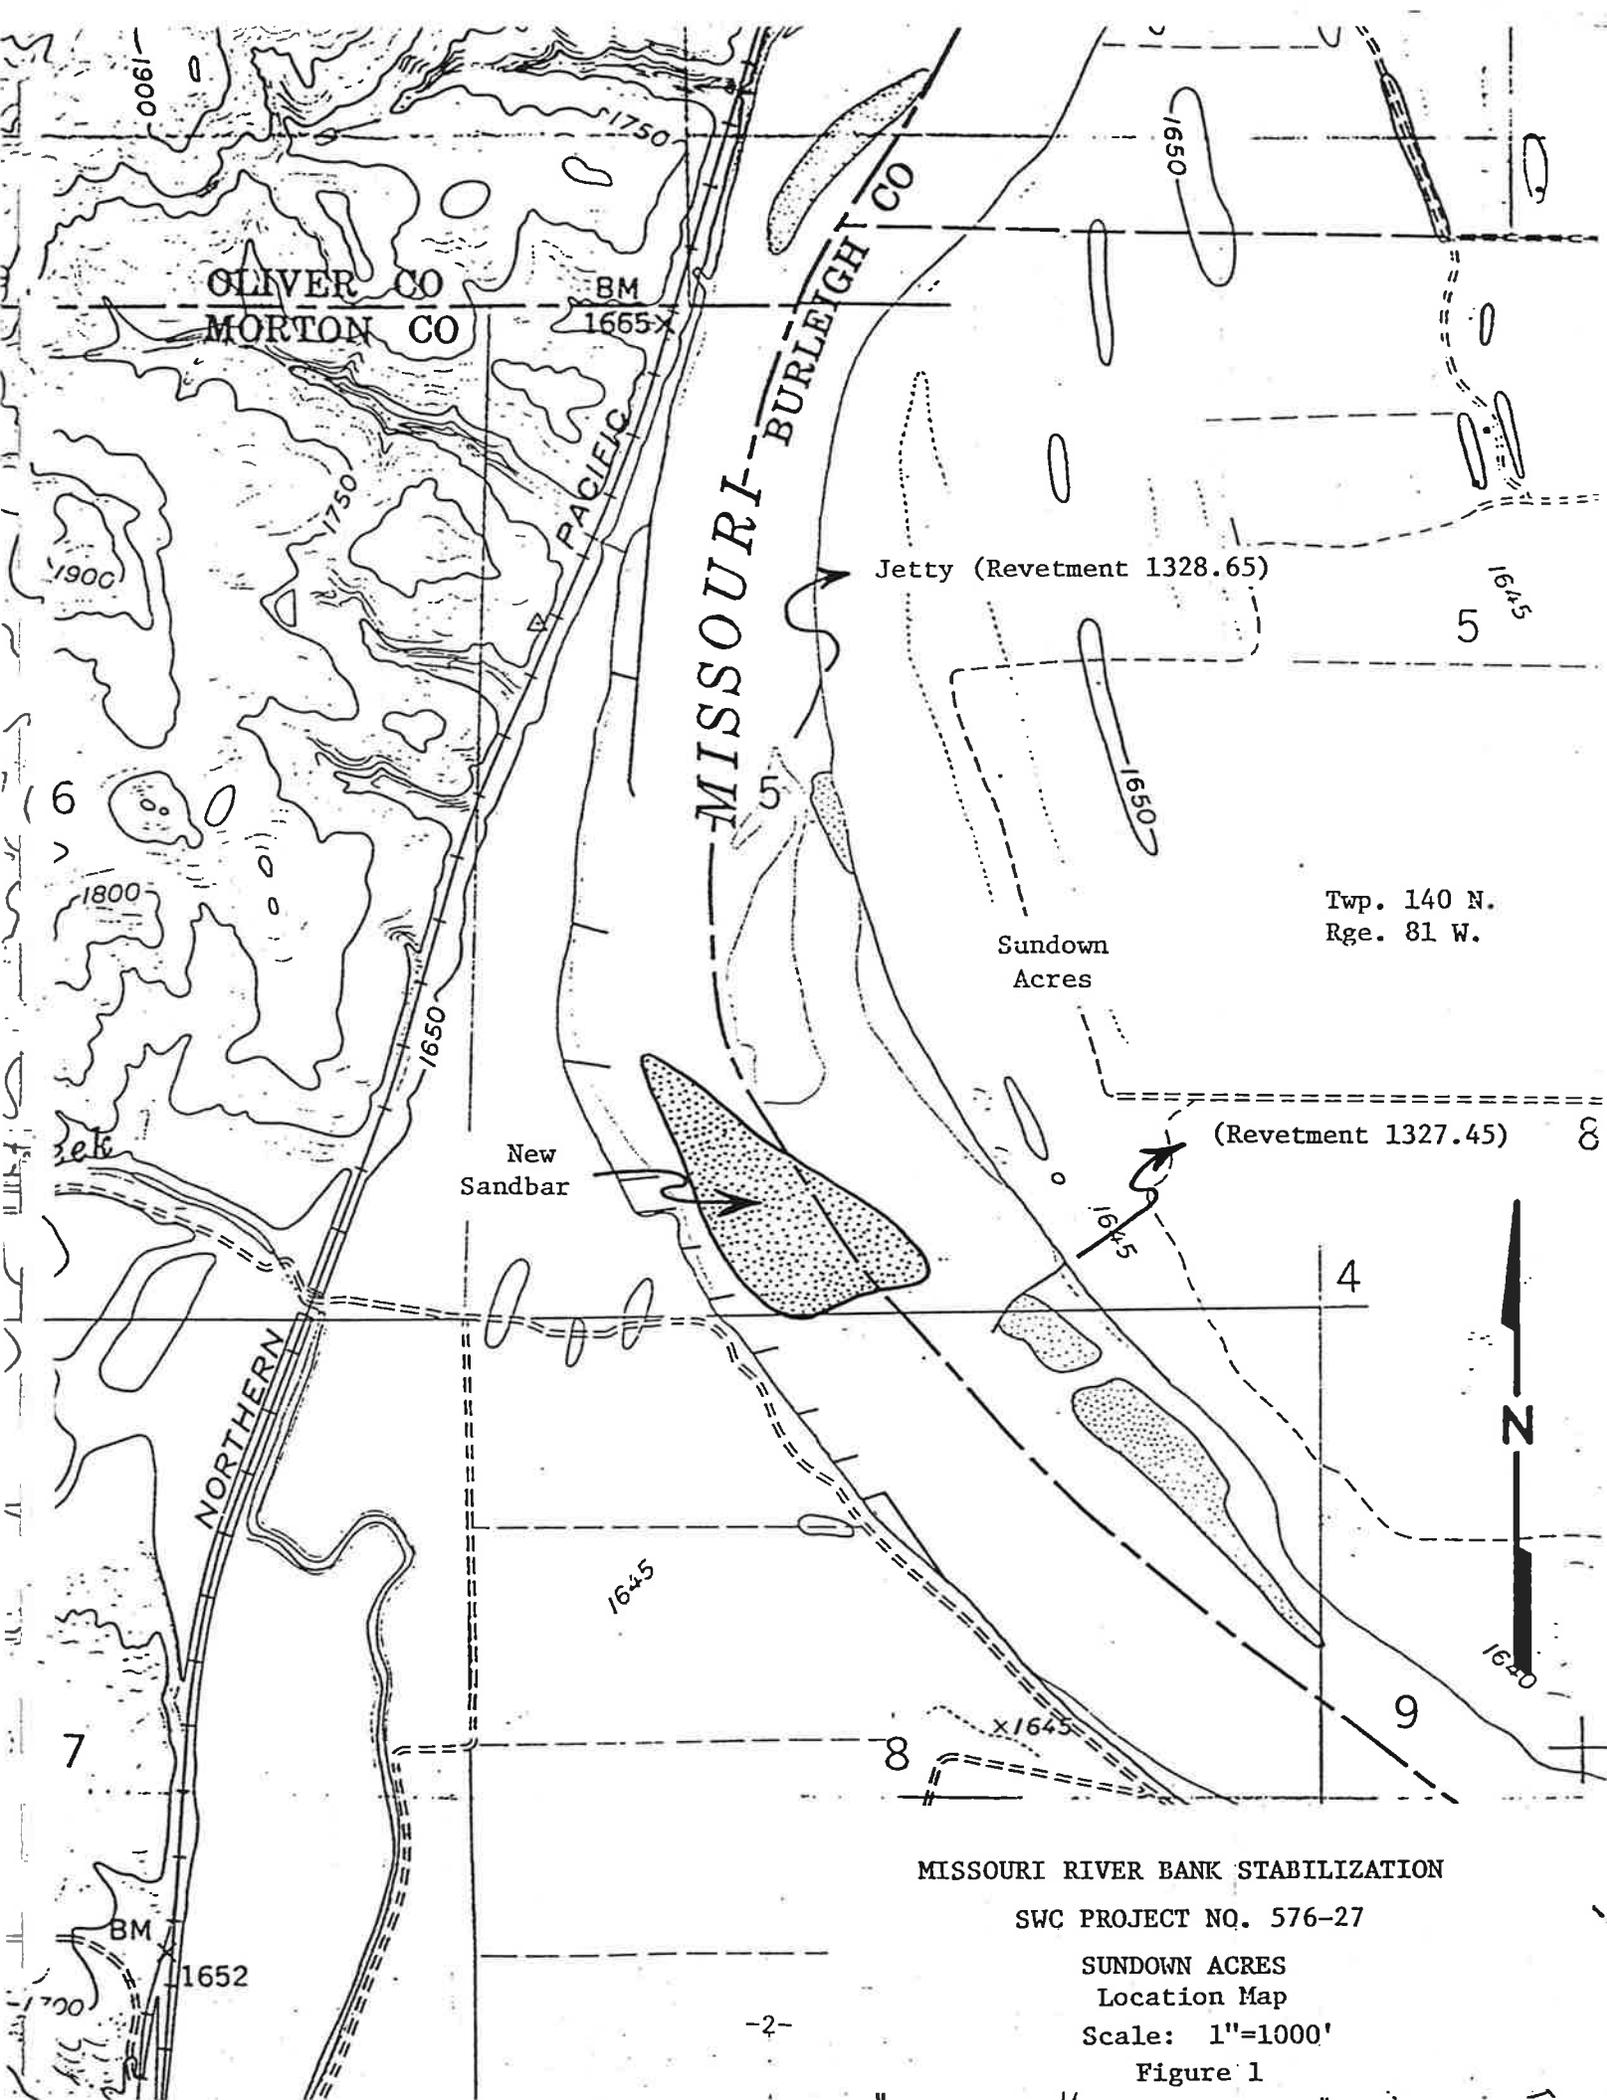
Figure 1

Jetty (Revetment 1328.65)

Sundown Acres

New Sandbar

(Revetment 1327.45)

Location Map

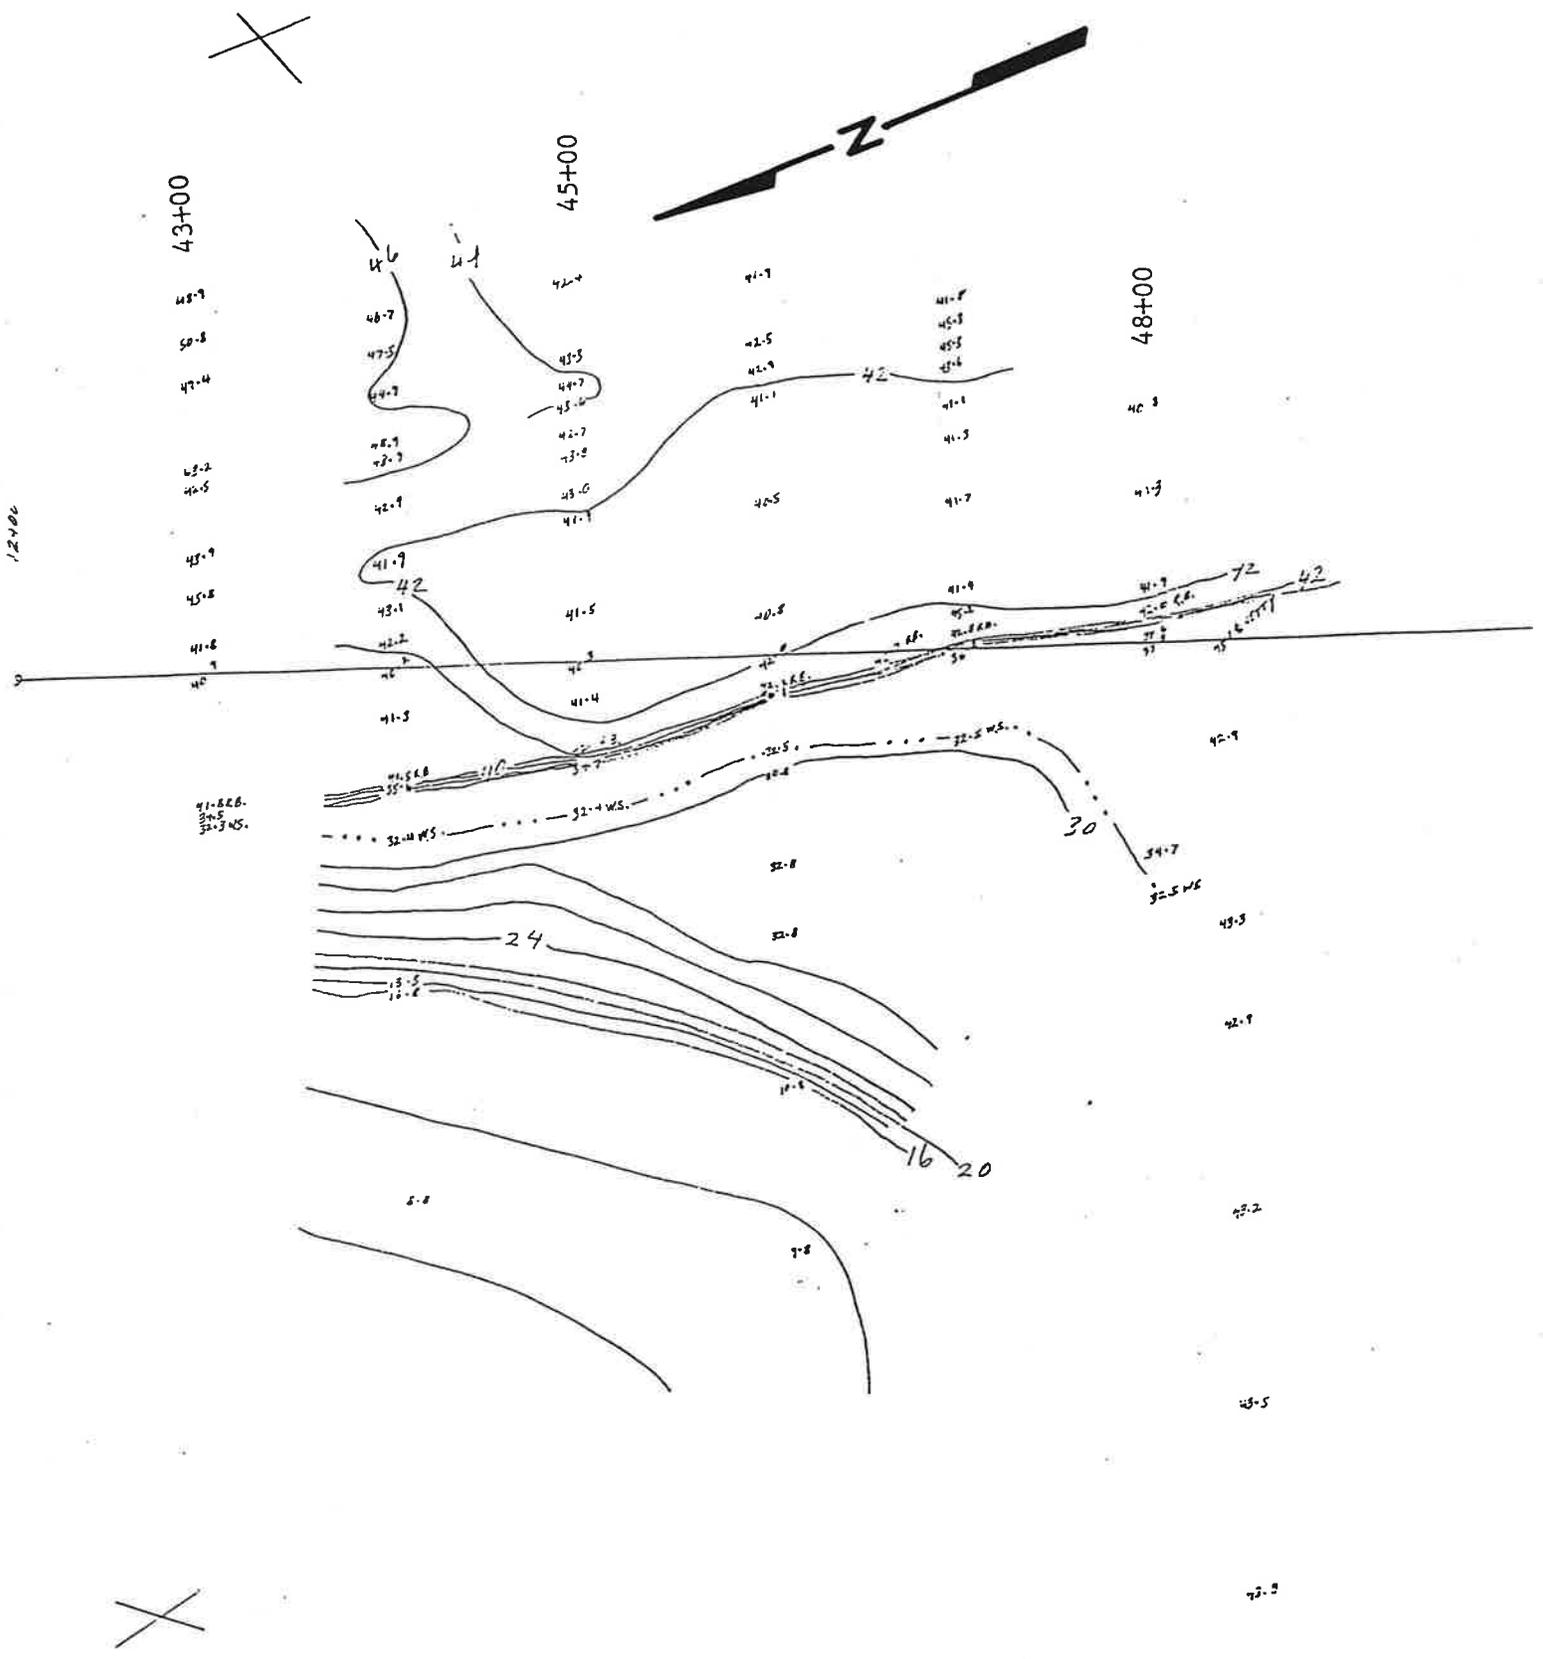
MISSOURI RIVER BANK STABILIZATION
 SWC PROJECT NO. 576-27
 SUNDOWN ACRES
 Topography Map
 Stations 43+00 to 48+00
 Sec. 5, T.14N., R.81W.
 Prefix Elevation 1600 msl
 Contour Interval - 2 feet
 7-3-86 Scale: 1"=100'

The project is located approximately nine miles north of Bismarck in Section 5, Township 140 North, Range 81 West, in Burleigh County. The project is along the left river bank at approximate Missouri River mile 1328. The project boundaries include the area between revetment 1328.65 and revetment 1327.45. A topographic map of the project area is shown in Figures 2, 3,

water elevation of 1635 msl. Figures 2, 3, and 4, show the deep depressions immediately off the banks. As the river flows approach the bank, the flows fall into the depression creating a circular motion which further increases the potential for erosion.

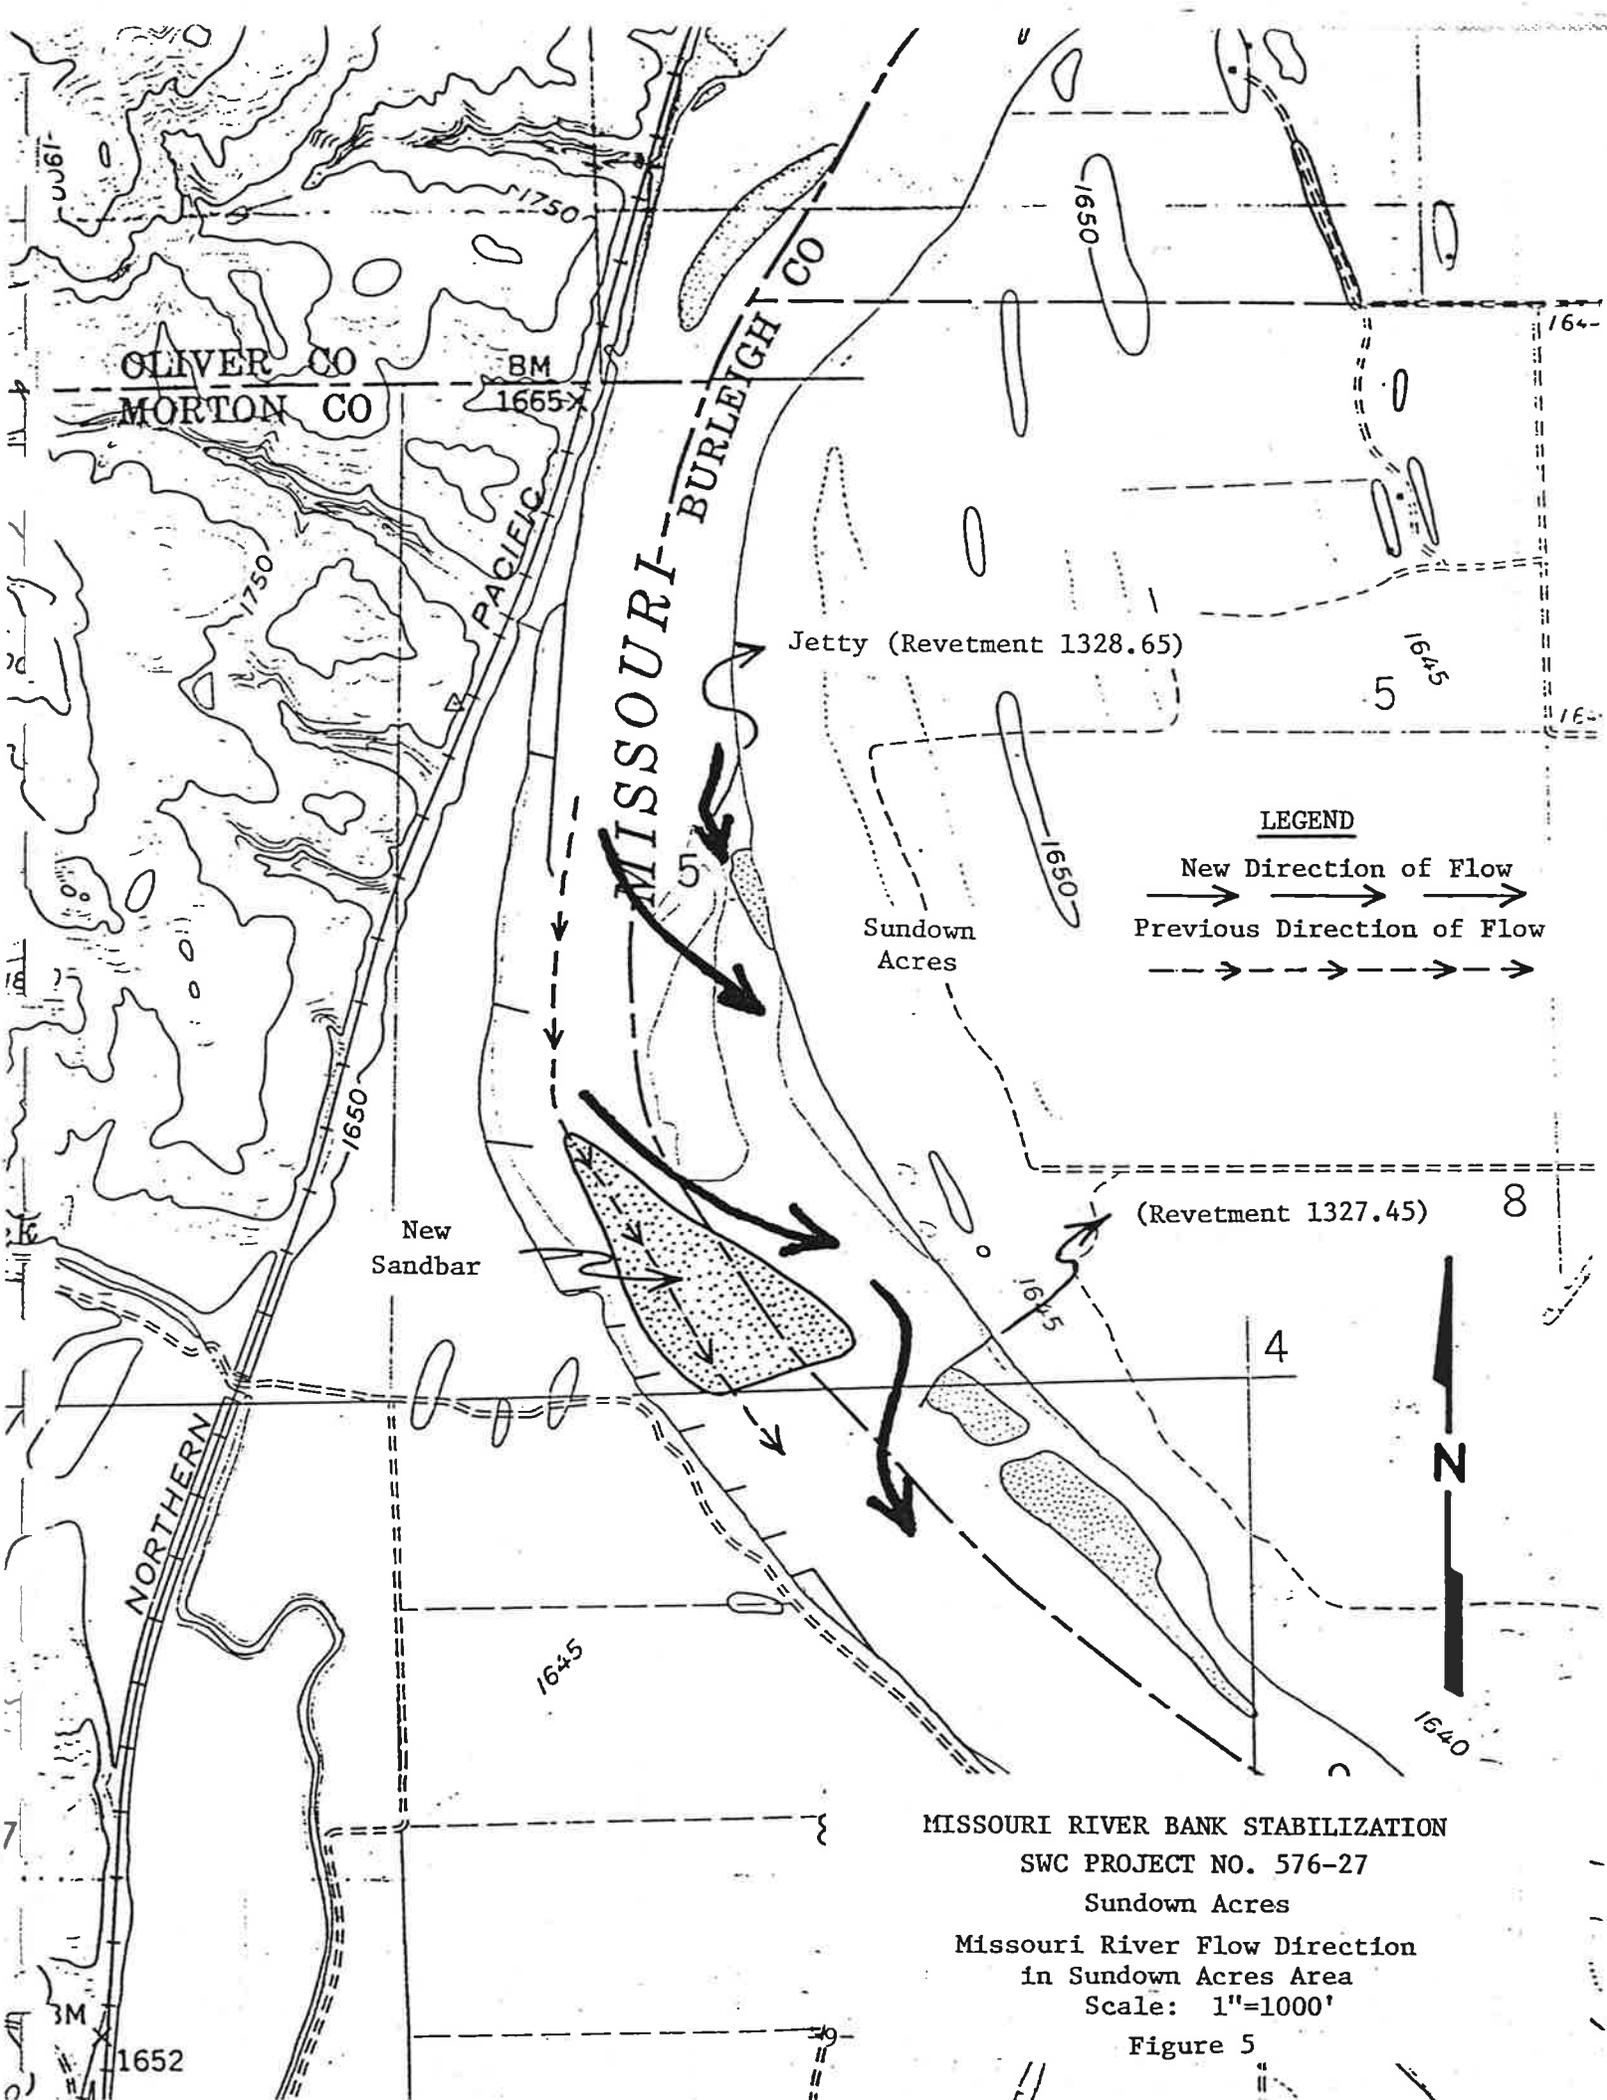
Figure 5

Missouri River Flow Direction
 in Sundown Acres Area
 Scale: 1"=1000'

Aerial photographs indicate the flow direction of the river has changed largely due to the formation of a large new sandbar located on the west side of the river. The full force of the river now flows directly toward the project areas banks as shown in Figure 5.

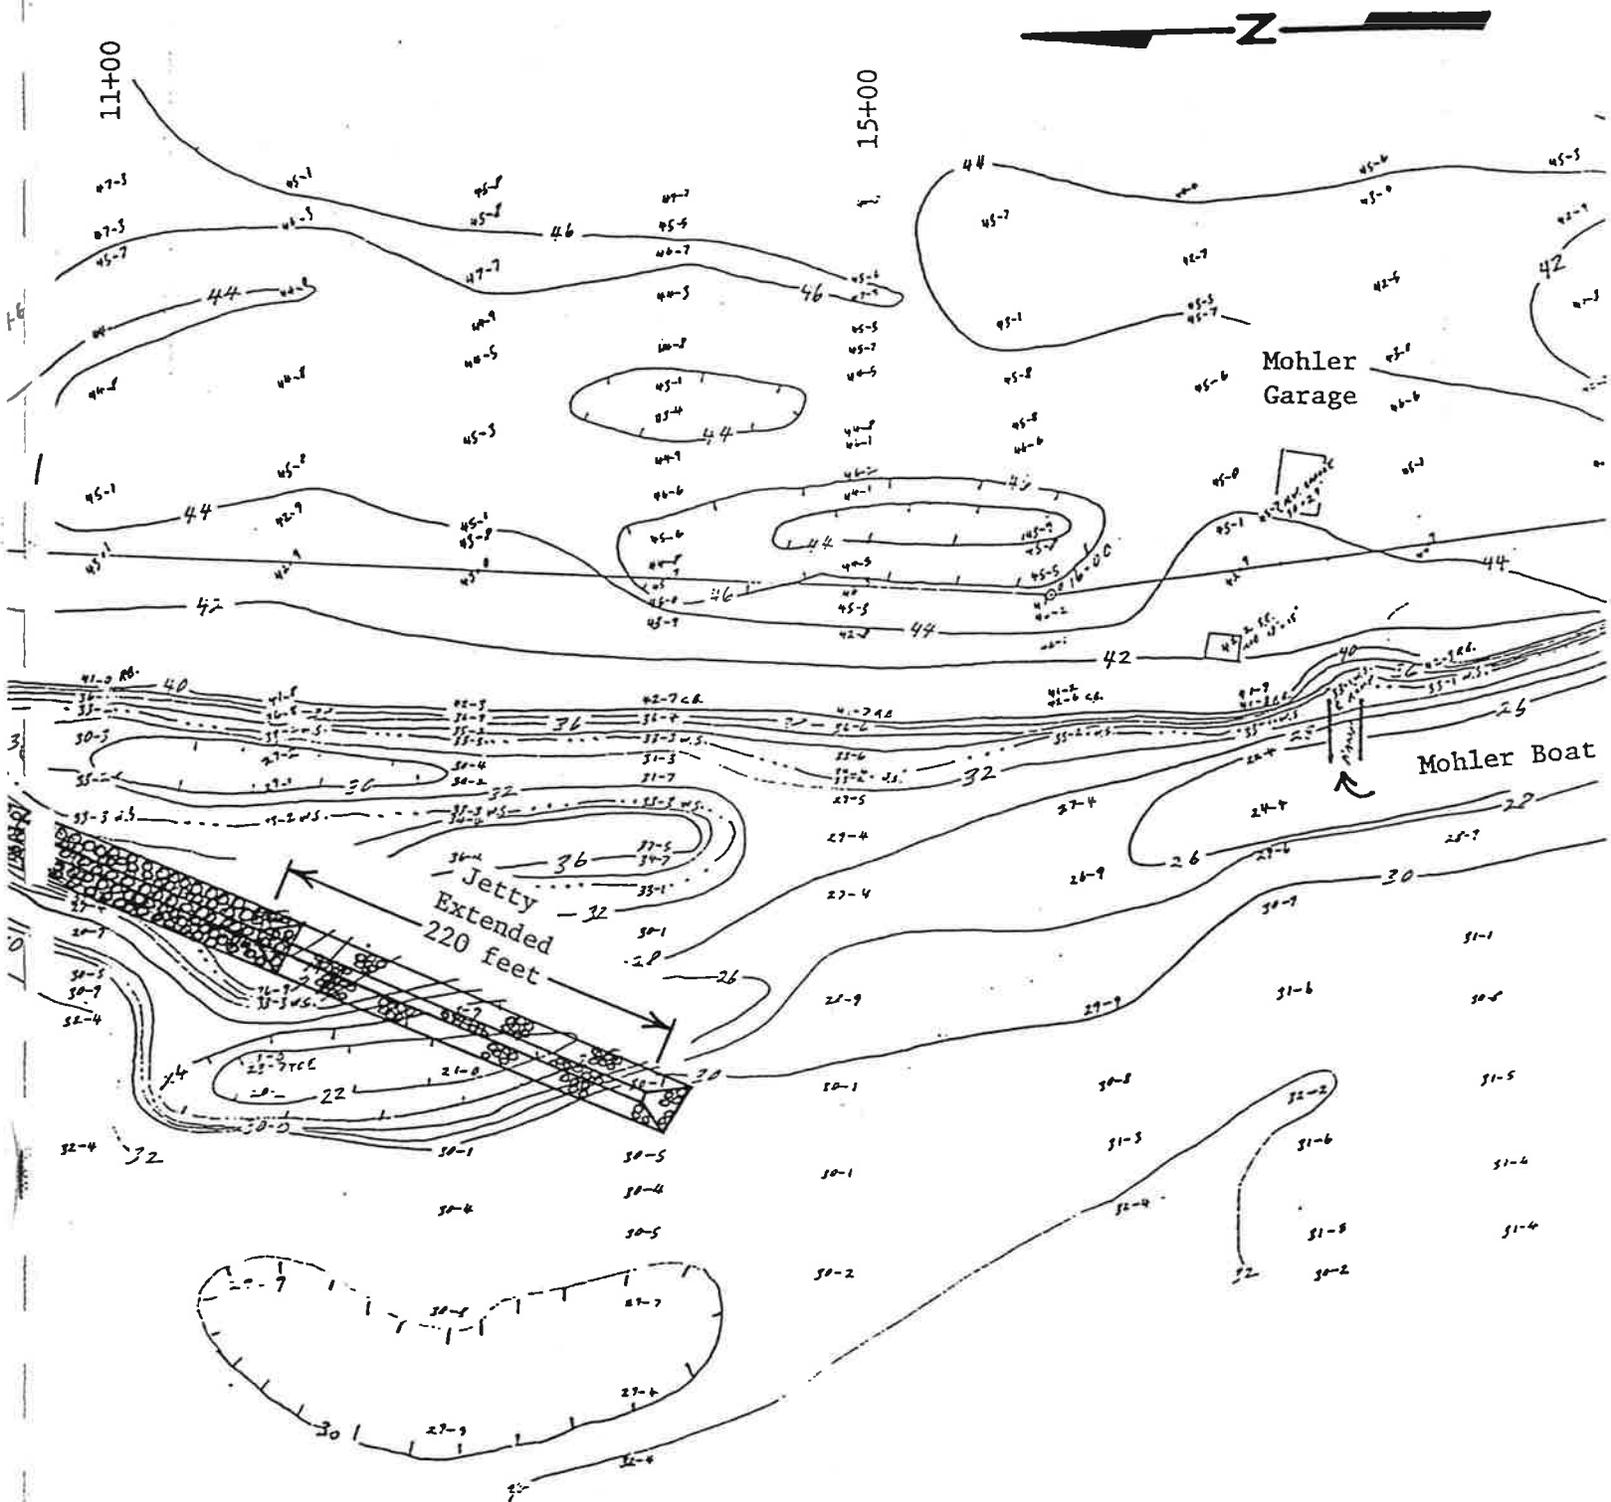
MISSOURI RIVER BANK STABILIZATION
 SWC PROJECT NO. 576-27
 SUNDOWN ACRES
 Alternative #2-Jetty Extension
 Prefix Elevation 1600 msl
 Contour Interval - 2 feet
 Sec. 5, T.140N., R.81W.
 Scale 1"=100'

This alternative considers the extension of the existing jetty through the depressional area and tying it into a sandbar at elevation 1630 msl, as shown in Figure 6. To tie-in with the high area, the existing jetty would need to be extended 220 feet. This would effectively block the flow through the depressional area, thereby protecting additional bank line. The extended portion of the jetty would be constructed to elevation 1637 msl; three feet below the existing jetty and two feet above the normal water surface elevation. A profile and typical section of the jetty extension is shown in Figure 7.

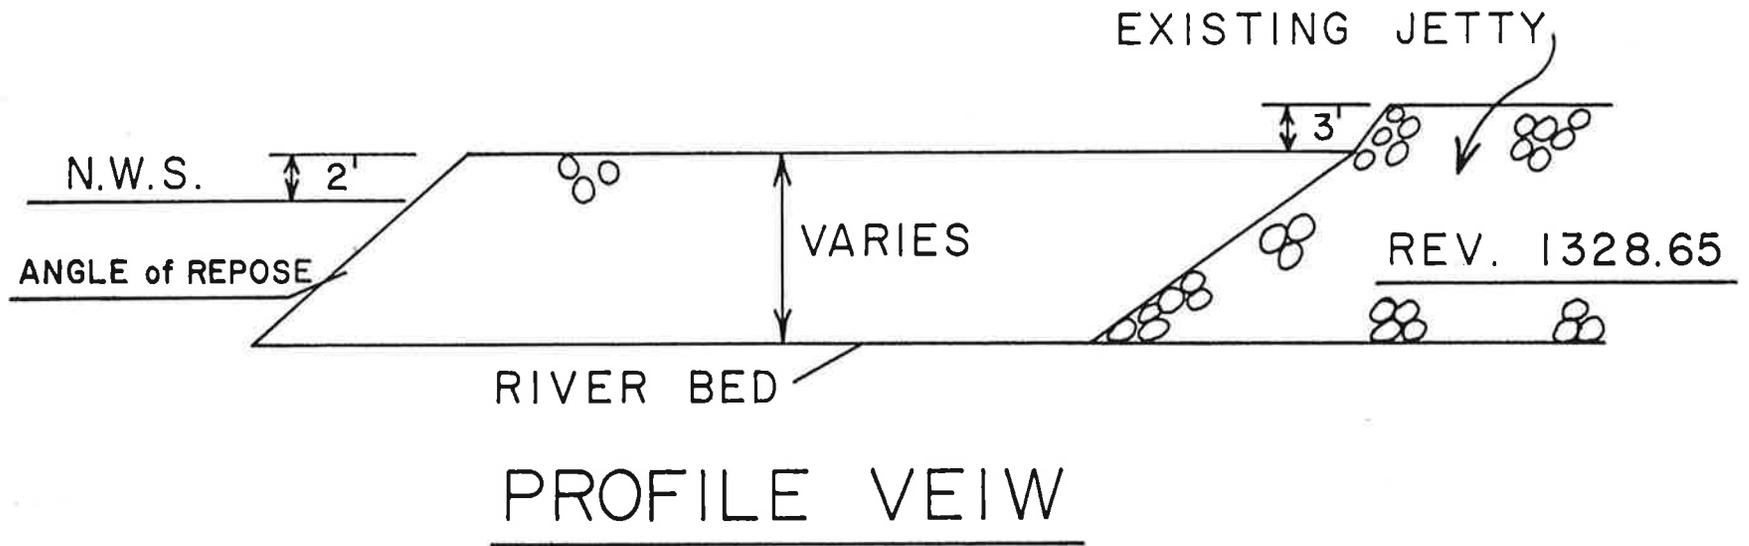
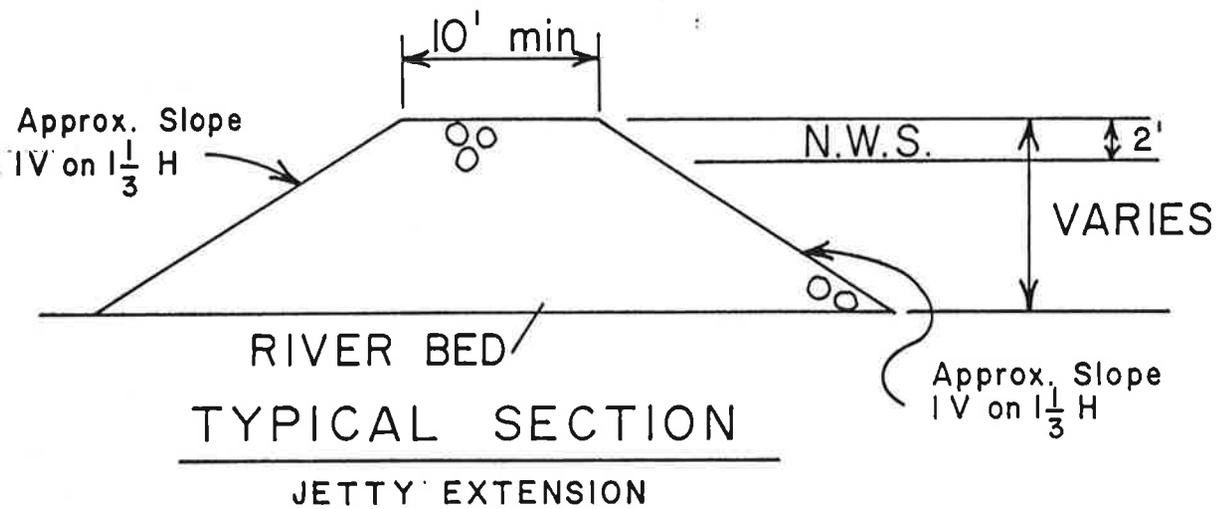
MISSOURI RIVER BANK STABILIZATION
 SWC PROJECT NO. 576-27
 Sundown Acres
 Profile and Typical Section
 No Scale
 Figure 7

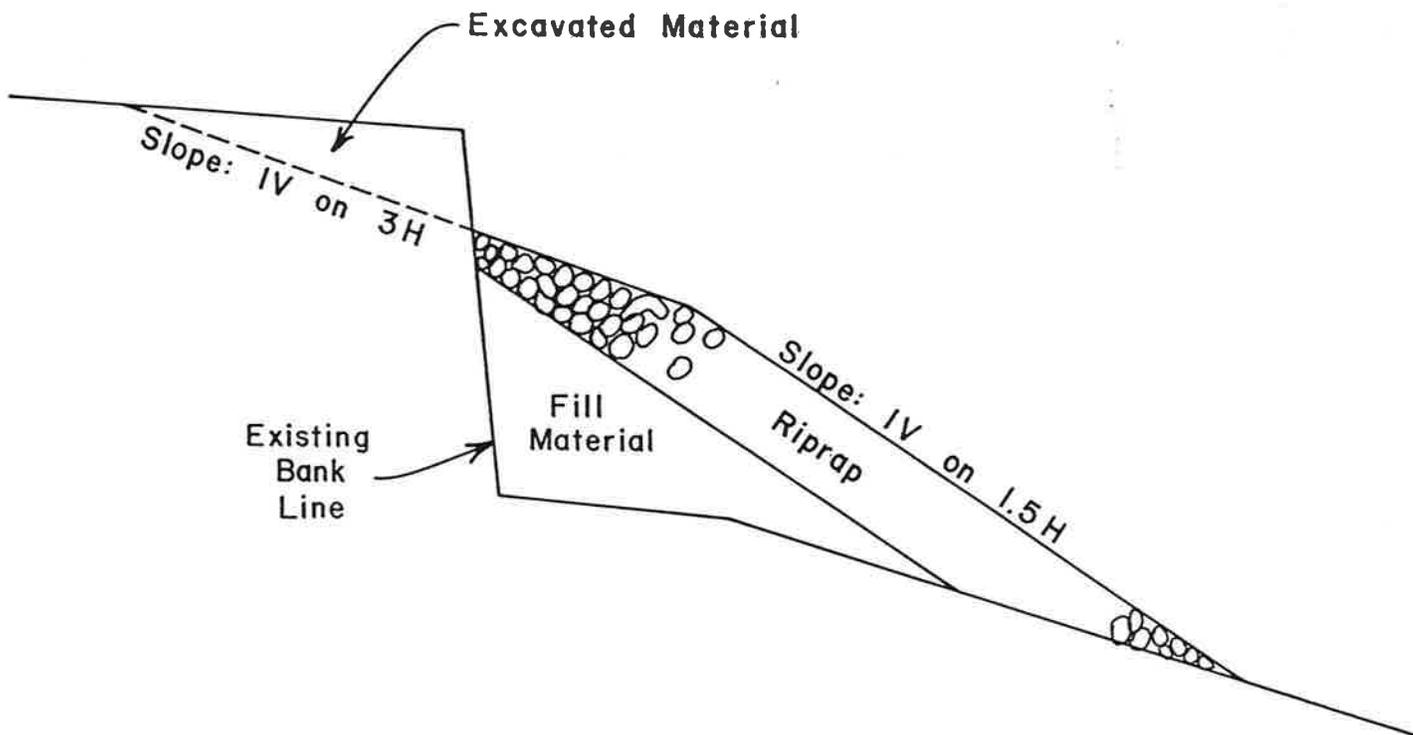
Figure 8

MISSOURI RIVER BANK STABILIZATION
SWC PROJECT NO. 576-27
SUNDOWN ACRES
Typical Cross-Section - Alternative 3
Scale: 1"=5'

This alternative consists of straightening the bank line and applying a continuous layer of rock riprap material. The stone would be placed at a rate of 4 tons per linear foot with a crown width of 4 feet. The bank area above the riprap would be back-sloped at 1:3 (1 Vertical to 3 Horizontal) and the riprap would be placed on a 1:1.5 sloped surface. A typical section of an Alternative #3 riprapped bank, is shown in Figure 8. The riprap would extend down a minimum of 8 feet to elevation 1630 msl.

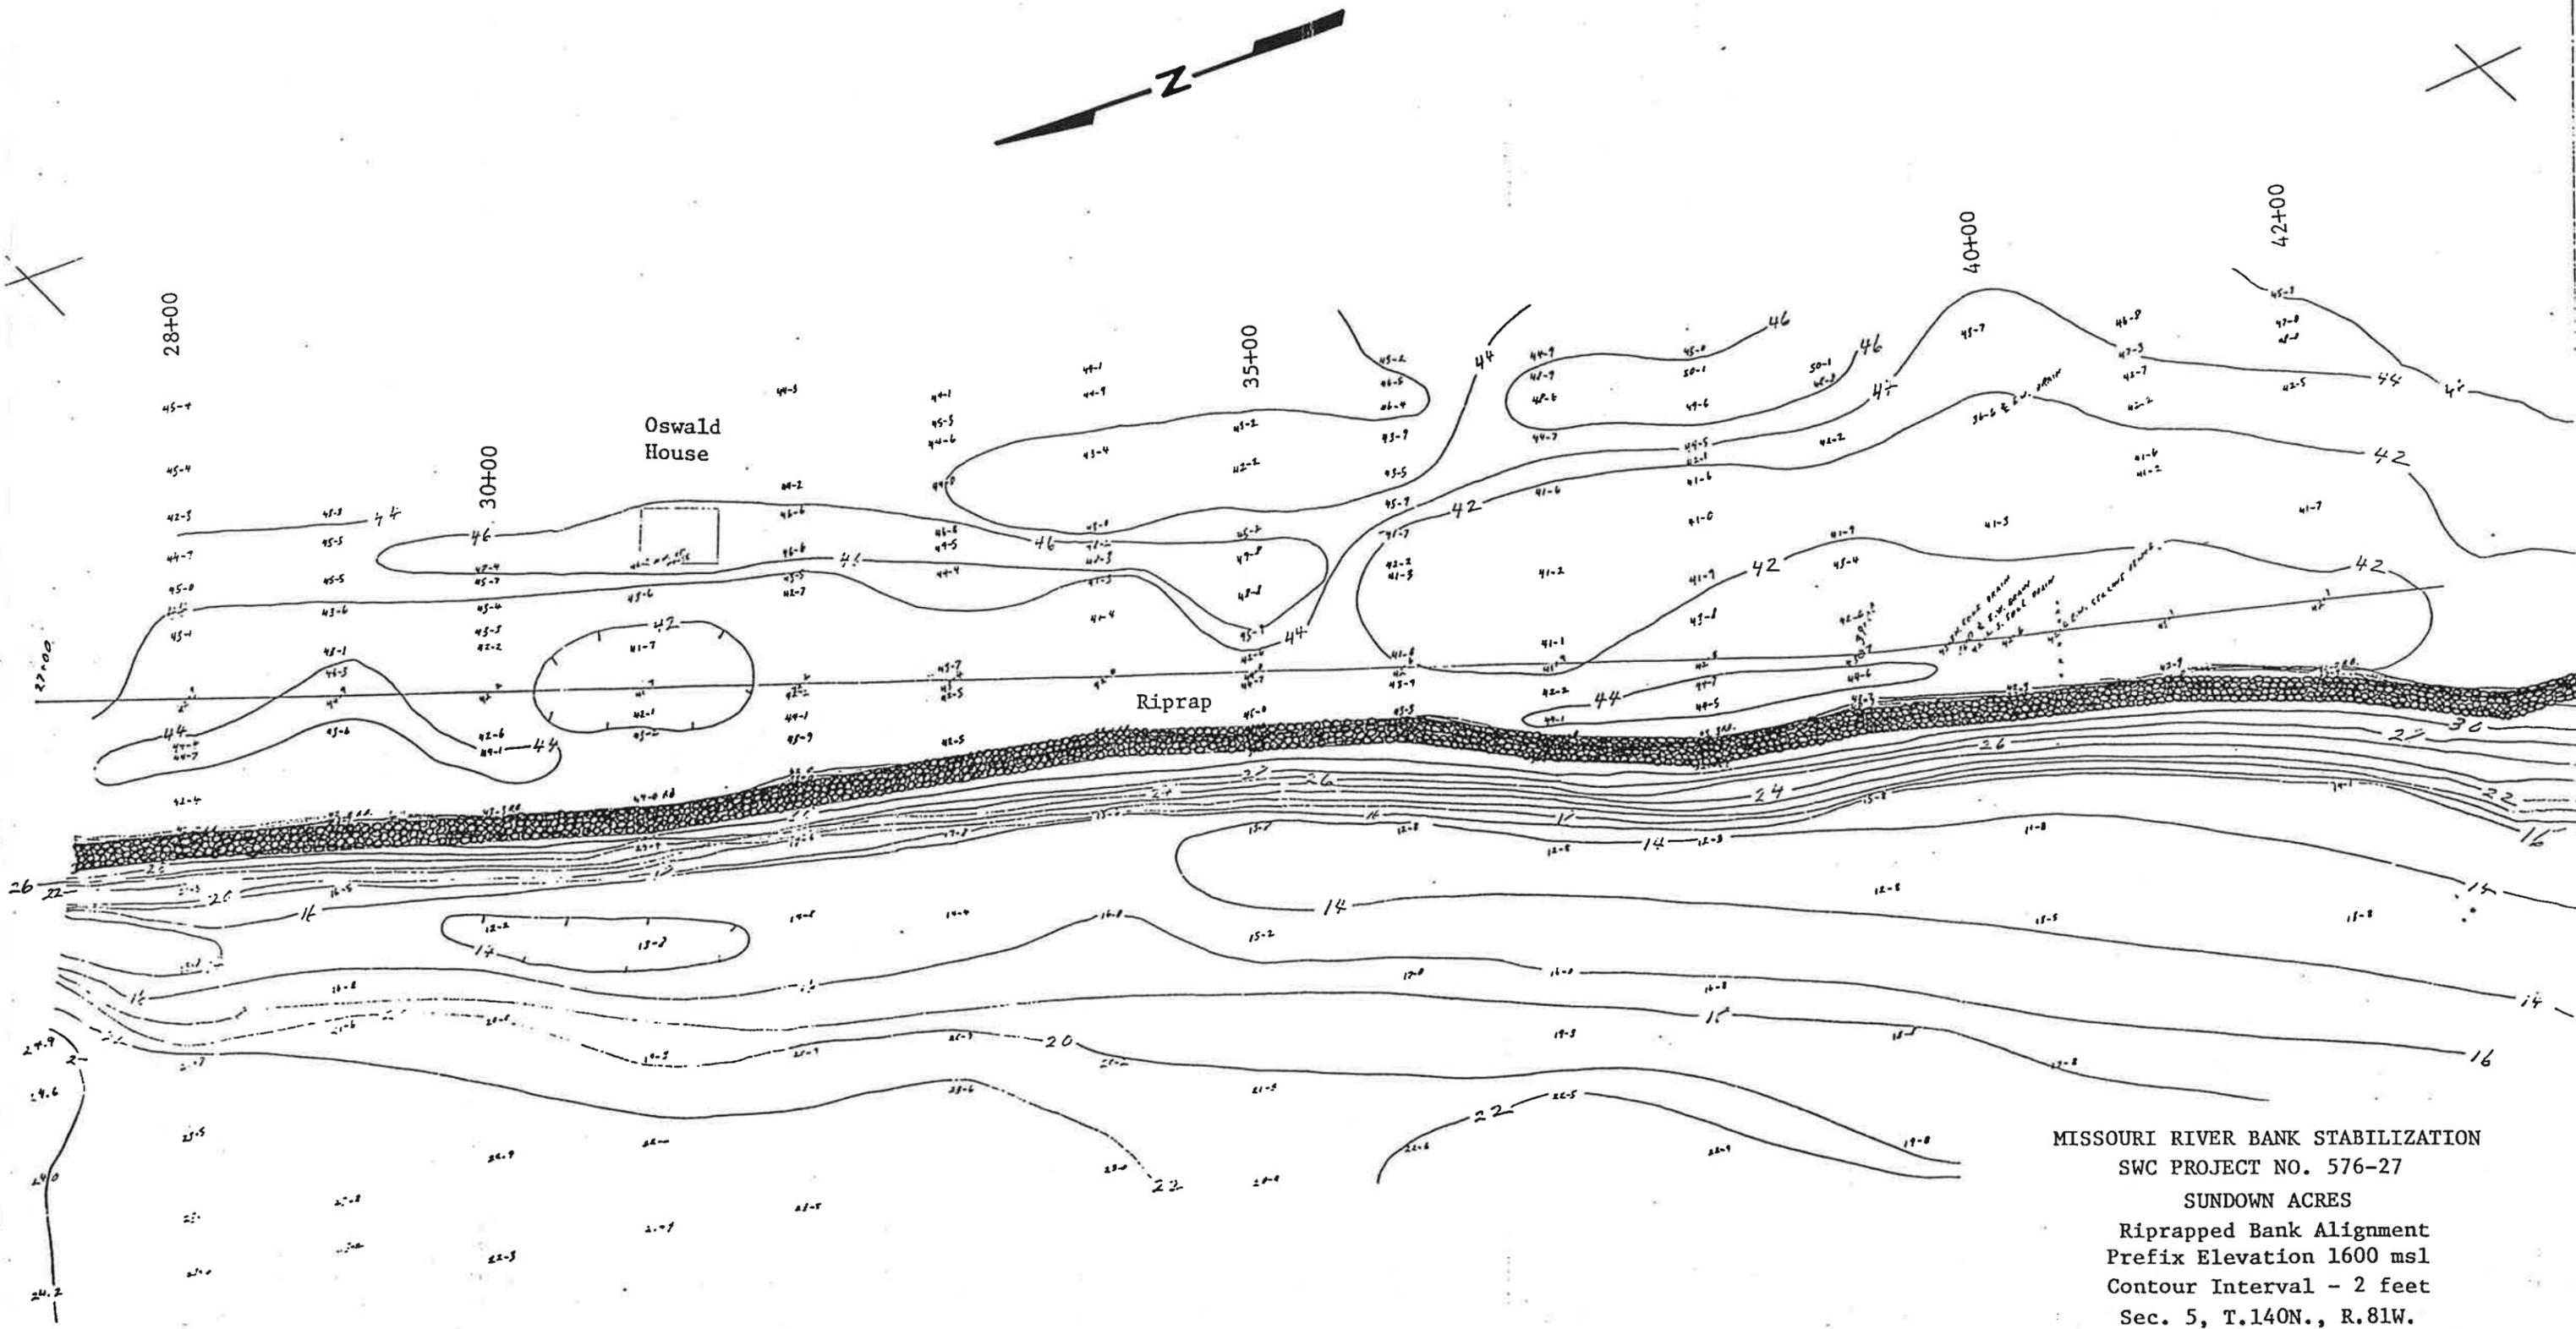
MISSOURI RIVER BANK STABILIZATION
 SWC PROJECT NO. 576-27
 SUNDOWN ACRES
 Riprapped Bank Alignment
 Prefix Elevation 1600 msl
 Contour Interval - 2 feet
 Sec. 5, T.140N., R.81W.
 Scale: 1"=100'
 Figure 10

The irregular shape of the bank line increases the susceptibility of the bank to erosion, causes whirlpools and increases the flow turbidity which further increases the potential for the flows to erode. Straightening the bank line reduces the erosion potential and also reduces the cost because less riprap is required. Figures 9, 10, and 11, show the alignment of the straightened and riprapped bank line.

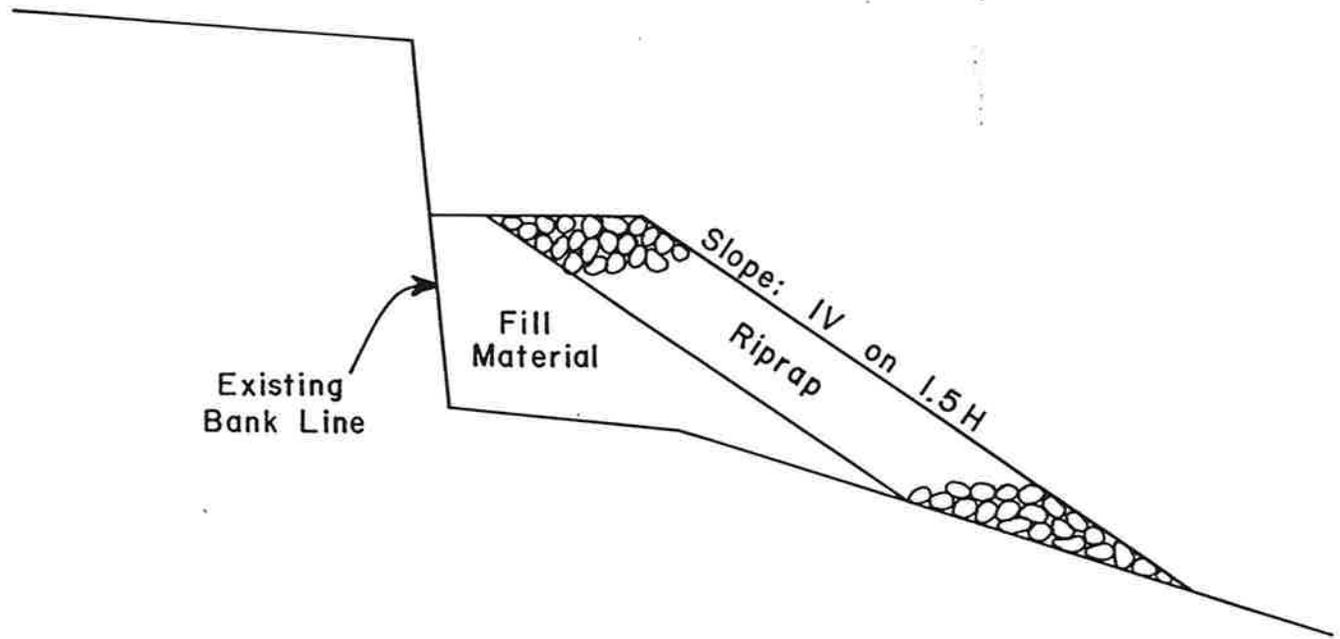
MISSOURI RIVER BANK STABILIZATION
SWC PROJECT NO. 576-27
SUNDOWN ACRES
Typical Cross-Section - Alternative 4
Scale: 1"=5'
Figure 12

This alternative is essentially the same as Alternative #3 except that the bank above the riprap would not be sloped in most areas and the riprap would have a flat top rather than sloped. A typical section of an Alternative #4 riprapped bank, is shown in Figure 12. Alternative #4 would be less expensive than Alternative #3, but would provide less protection during high runoff. Alternative #3 would provide an average of 2 feet of additional coverage on the top portion of the riprap. Alternative #4 would be more of a hazard in some areas due to the sudden drop off of the bank onto the riprap. Alternative 3 would provide easier access to the river and would be more esthetically pleasing than Alternative #4. Cost estimates for Alternative #4 constructed from Station 17+70 through Station 32+00 (Alternative #4A - 1,430 feet) and from Station 17+70 through 45+00 (Alternative #4B - 2,730 feet) are given below.
