PRELIMINARY ENGINEERING REPORT

ODLAND DAM RESTORATION

GOLDEN VALLEY CO., NORTH DAKOTA

SWC PROJECT NO. 394

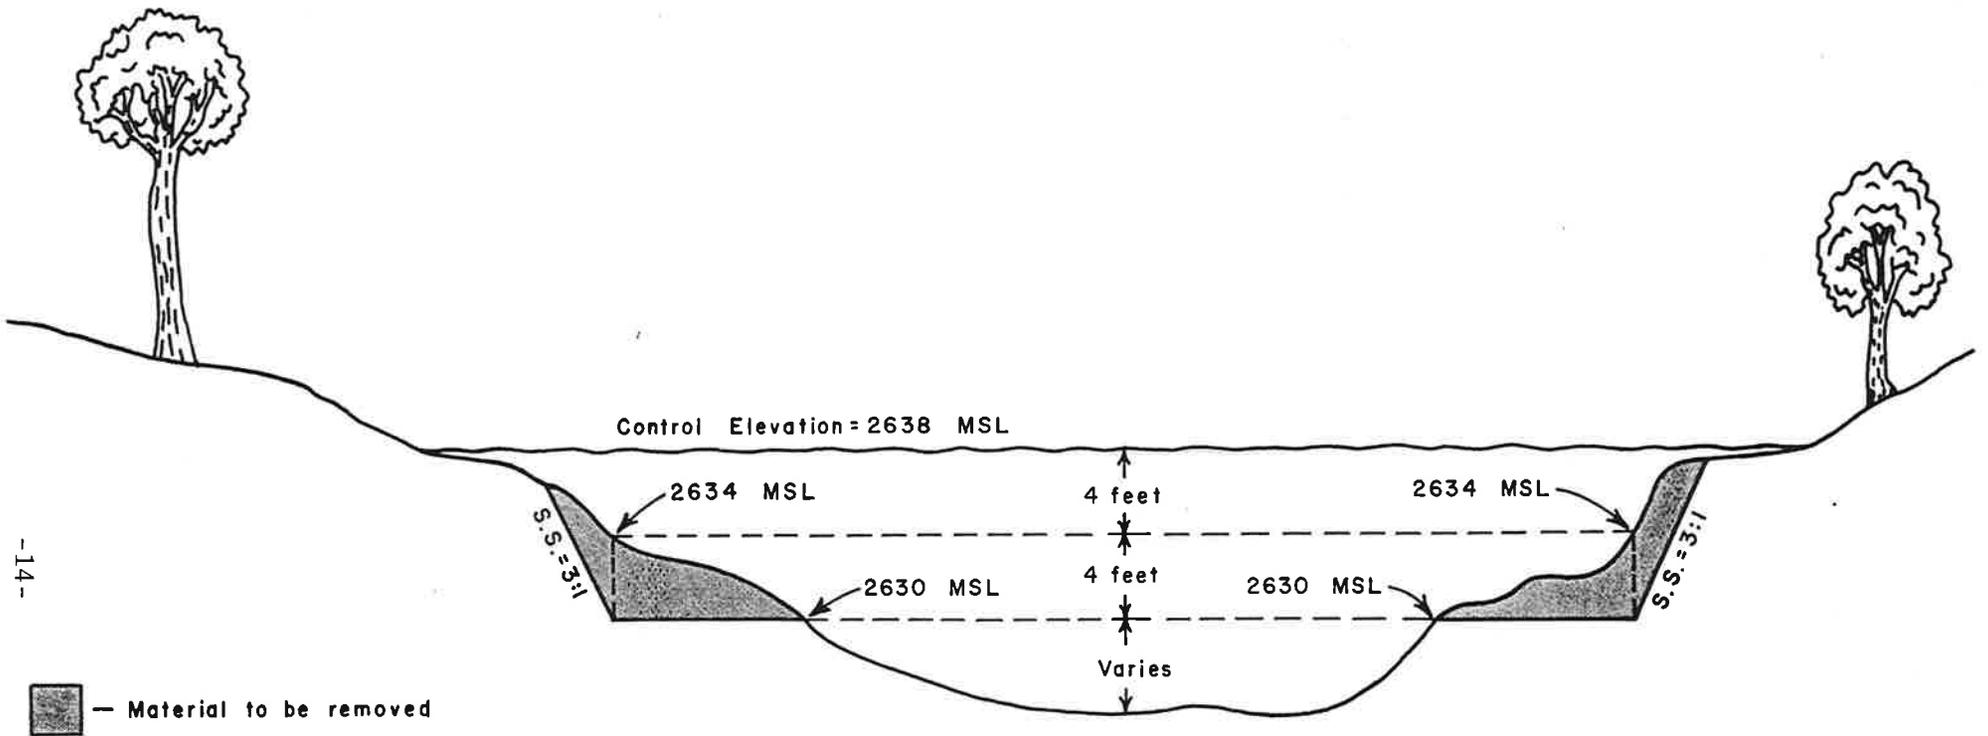
TYPICAL CROSS-SECTION

Figure 3 shows a typical cross-section of the reservoir bottom and the material which would be removed. As Figure 3 illustrates, all material between elevations 2630 and 2634 msl will be excavated from the reservoir bottom. All areas currently 4 feet deep will be 8 feet deep, as measured from the control elevation of 2638 msl. The slope adjacent to the excavated reservoir bottom will be constructed at a slope of 3H:1V.

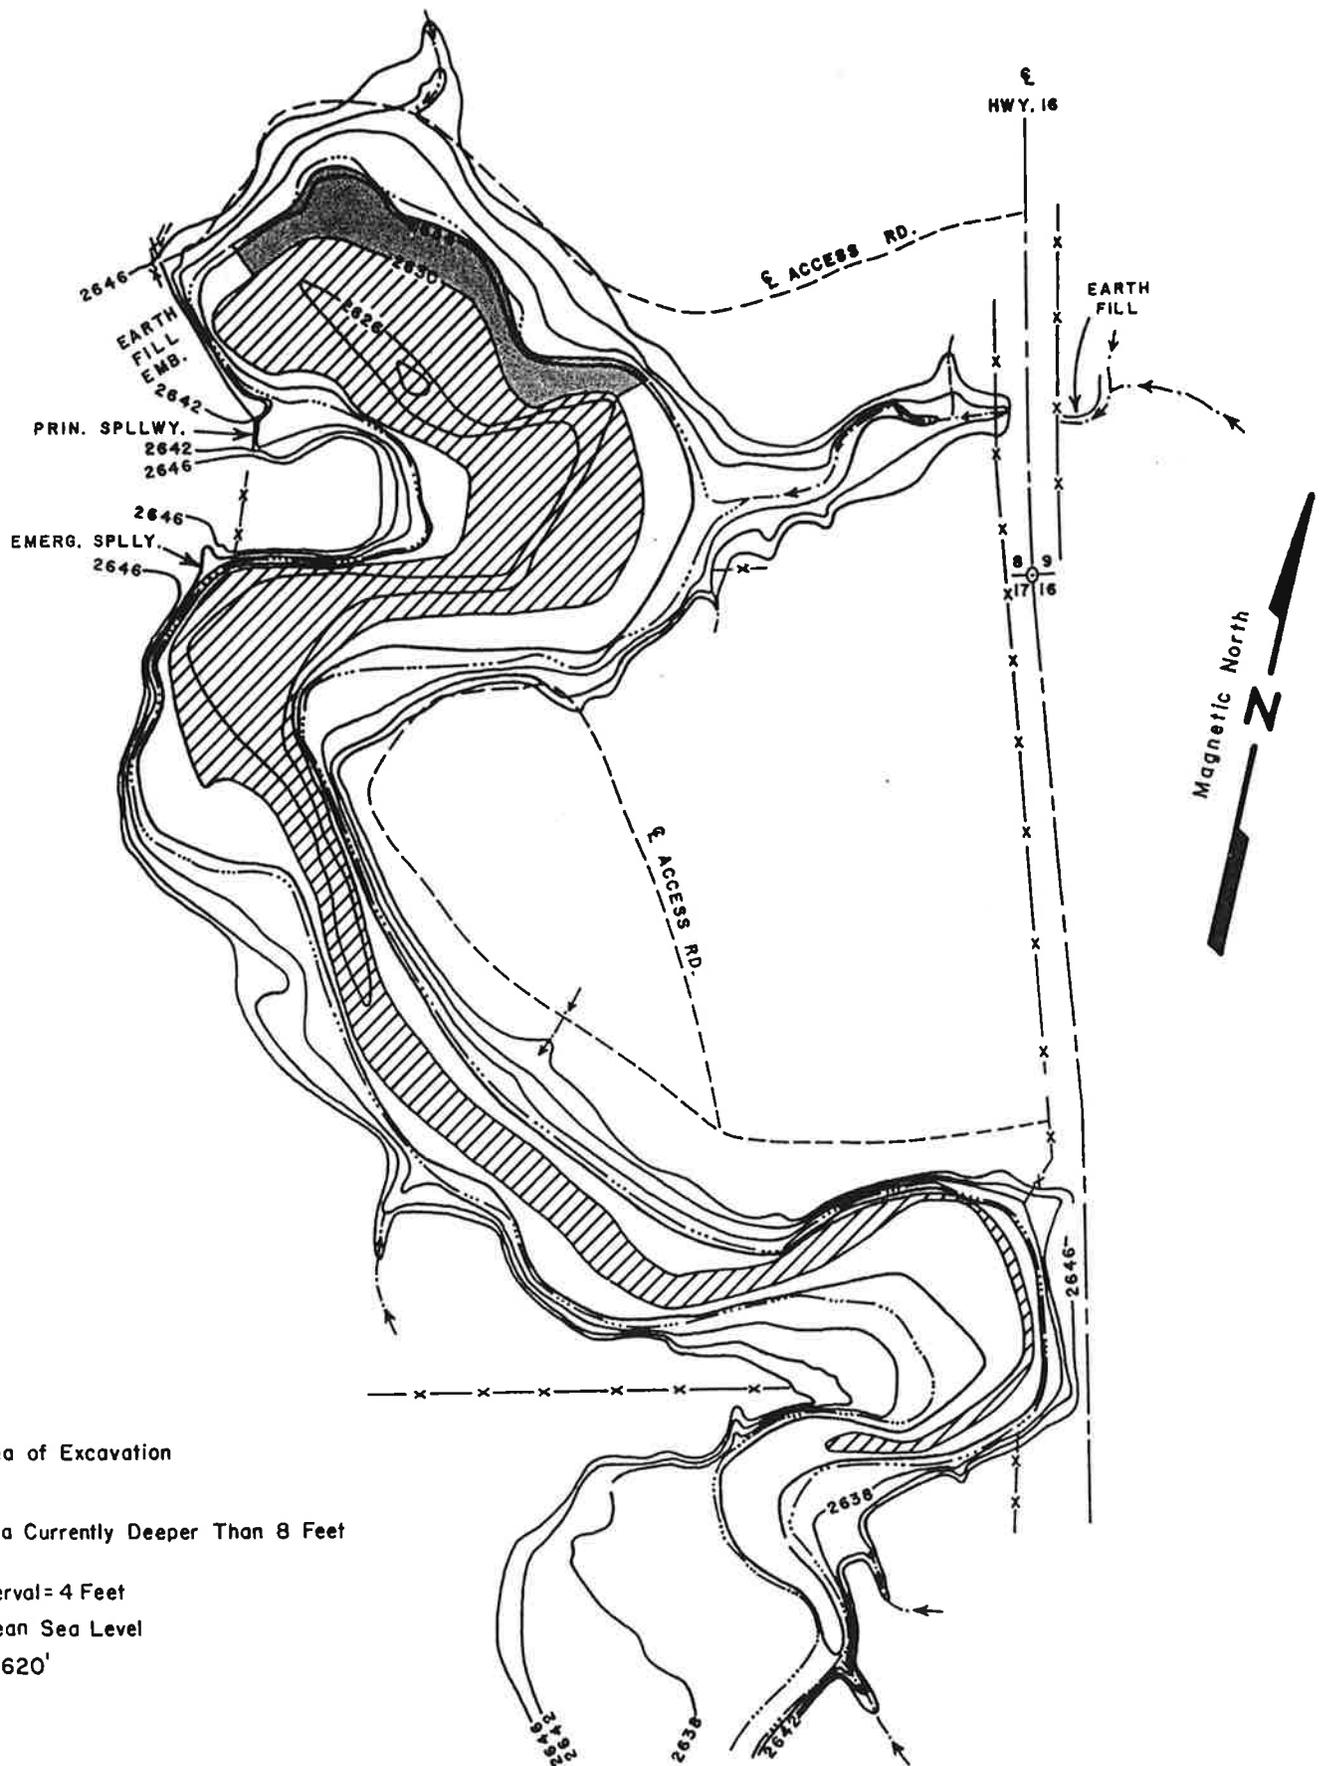
ALTERNATIVE I
Figure 4

Contour Interval = 4 Feet
 Datum is Mean Sea Level
 Scale: 1" = 620'

Four alternative plans for restoring the lake have been studied. The four alternatives consider excavation of different portions of the reservoir bottom. Figures 4, 5, 6, and 7, show those areas of the reservoir which would be deepened for Alternatives 1, 2, 3, and 4, respectively. As the figures show, there will be no excavation in the immediate area around the embankment and the principal spillway. There currently are seepage problems in these areas and excavation in the immediate vicinity may worsen the existing problem.

Alternative 1 involves the removal of sediment beginning adjacent to the boat ramps near the north embankment and extending approximately 1,700 feet along the northern portion of the reservoir (Figure 4). The amount of material removed would be 18,000 cubic yards. The reservoir capacity would be increased 11.2 acre-feet. The average depth of the reservoir would be increased 2 percent from 5.5 feet to 5.6 feet. The portion of the reservoir at least 8 feet deep

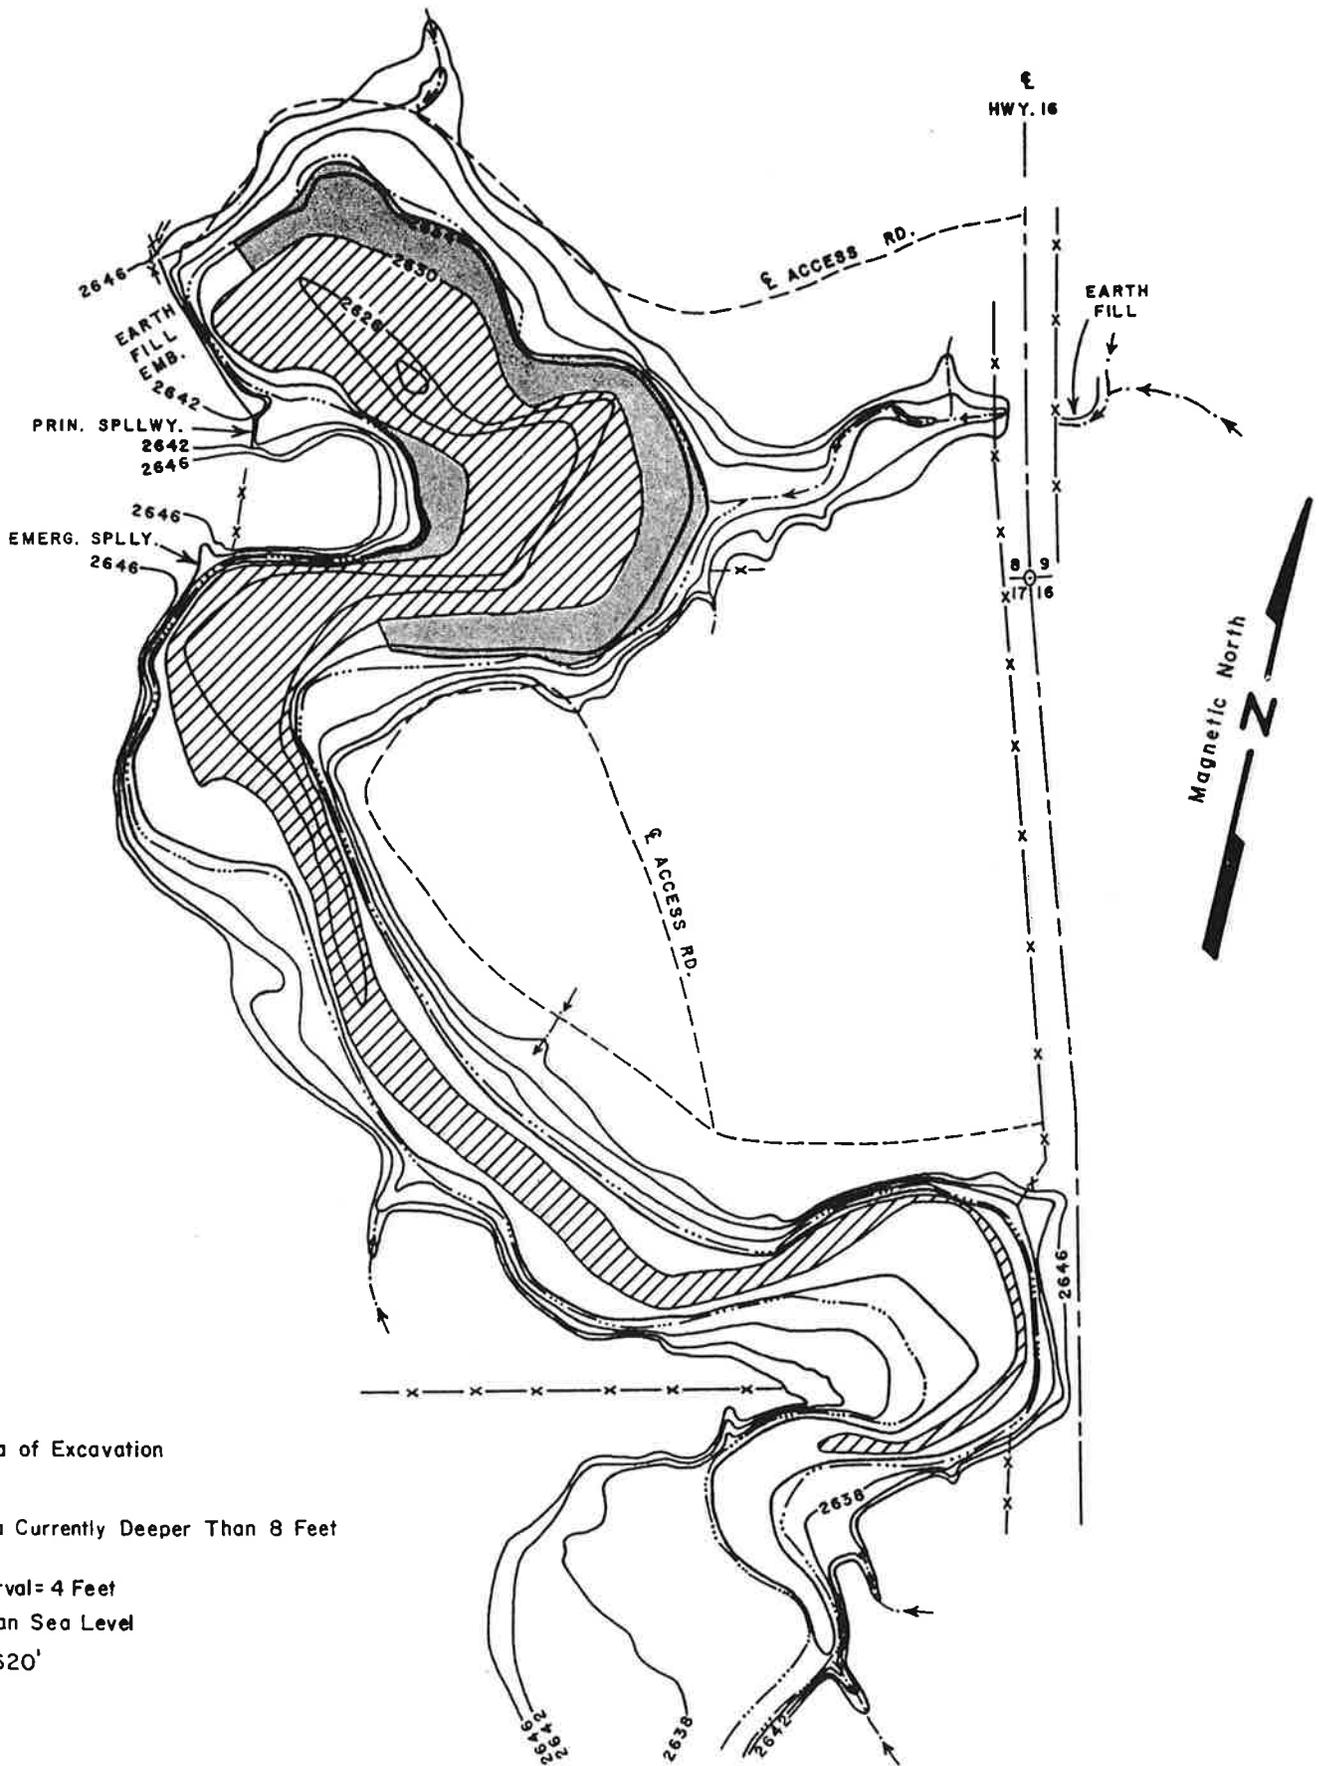
ALTERNATIVE 2
Figure 5

Contour Interval= 4 Feet
 Datum is Mean Sea Level
 Scale: 1" = 620'

Alternative 2 would include the removal of sediment from the same area as Alternative 1 and an additional 1,650-foot strip along the eastern edge and an 850-foot strip along the western portion of the reservoir (Figure 5). A total of 41,900 cubic yards of material would be removed adding 25.9 acre-feet to the capacity of the reservoir. The average depth of the reservoir would be increased 4 percent to 5.7 feet. The area of the reservoir at least 8 feet deep would be increased 29 percent to 47.5 acres.
