# RICE LAKE PHASE 1 INVESTIGATION REPORT

Emmons County, North Dakota

SWC Project #2147  
August 2020

*SWC Project #2147*

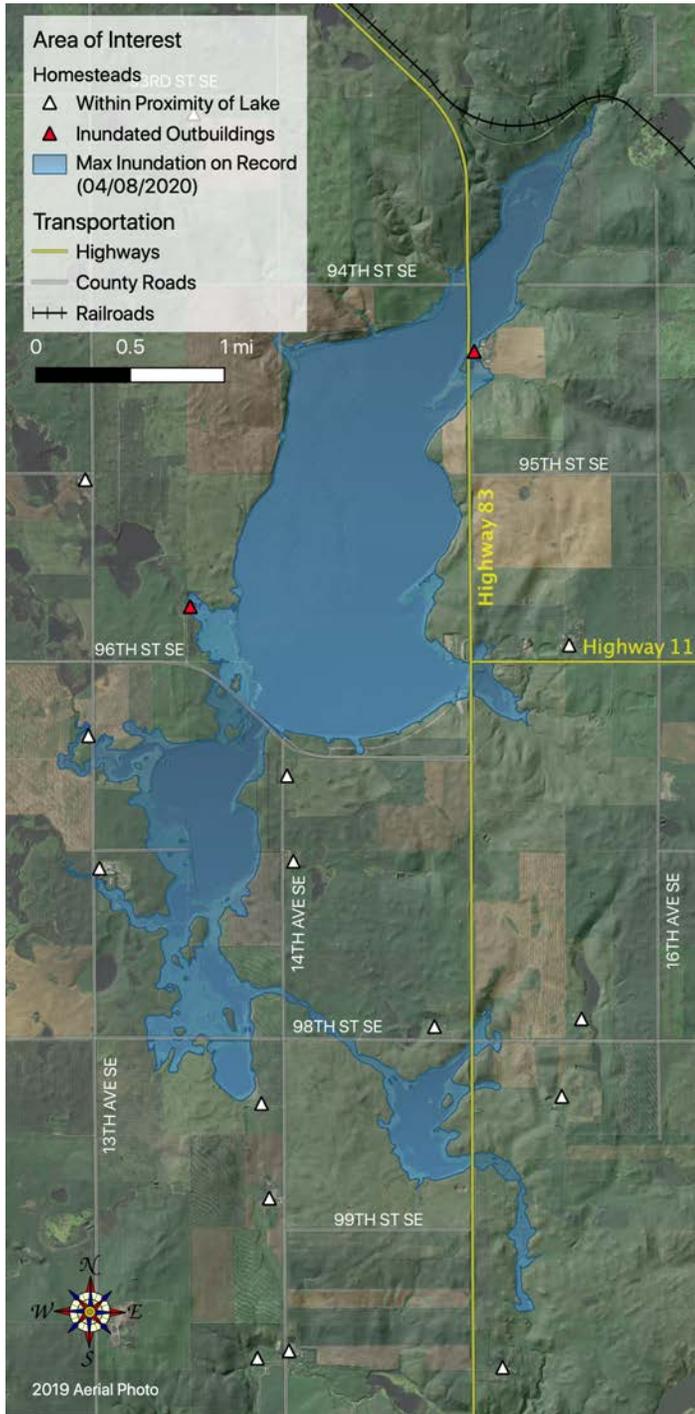
Figure 11 – Homesteads within the Rice Lake Area of Interest

Figure 11 displays the homesteads within the Rice Lake area of interest that is delineated in Figure 1. There are 2 homesteads with inundated outbuildings as of June 10, but all marked residences are currently accessible. Homeowners in the area have also mentioned there is water in numerous basements. Future development of homes around the lake is imminent. It is recommended extra precautions are taken when determining placement of these homes and whether to include a basement.
